Repeated resetting of the Antenna Unit Processing (AUP) module due to high contact resistance of connector on Interconnection Board (ICB)

Artemis MK5 Engineering Note EN5-1

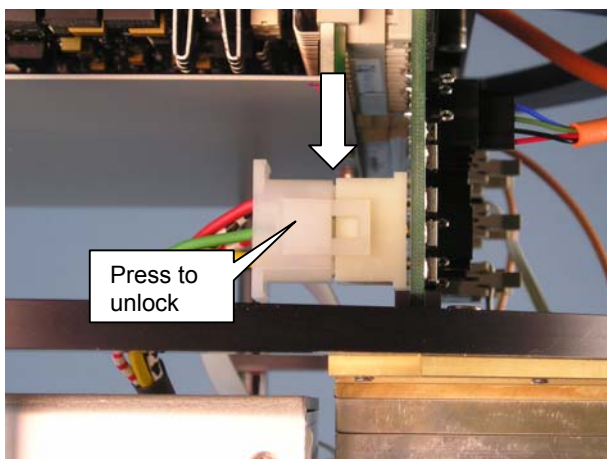
Photo 1

It has appeared that the 6-way connector used for the connection of the supply voltages from the power supply module A5PS to the Interconnection Board A5ICB – see photos below - may have a considerable contact resistance. If this is the case, this may cause the supply voltage of the Antenna Unit Processing (AUP) module to drop below the minimum voltage, upon which the AUP module will repeatedly reset itself.

Investigation of the 6-way connector has revealed that the male and female part of the connector may mechanically not match properly. An official complaint has in the mean time been filed with the supplier of the connector, who in turn has filed this complaint with the manufacturer.

1. Switch the Antenna Unit or Beacon Unit off (switch off the power to the unit).
2. Remove the bottom cover from the Antenna Unit or Beacon Unit.
3. Locate the white 6-way cable connector at the inside of the Interconnection Board (photo 1).

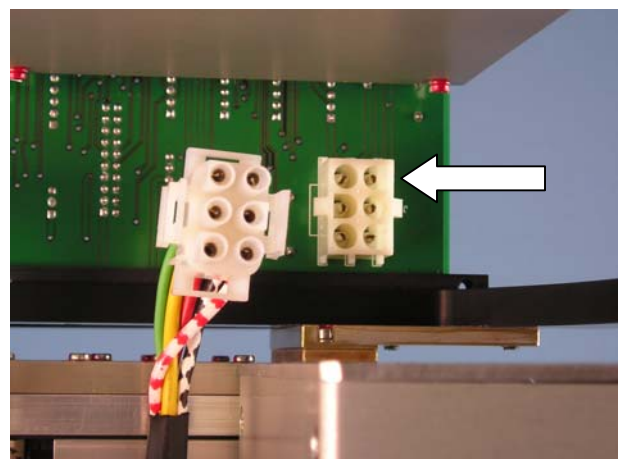
Photo 2

If the phenomenon of a repeatedly resetting AUP module is experienced, the cause of this may be a high contact resistance of the 6-way connector, and in particular of the contacts carrying the 5.1 V supply voltage from the power supply module A5PS to the Interconnection Board A5ICB. If this is the case, the following may be a remedy (see overleaf).

4. Press the locking mechanism on the connector with thumb and index finger and pull the cable connector from the Interconnection Board.
5. Take a small, sharp screwdriver and push it carefully in the slot of each of the six male contact pins (on the Interconnection Board) until the two halves of the contact pins are a bit more apart from each other (photo 2).
