Service Experience 2006, ME and MC Engines

Introduction

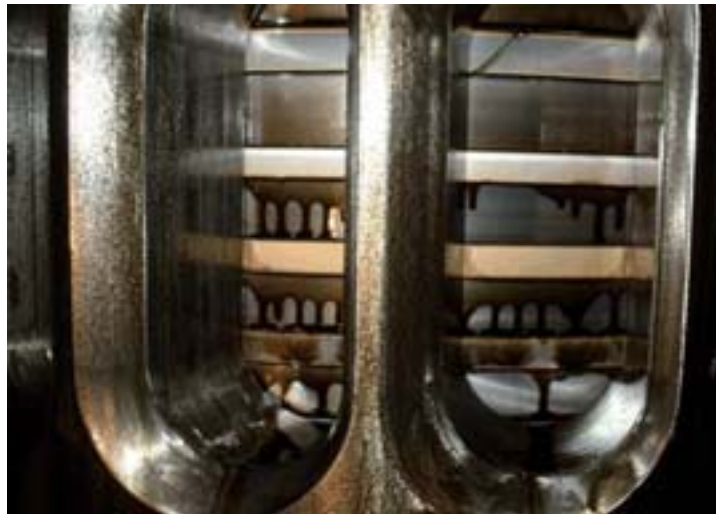
Fig. 12: 12K98ME, port inspection shows excellent condition

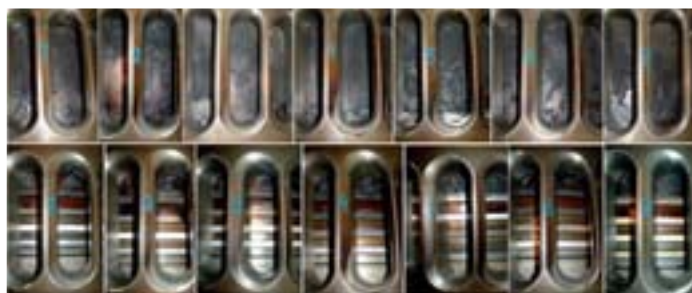
Fig. 11 demonstrates the cylinder condition on the first 7S50ME-C after 10,717 running hours, and the condition is perfect. As regards the cylinder condition, in particular, observations

Fig. 11: 7S50ME-C, cylinder condition after 10,717 running hours

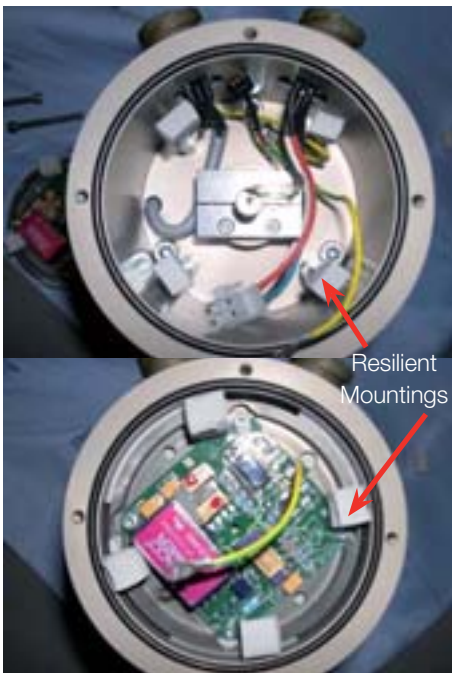
Fig. 15: ELFI valve, PCB secured by resilient mountings

On the Print Circuit Board (PCB) components have come loose due to vibrations. Fig. 14 shows a DC-DC converter which has come off. Improvements by means of resilient mountings have been introduced on all vessels in service with ELFI valves, and performance has been good hereafter, see Fig. 15 .

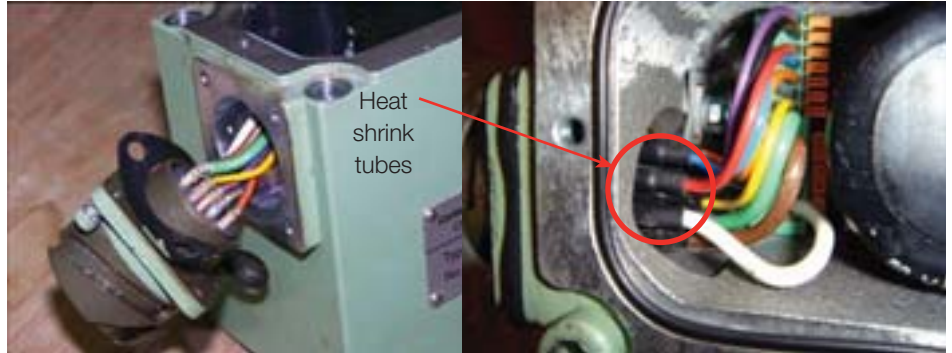
Fig. 19: ELVA valve, reinforcement by heat shrink tubes

pin is reinforced by a heat shrink tube, Fig. 19.

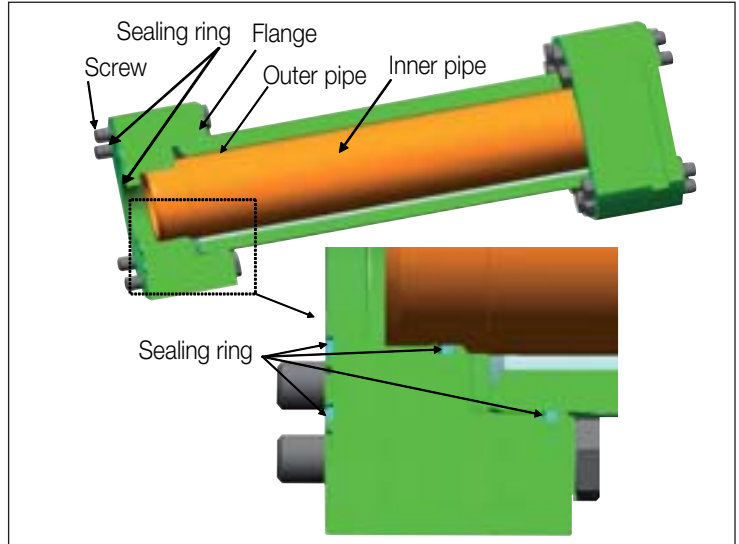
Problems with hydraulic oil leakages have been seen during shop tests on the largest engines because of seal damage. The main reason for these problems was lack of quality from a new sub-supplier of these sealings. In any case, it was decided to upgrade the seal design for the 80-98 bore engines, see Figs. 24 and 25.

Fig. 24: Double-wall piping, old sealing arrangement

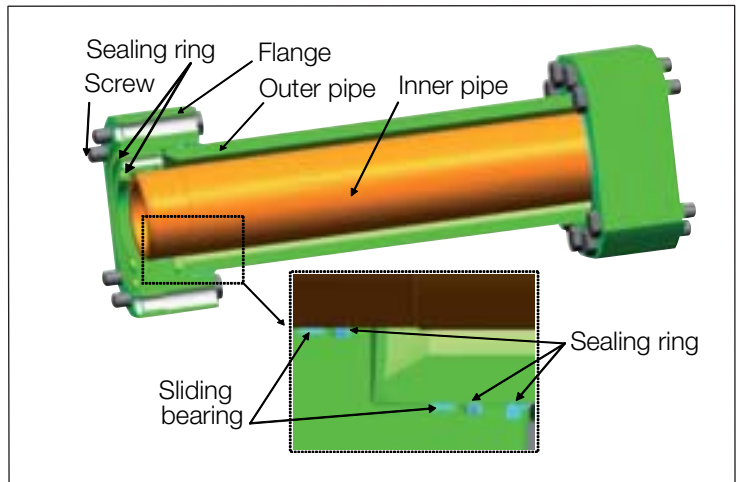
Fig. 25: Double-wall piping, new sealing arrangement

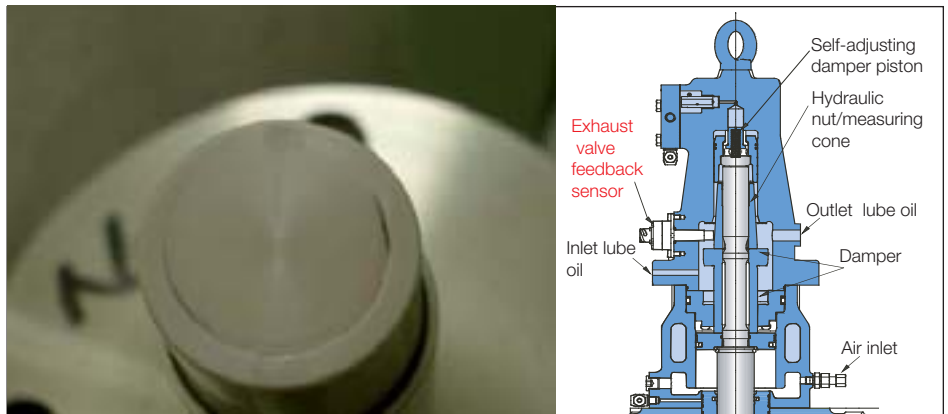
The plastic sensor tip has broken loose or it has been pressed in, Fig. 23. The tip has been reinforced and the internal moulding in the tip has been improved by process improvements.

Fig. 23: Exhaust valve feedback sensor

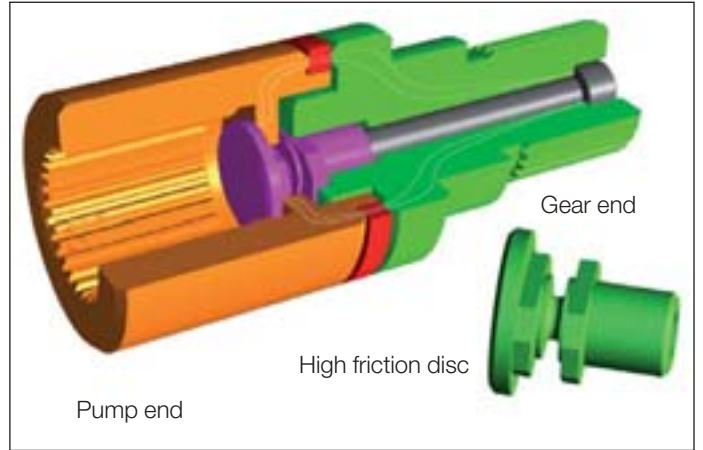
Fig. 31: Pump safety shaft, new shaft assembly with central bolt

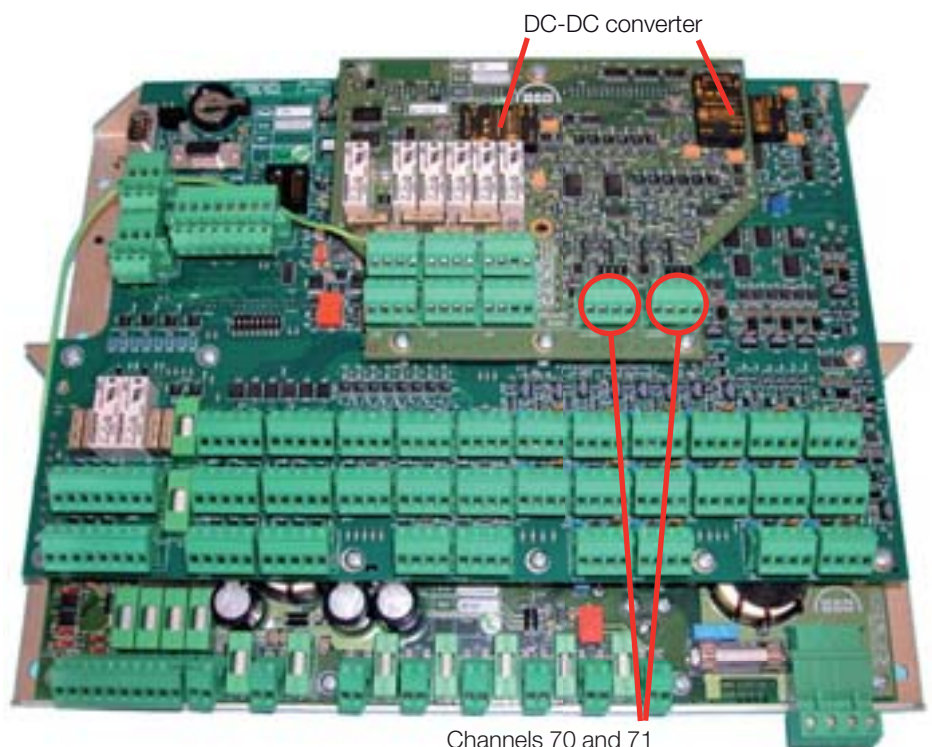
On the MPC, channels 70 and 71 have been damaged in some cases. This was caused by wrong or fluctuating signals at the outputs. Consequently, a breakdown of a capacitor in the DC-DC converters (Fig. 33) took place. This was determined to happen when 24V or higher voltages (noise, etc.) were applied backwards into the terminals

Fig. 33: MPC board, failure of channels 70 and 71

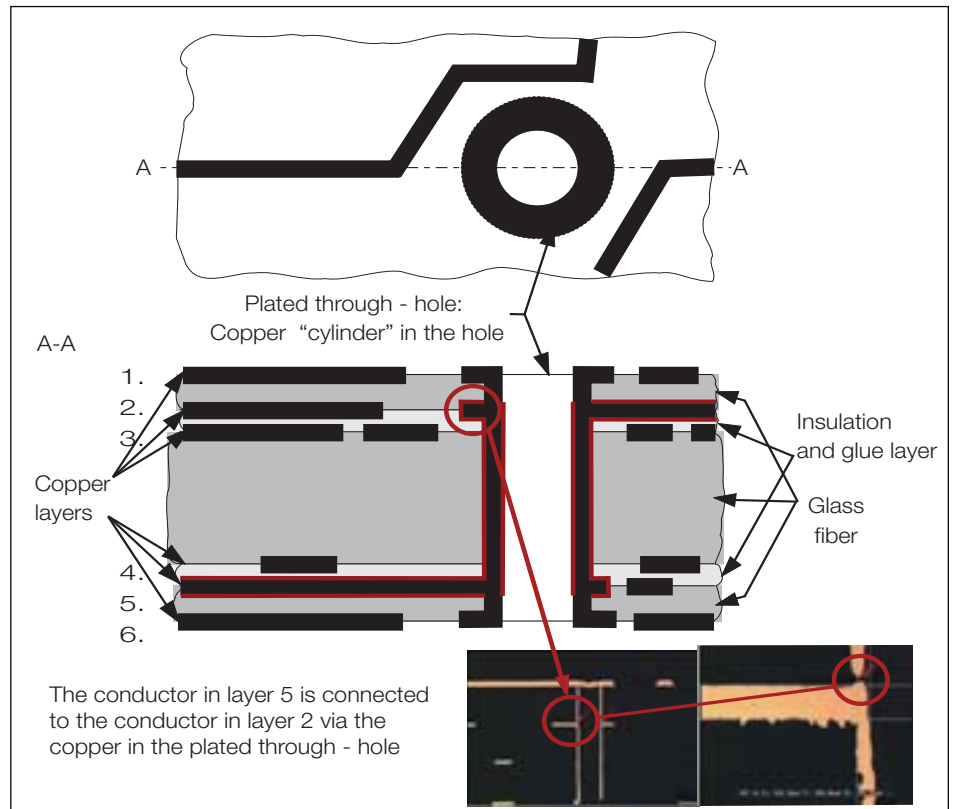
Production failures in the Printed Circuit Boards (PCBs) have caused broken connections in the inner layers, Fig. 35. The PCB base material has been changed to a type with a lower thermal expansion coefficient in the cross-sectional direction. Furthermore, the copper layer thickness in plated-through holes has been increased to fulfil the specification.

Fig. 35: PCB, broken copper layers

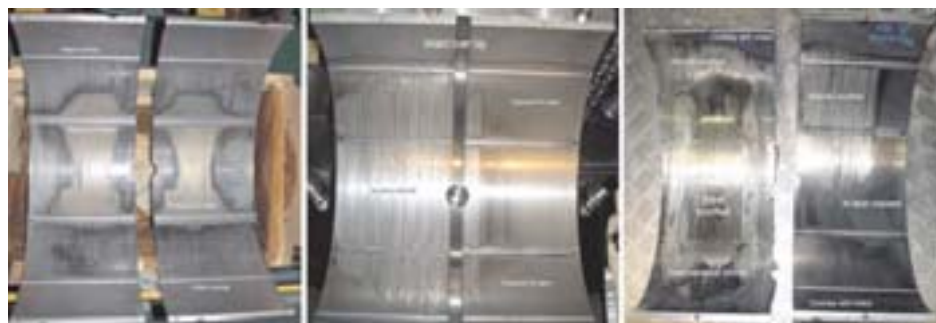
Partially corroded overlay, not yet scuffed

Fig. 61: Crosshead bearing overlay corrosion

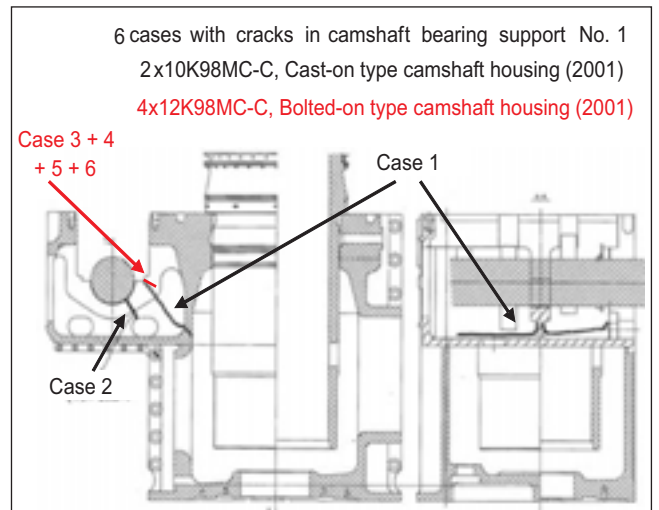
Fig. 65: Crack paths in camshaft bearing pedestals

4. For engines with cracks propagating in the main cylinder frame structure (Fig. 65, case 1), a new one-cylinder frame block has been prepared. This block will be exchanged when the vessel docks in August 2006.
5. Fig. 65, case 2 shows a crack in a cylinder frame with an integrated camshaft housing. However, the crack has only propagated in the bearing pedestal No. 1 in the camshaft housing. Fig. 71 shows the principle of two hanging bearings installed hanging from cylinder No. 1 base plate. This will completely offload the camshaft bearing pedestal No. 1 when the bearing shell is removed. Installation of this solution

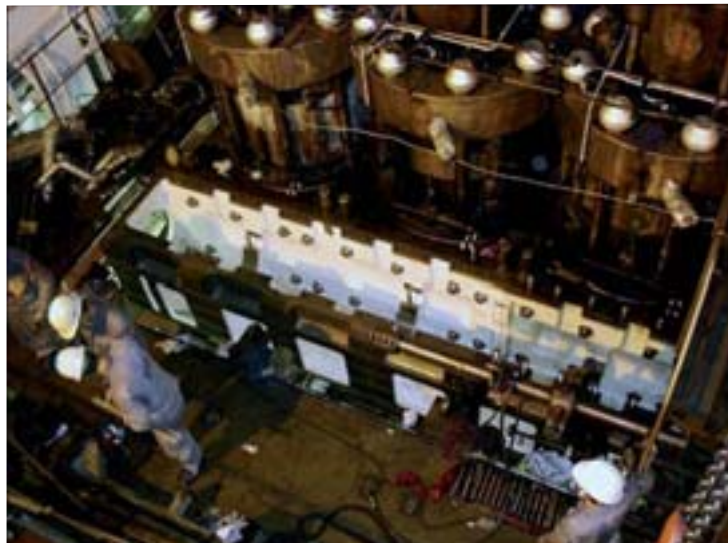
Fig. 72: Exchange of cracked two-cylinder camshaft housing section
