Service Experience 2008, MAN B&W Engines ME/ME-C and MC/MC-C Engine Series

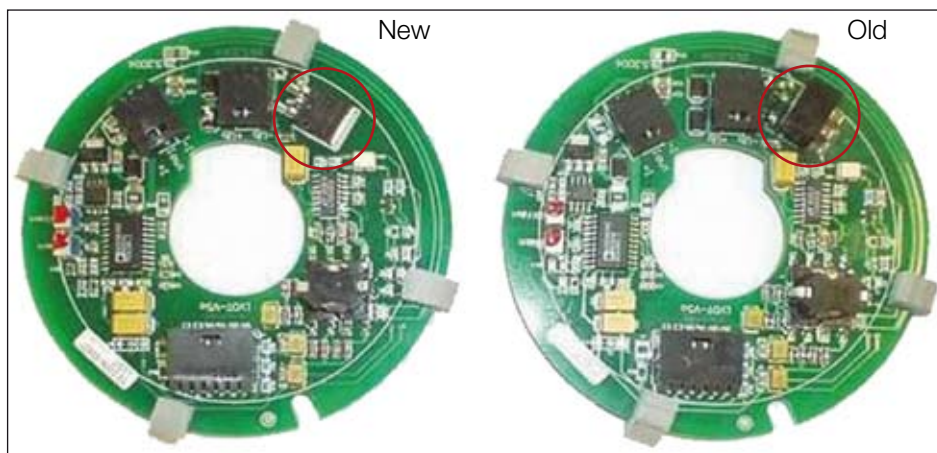
In the original version, the electronics on the printed circuit board (PCB) in the Curtiss Wright FIVA valve showed thermal instability causing untimed actuation of the valve. The reason was an analogue voltage regulator generating

Fig. 8.4: FIVA valve feedback failure: exchange of analogue voltage regulator with switch mode voltage regulator

an excessive amount of heat raising the temperature by 35°C on the PCB. In some cases, this caused a temperature shutdown of the LVDT converter in the feedback loop, resulting in the above-described unstable function of the FIVA valve. The solution was to exchange the analogue voltage regulator with a switch mode regulator, Fig. 8.4. Hereby, the temperature of the PCB was lowered by approx. 35°C.

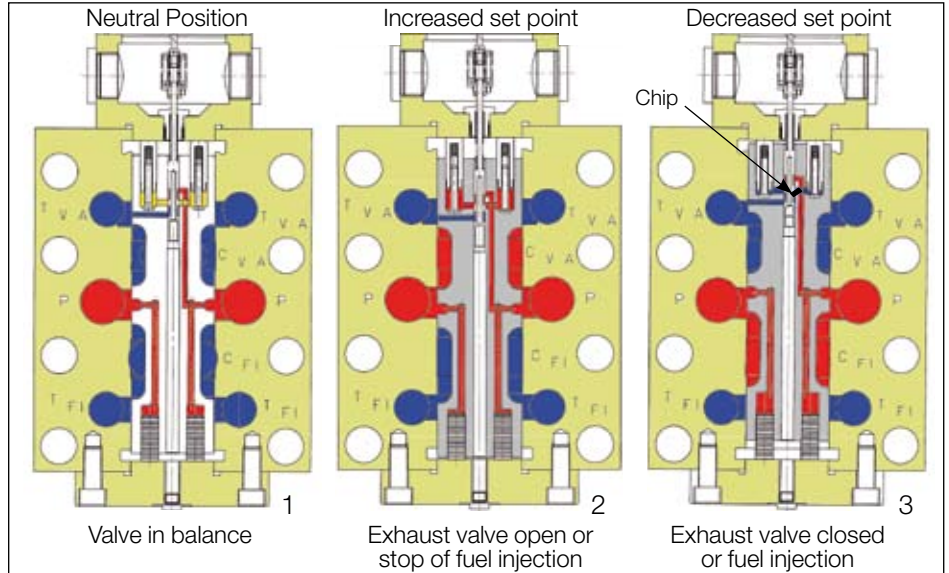
Fig. 8.6 gives an explanation of what happens if a loose drilling chip is stuck between the pilot slide and the main slide.

Fig. 8.6 (left hand side) shows the valve in balance. This means that the constant pressure on the bottom of the main slide is balanced by a pressure creating a similar force in downward direction, thus keeping the slide in neutral ("zero") position.

In order to open the exhaust valve or to stop fuel injection (Fig. 8.6, centre), the pilot slide should be moved downward, thereby increasing the pressure on the top of the main slide and moving the main slide downward. This will result in exhaust valve opening or stop of fuel injection.

When the pilot slide is moved upward (Fig. 8.6, right hand side), pressure on the top of the main slide is decreasing and the main slide is moved upward enabling closure of the exhaust valve or fuel injection. If a drilling chip is stuck in between the pilot and the main slide when the exhaust valve is closing, there is a risk of fuel injection just after closing of the exhaust valve. This will create an excessive pressure build-up in the combustion chamber and a risk of cylinder cover lifting. This was the cause

Fig. 8.6: CWAT FIVA valve: Movement of pilot valve and main slide

of the two cylinder cover lifts on the 6S70ME-C engines on testbed in 2007.

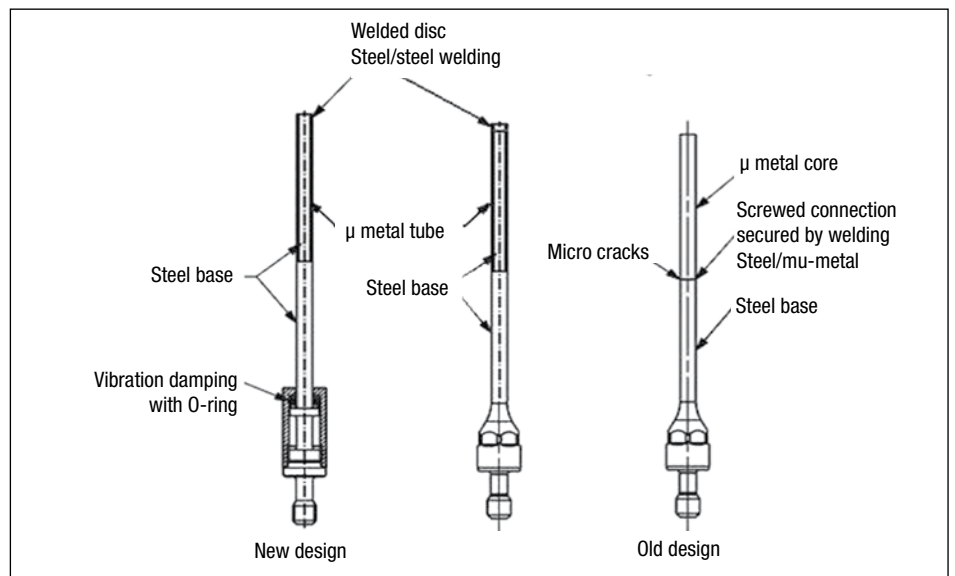
- A: Breakage of the rod in the sensor. The rod in the sensor has been redesigned, Fig. 8.9a
- B: Broken or loose connection between the print board and the external connector (type: Canon), Fig. 8.9b. Redesign of the connection has solved the problem.

Fig. 8.9a: Redesign of rod for sensor in H.F. Jensen feedback sensor

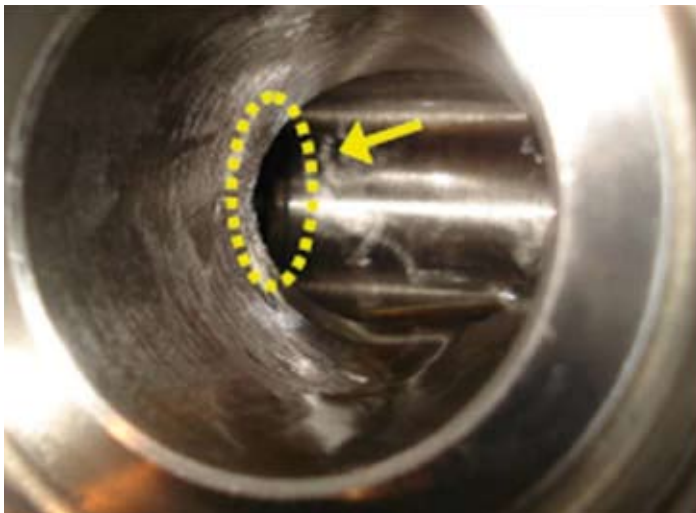
Cavitation in the exhaust valve actuation system has been seen in the exhaust valve top part, Fig. 8.11a, as well as in the exhaust actuator top cover, Fig. 8.11b.

Fig. 8.11a: Cavitation in exhaust valve top part

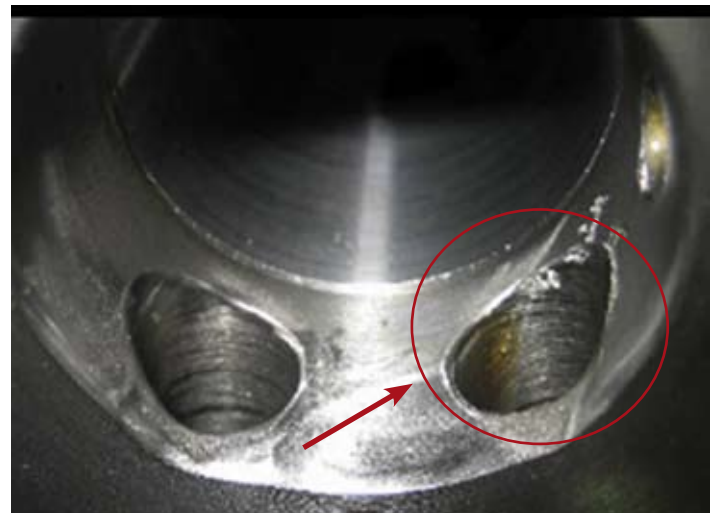
Furthermore, damage to the oil inlet non-return valves on the actuator top cover indicates excessive pressure fluctuations in the exhaust valve actuation system.

Fig. 8.11b: Cavitation in exhaust actuator top cover

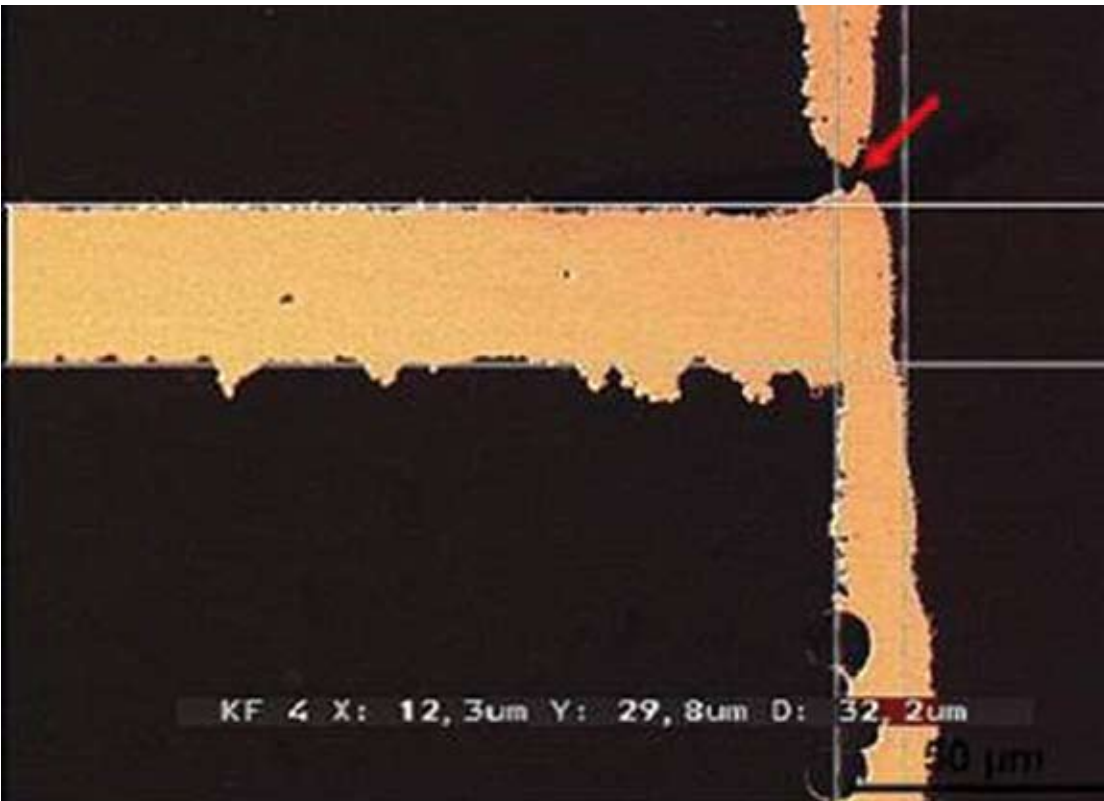
In 2007, we experienced one severe case of cylinder cover lift on a 6S60ME-C engine in service. After investigations into the parts involved on the cylinder unit in question, it was concluded that the reason was an error in the feedback loop for the FIVA control, Fig. 8.3. However, in this case the error was in the MPC part of the feedback loop. A loose/broken connection in the feedback circuit of the MPC was found during the investigation, see Fig. 8.15.

Fig. 8.15: Broken/loose connection in the MPC

Firstly, a circular letter warning against a specific alarm sequence was issued in order to exchange MPCs with similar potential defects. This circular letter was sent to all operators of ME engines.

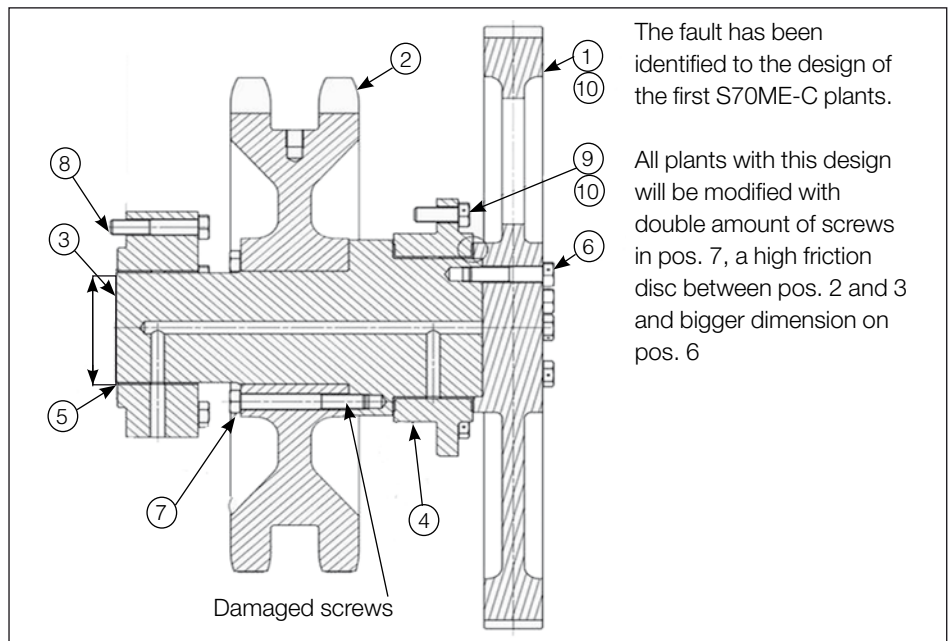
Fig. 8.19: S70ME-C assembly of shaft for hydraulic pump

For a series of the first S70ME-C plants, the chain wheel and gear wheel assembly on the HPS common shaft has shown to be under-dimensioned, Fig. 8.19. An upgrade of the bolt connections has been introduced on the concerned vessels in service.

The fault has been identified to the design of the first S70ME-C plants.

All plants with this design will be modified with double amount of screws in pos. 7, a high friction disc between pos. 2 and 3 and bigger dimension on pos. 6

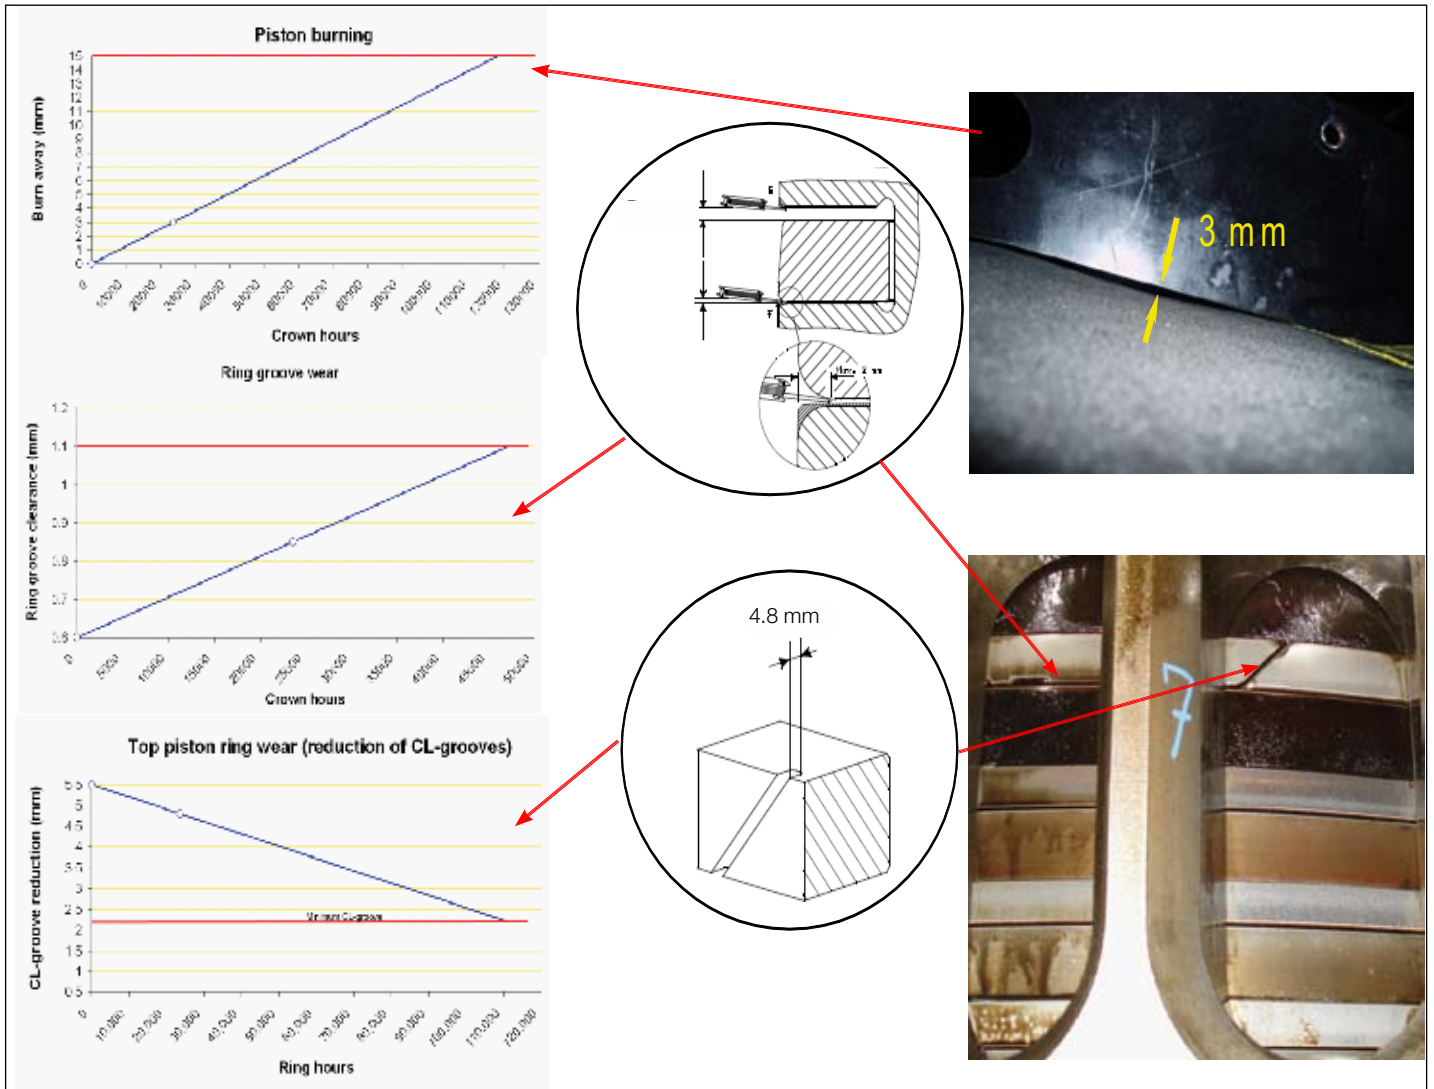
Fig. 8.24: 10K98MC-C, unit no. 7, at 23,500 hours without overhaul. The condition does not call for piston overhaul

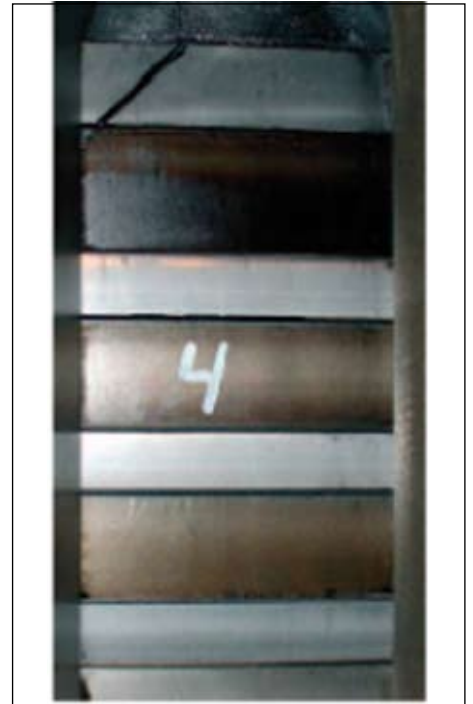
Fig. 8.30: Unit running very well after 20,021 running hours. Note that the last remains of the alu-coat are still visible on the lower edge, indicating remaining rounding left. This means that the ring wear is less than 2 mm out of possible 3 mm. Consequently, many more hours are left from the point of view of wear.

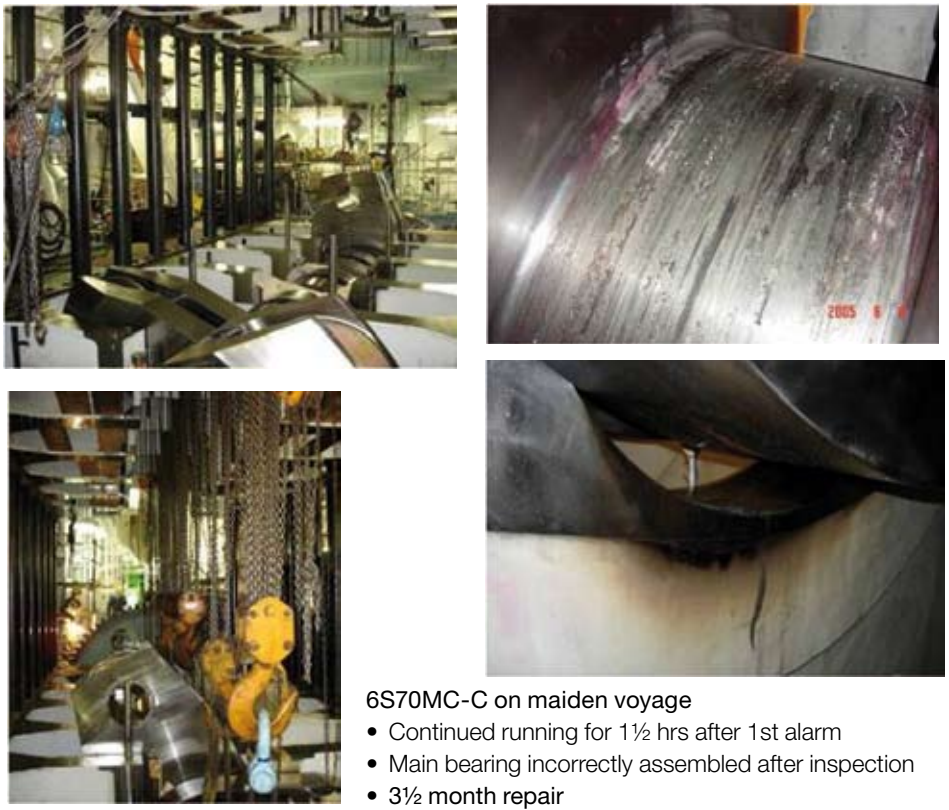
However, in a few cases we experienced severe damage causing long-term off-hire periods involving also costly repairs of the bedplate and/or the crankshaft. An example is shown in Fig. 8.37. In this case, the reason for the damage was incorrect assembly after an open-up inspection of a main bearing after sea trial. This sequence of events following open-up inspections of bearings is unfortunately being reported from time to time. We have therefore changed our instruction material, not calling for open-up inspection at regular intervals. In parallel, we have made so-called bearing wear monitoring (BWM) systems a standard on engines ordered in 2008. BWM systems can also be retrofitted on existing engines

Fig. 8.37: Main bearing damage on 6S70MC-C
