Service Experience of MAN B&W Two Stroke Diesel Engines

Stig Baungaard Jakobsen

MAN Diesel, Low Speed, Copenhagen (Denmark)

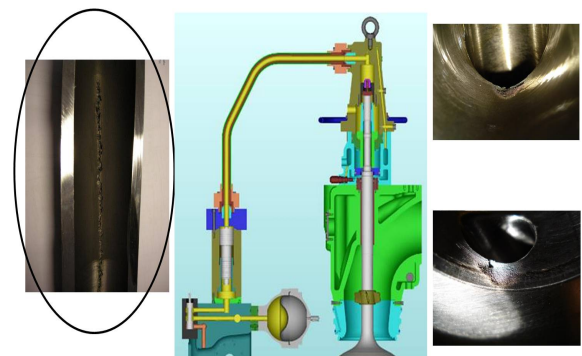
Fig. 1 shows cavitation damage in the high pressure pipe between the exhaust actuator and the exhaust valve. Also cavitation damage in the actuator top cover and in the top of the exhaust valve can be seen. This kind of damage is seen on the large bore versions of the ME engine (80, 90 and 98-cm bore), however, not to the same extent on all units on the engine. Therefore, damage can be counteracted with relatively small changes.

Figure 1 – Cavitation in hydraulic exhaust actuation system

Service tests where the proportional feature of the FIVA valve is used are presently ongoing. So far, we have only used the proportional control of the FIVA valve for injection rate shaping, but now we also use it in order to open and close the exhaust valve gently. Fig. 2 shows the original lifting curve and the modified lifting curve of the exhaust valve. No big changes can be seen. However, the oil pressure fluctuations in the actuator system are modified to some extent, and we expect that this will reduce/eliminate the cavitation damage in the exhaust actuation system.

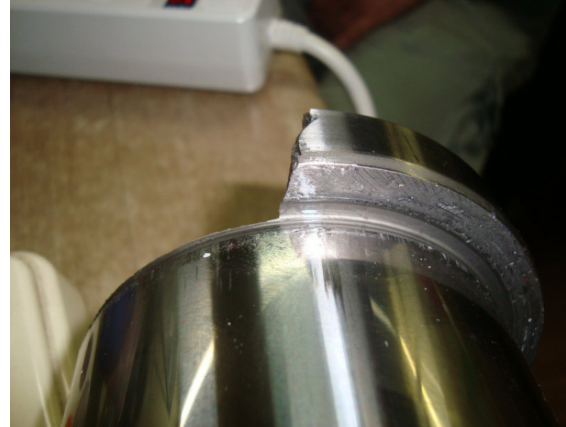
Figure 4 – Piston collar breakage

On a few actuators for the original 200 bar hydraulic system, we have seen breakage of the step-1 piston collar, Fig. 4. We are convinced that this problem relates to delayed “take-off” of the step-1 piston from the bottom position, Fig. 3 (A). This is caused by a “glue-effect”, which exists from time to time. When the step-1 piston is delayed it will create very high pressures in the “damper” chamber and hereby increased load on the piston collar is generated. Various means to avoid the “glue-effect” can be introduced by generating a force by the oil pressure under the step-1 piston. An example for retrofit is seen in Fig. 5. Such design modifications have eliminated the trouble with step-1 piston breakage.

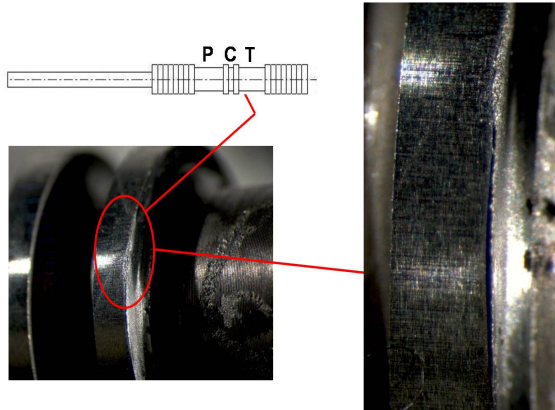
We have seen cavitation attacks on the pilot spools of both the Curtis Wright FIVA valve, Fig. 6, and the Parker valve on the MAN B&W FIVA valve, Fig. 7. Presently, this limits the overhaul intervals of the FIVA valves to some 8,000-10,000 hours. Our goal for overhaul intervals on FIVA valves is 32,000 hours.

Figure 6 – Curtis Wright FIVA: cavitation on pilot spool

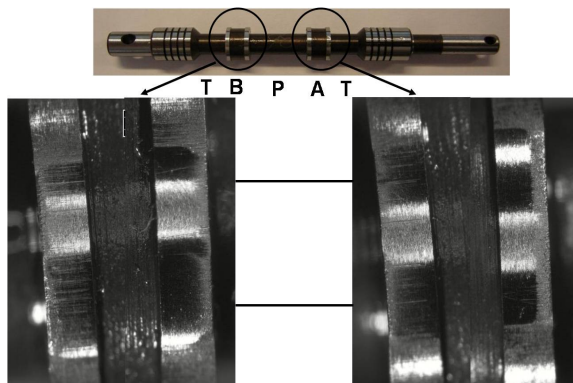
Figure 7 – MAN B&W FIVA: cavitation on Parker valve pilot spool

The cavitation damage on the Parker spools is mainly related to the tank ports for the pilot step. We have therefore designed two (2) service tests, which are currently accumulating hours on two (2) 12K98ME plants. Fig. 8 shows the test FIVA with the pilot tank port connected to the FIVA main spool pressurized tank port. Fig. 9 shows the other FIVA valve with the pilot tank port connected to a completely pressure-less drain.

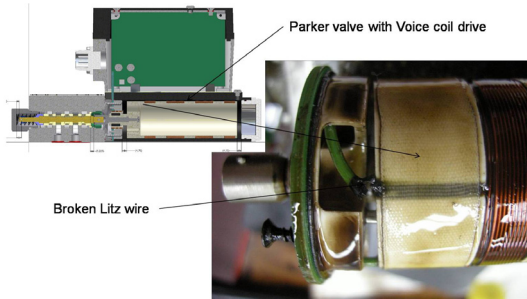
Figure 10 – Parker Pilot Valve

For an MAN B&W FIVA valve, we have experienced an untimed injection in one single case on one cylinder unit on a 6S60ME-C engine in August 2009. The failing FIVA valve was returned, and investigations showed that the problem was related to the pilot step, the Parker valve. Close investigations together with the subsupplier revealed that a broken wire, a so-called Litz wire, had caused the malfunction of the Parker valve, Fig 10.

Tests also revealed that the broken Litz wire resulted in an overshoot and that explained the untimed fuel injection experienced in the vessel with the 6S60ME-C engine.

Production of the Parker valves was changed based on this experience, and zener diodes were included in the electronic control design of the Parker valve. These diodes eliminate overshoot in case of a broken Litz wire.

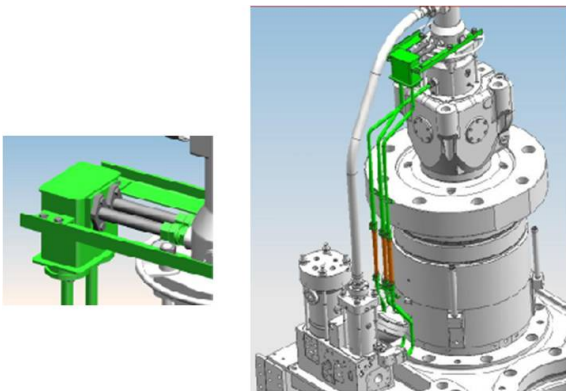
On 80-cm and 98-cm bore engines, we have seen breakage of the drain lines from the exhaust valve. A design with a so-called drain box, Fig. 14, has been tested successfully. This design will counteract the trouble with drain line breakage.

Figure 14 – Exhaust valve drain line with drain box

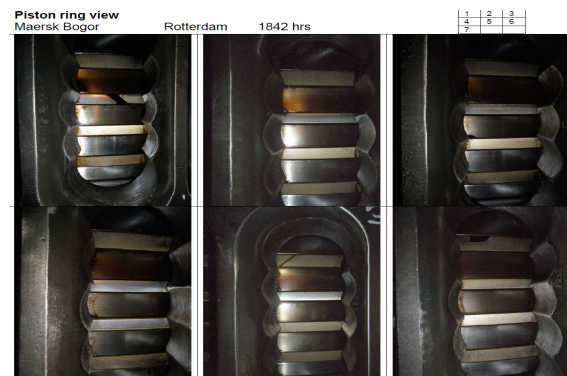
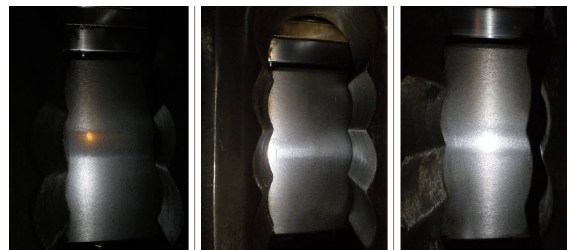
Figure 15 – Piston ring condition

Figure 16 – Piston skirt view

Scavenge port inspection has been carried out after 1,842 running hours. The results can be seen in Figs. 15 and 16 for piston ring and piston skirt condition, respectively. Fig. 17 shows the pitch-honed liner from the scavenge ports. All inspection areas indicate that very successful running-in has taken place and that cylinder condition for all units is excellent.

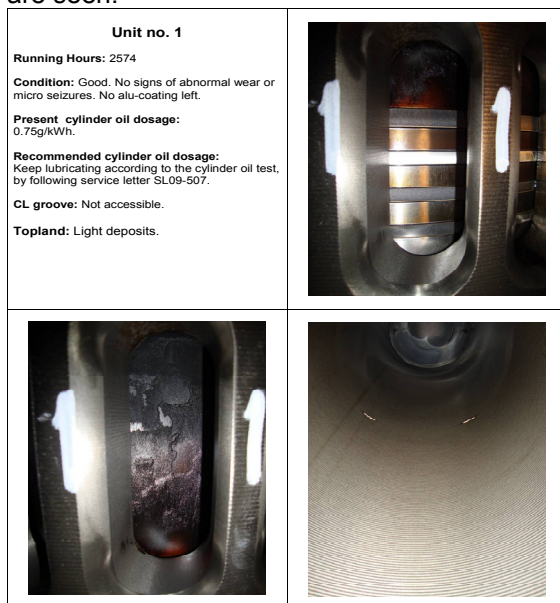
Scavenge port inspection was made at 2,574 hours of operation for the 6S40ME-B9 prototype. Figure 18 shows pictures from this inspection. The pistons are equipped with an alu-coat ring package. As shown in Fig. 18, running-in has finished, and the piston ring base material is working directly against the cylinder liners. Light piston top-land deposits are seen.

Figure 18 – Scavenge port inspection

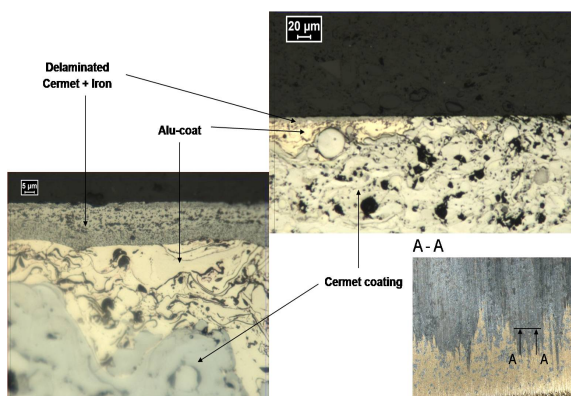
Figure 20 shows cross sections of piston rings with iron and cermet (delaminated) layers positioned on top of the alu-coat layer during running-in, leading to unstable cylinder condition caused by the quality of the cermet coating.

Figure 20 – Piston ring quality

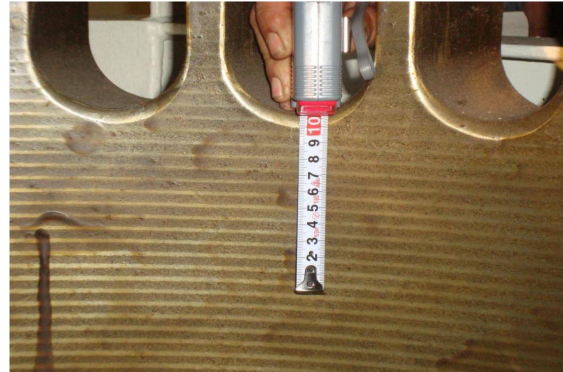
tougher running-in and an increased production of 'liner-iron'. The photo shows an unused spare cylinder liner on a vessel where cylinder liner scuffing has occurred.

Figure 21 – Cylinder liner quality: insufficient plateau honing

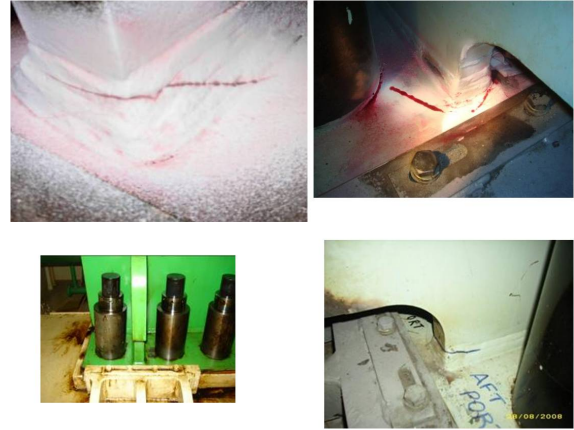
In 2008, cracks in the lifting bracket on K98 bedplates were discovered on engines produced 5-7 years earlier, Fig. 25. Soon after the first cracks were discovered, a so-called ‘Circular Letter’ was issued to all owners/operators of K98 engines, see Fig. 26. In this letter we asked for help to inspect for lifting bracket cracks. Furthermore, we informed about preventive countermeasures, which were burr grinding of the weld seams on the aftmost and foremost brackets. Also, a repair procedure was developed when the cracks first occurred. A modified bracket profile has been designed for new engines, Fig. 27.

Figure 25 – Lifting bracket cracks

Due to the high number of K98 engines in service, these rectifications are still ongoing and, fortunately, we are able to perform this work without disturbing the operation of the vessels involved.

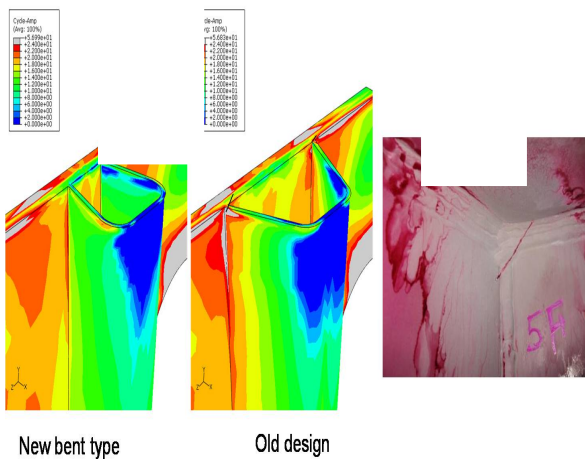
Figure 29 – Welded cylinder frame: fatigue crack originating from stay bolt covers

We are confident that the crack problems related to the stay bolt cover plates have now been eliminated. For engines in service with first generation welded cylinder frames, repair work is in progress.

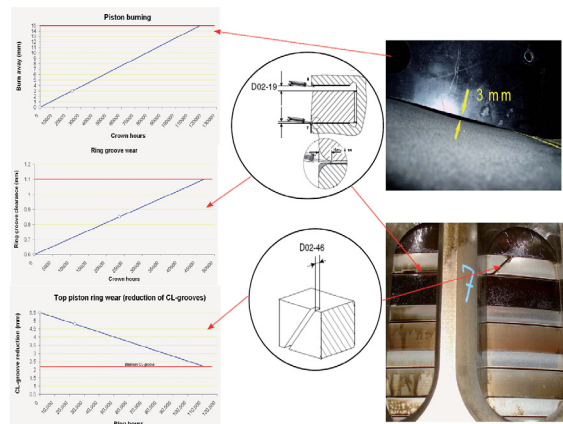
Figure 32 – 10K98MC-C, unit no. 7, at 23,500 hours without overhaul. The condition does not call for piston overhaul

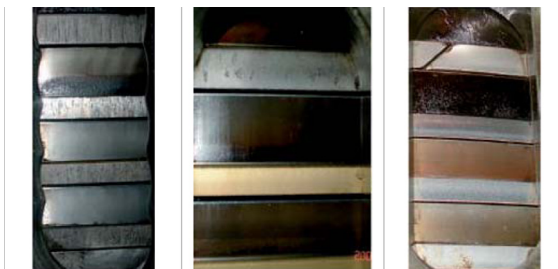
Figure 33 – Totally scuffed unit. Lubrication should be increased to maximum until overhaul is convenient with regard to the schedule of the ship. Due to the friction heat developed, the piston rings get hardened and the wear rate of the liner increases significantly. However, the hardening protects the rings, which is why operation may be continued safely until next convenient port stay.

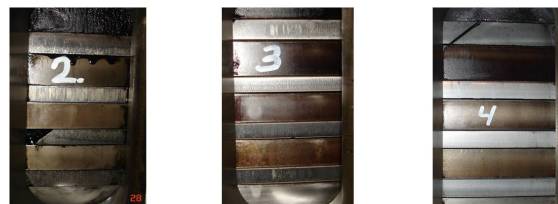
Figure 36 – (2) Totally scuffed unit. Lubrication should be increased to maximum until overhaul is convenient with regard to the schedule of the ship. Due to the friction heat developed, the piston rings get hardened, and the wear rate of the liner increases significantly. However, the hardening protects the rings, which is why operation may be continued safely until next convenient port stay.

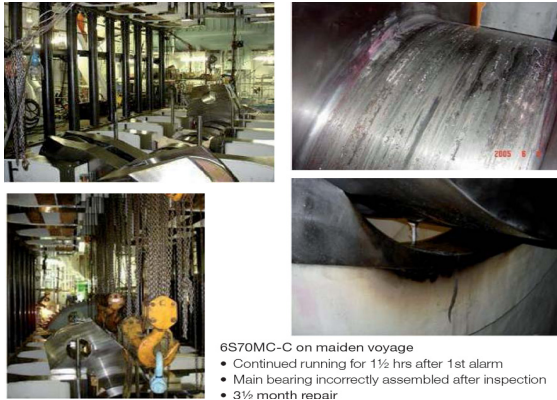
However, in a few cases, we experienced severe damage, causing long-term offhire periods involving also costly repairs of the bedplate and/or the crankshaft. An example is shown in Fig. 45. In this case, the reason for the damage was incorrect assembly after an open-up inspection of a main bearing after sea trial. This sequence of events following open-up inspections of bearings is unfortunately being reported from time to time. We have therefore changed our instruction material, not calling for open-up inspection at regular intervals. In parallel, we have made so-called bearing wear monitoring (BWM) systems a standard on engines ordered in 2008. BWM systems can also be retrofitted on existing engines

Figure 45 – Main bearing damage on 6S70MC-C
