Service Experience

MAN B&W Low Speed Diesel Engines

Service Experience of MAN B&W Low Speed Diesel Engines

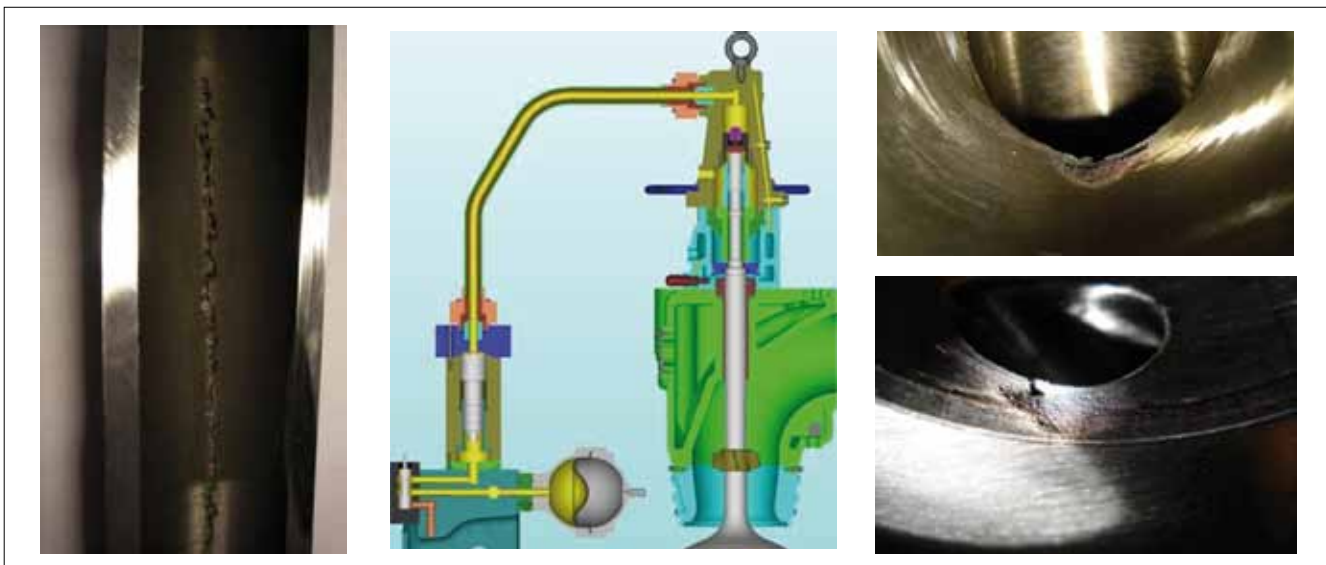
Fig. 1 shows cavitation damage in the high pressure pipe between the exhaust actuator and the exhaust valve. Also cavitation damage in the actuator top cover and in the top of the exhaust valve can be seen. This kind of damage is seen on the large bore versions of the ME engine (80, 90 and 98-cm bore),

however, not to the same extent on all units on the engine. Therefore, damage can be counteracted by relatively small changes.

Fig. 1: Cavitation in hydraulic exhaust actuation system

big changes can be seen. However, the oil pressure fluctuations in the actuator system are modified to some extent, and we expect that this will reduce/eliminate the cavitation damage in the exhaust actuation system.

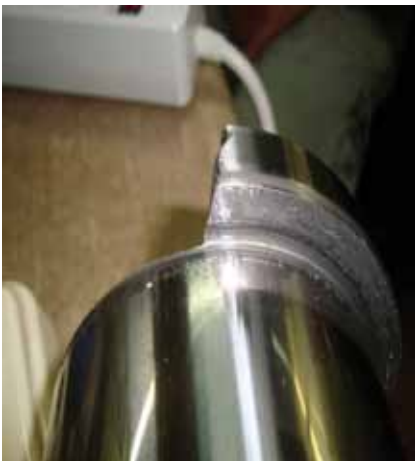
On a few actuators for the original 200 bar hydraulic system, we have seen breakage of the step 1 piston collar, Fig. 4. We are convinced that this problem relates to delayed “take-off” of the step 1 piston from the bottom position, Fig. 3 (A). This is caused by a “glue” effect, which exists from time to time. When the step 1 piston is delayed it will create very high pressures in the “damper” chamber and hereby increased load on the piston collar is generated. Various means to avoid the “glue” effect can be introduced by generating a force by the oil pressure under the step 1 piston. An example of retrofit is illustrated in Fig. 5. Such design modifications will eliminate the trouble with step 1 piston breakage.

Fig. 4: Piston collar breakage

Problem	Countermeasure
“Glue” effect between piston step No. 1 and distributor block, causing a launch delay for piston No. 1.	Grinding grooves in piston No. 1 for easy relief. Grooves: 8 x R 0.5 mm w. depth of approx. 0.3 mm.

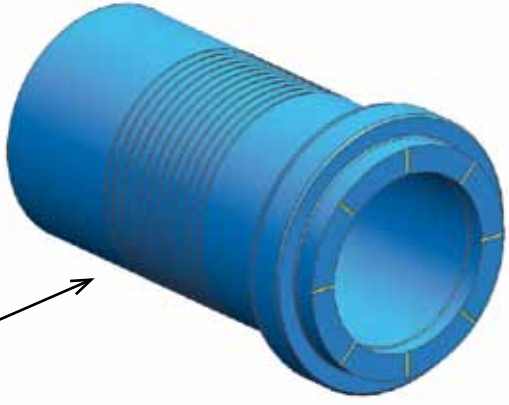
Area of contact causing glue effect

Relief grooves

Fig. 5: Example of retrofit

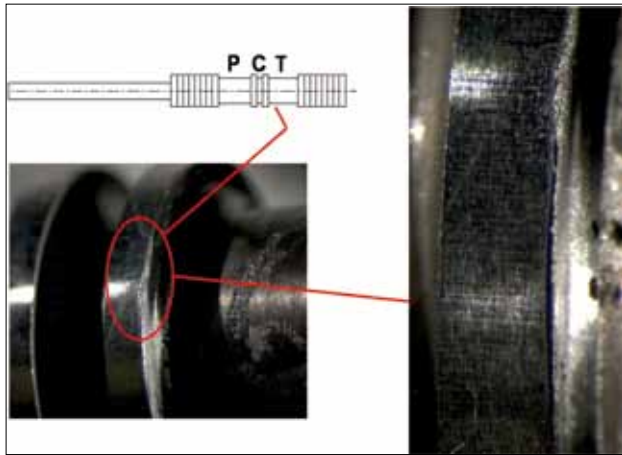
Fig. 6: Curtis Wright FIVA: cavitation on pilot spool

FIVA valve, see Fig. 6, and the Parker valve on the MAN B&W FIVA valve, see Fig. 7. Presently, this limits the overhaul intervals of the FIVA valves to some 8,000-10,000 hours. Our goal for overhaul intervals on FIVA valves is 32,000 hours.

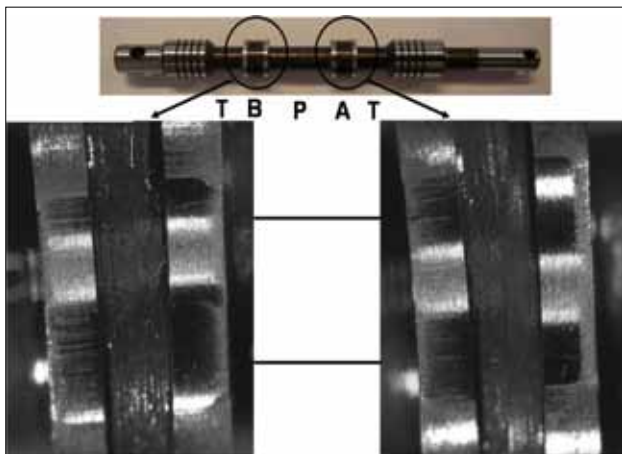
Fig. 7: MAN B&W FIVA: cavitation on Parker valve pilot spool

The cavitation damage on the Parker spools is mainly related to the tank ports for the pilot step. We have therefore designed two (2) service tests, which are currently accumulating hours on two (2) 12K98ME plants. Fig. 8 shows the test

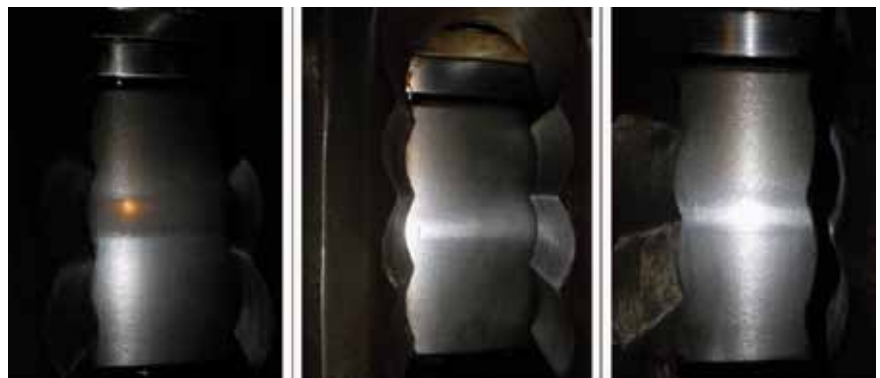
Scavenge port inspection has been carried out after 1,842 running hours. The results can be seen in Figs. 15 and 16 for piston ring and piston skirt condition, respectively. Fig. 17 shows the pitch-honed liner from the scavenge ports. All inspection areas indicate that

Fig. 16: Piston skirt view

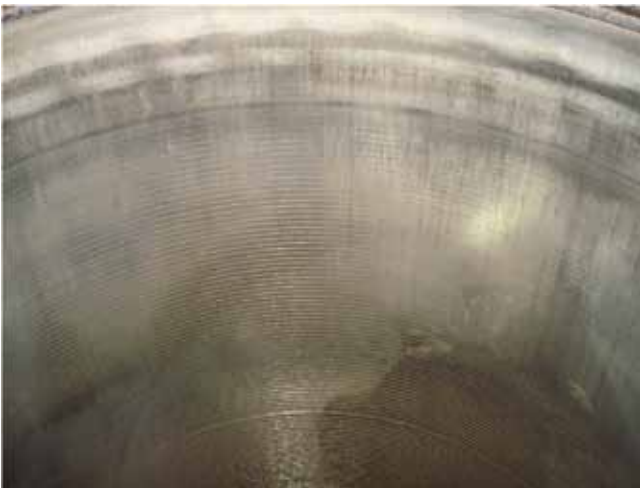
A further inspection was carried out after 3,800 running hours. One cylinder unit was opened up for inspection and liner calibration. Fig. 18 shows the top of the liner. The max. wear rate is 0.037 mm/1000 hrs. at the top dead centre of piston ring No. 2. This wear rate includes initial running-in wear and is very satisfactory.

Fig. 18: Top of liner after 3,800 hrs.

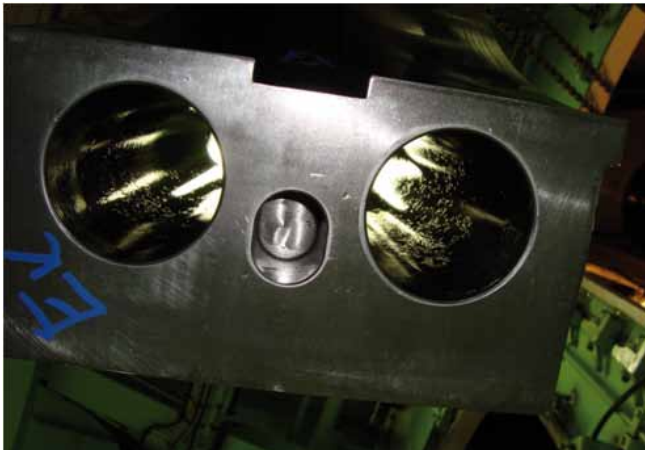
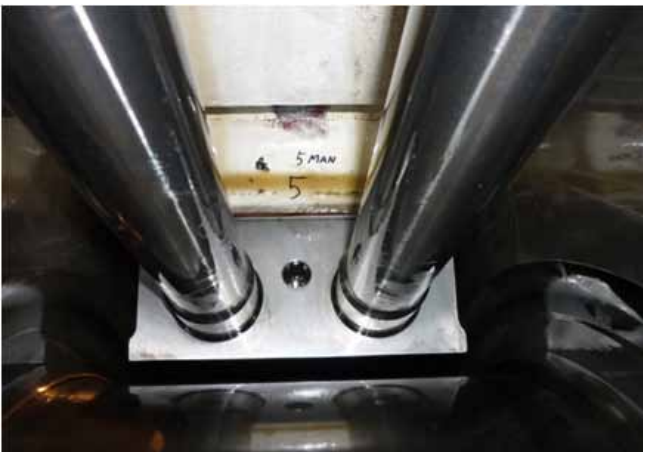
Fig. 21: Main bearing cap and bedplate contact area

The inspection results indicate excellent condition with respect to contact surfaces, with signs of relative movements as well as very good main bearing shell load imprints.

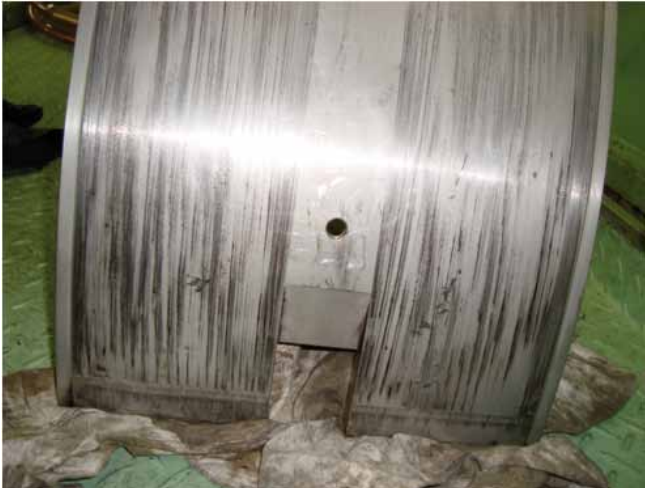
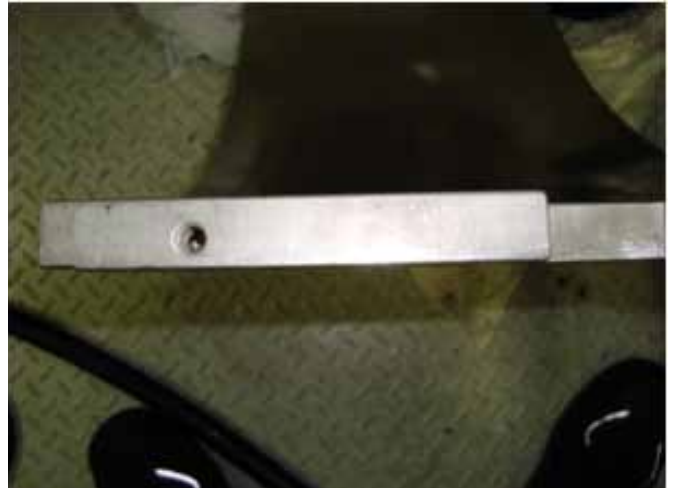
Fig. 22: Upper main bearing shell backside

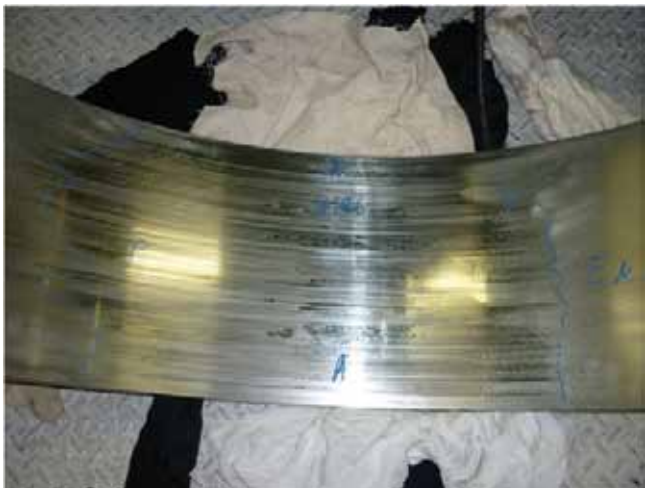
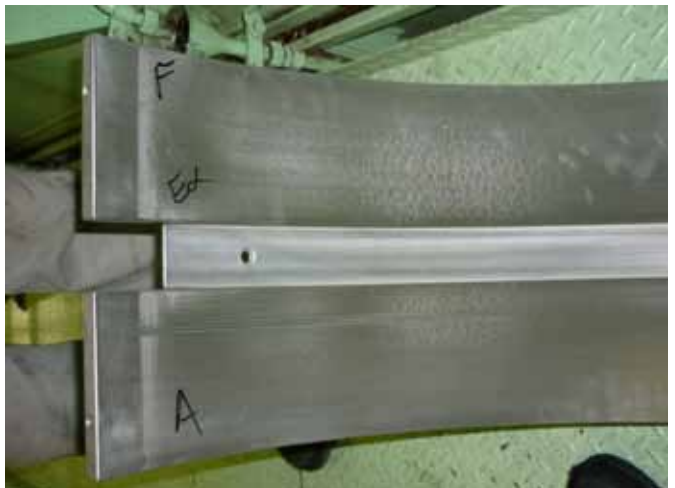
Fig. 23: Lower and upper shell, white-metal side

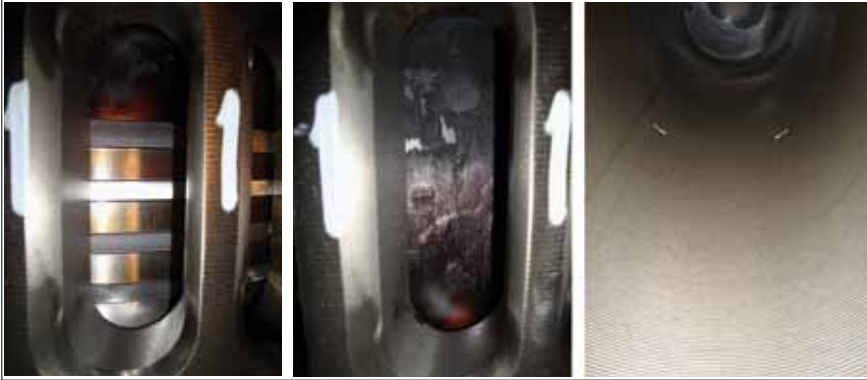
Running hours:	2,574
Condition:	Good. No signs of abnormal wear or micro-seizures. No alu-coating left
Present cylinder oil dosage:	0.75 g/kWh
Recommended cylinder oil dosage:	Keep lubricating according to the cylinder oil test by following service letter SL09-507
CL groove:	Not accessible
Topland:	Light deposits

Fig. 24: Scavenge port inspection

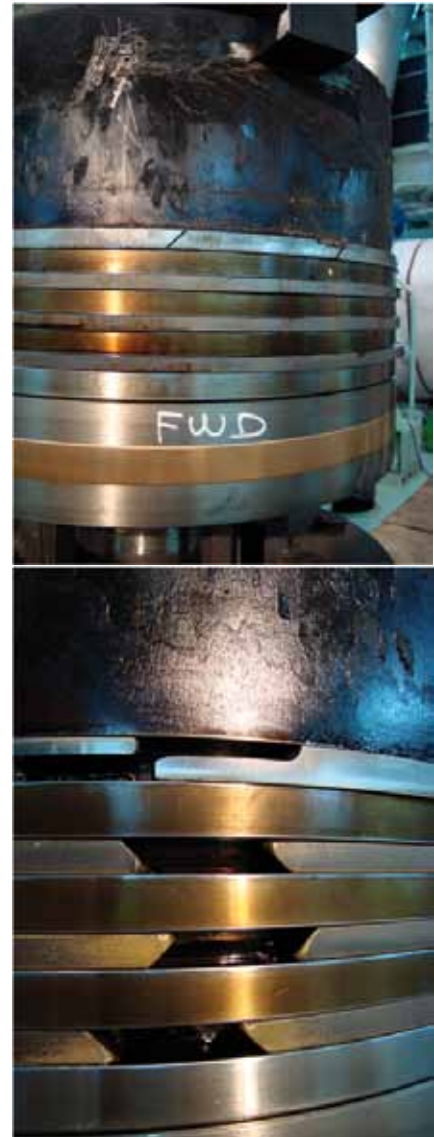
A piston overhaul was carried out after 4,000 running hours to inspect the condition of the new piston design, see Fig. 25, applied on the S40ME-B9 engines. Fig. 26 indicates a very good condition of the piston top-land (light deposits), piston rings (surface without any signs of seizures) and piston skirt (perfect condition of the bronze band).

Fig. 26: ME-B9 piston after 4,000 hrs

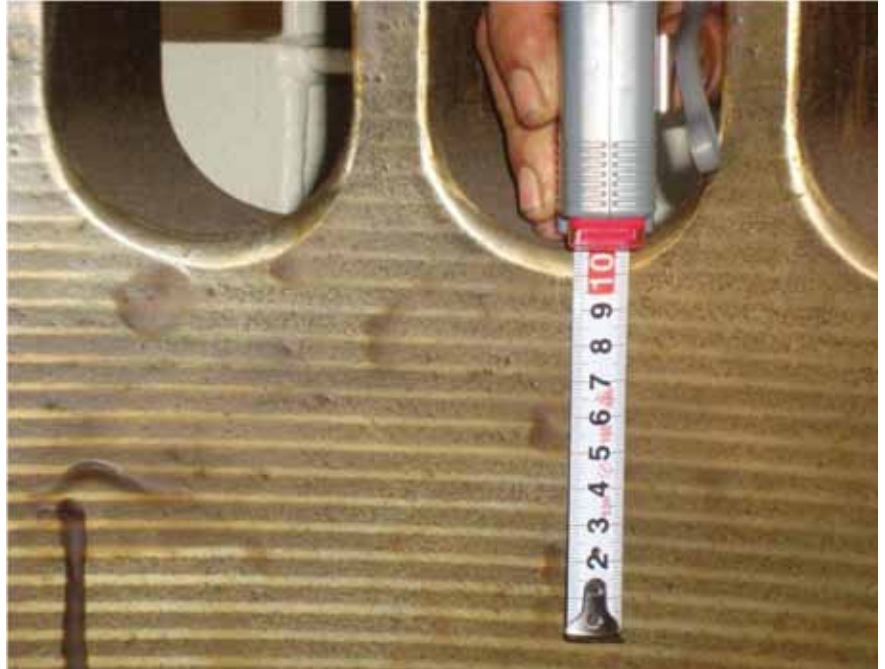
Fig. 31 shows an example of off-spec. honing of the cylinder liner surface. The honed area must nominally be 50% of the liner surface. As can be seen on the photo, the honed area is much smaller resulting in much tougher running-in and an increased production of 'liner-iron'. The photo shows an unused spare cylinder liner on a vessel where cylinder liner scuffing has occurred.

Fig. 31: Cylinder liner quality: insufficient plateau honing

liner machining was checked and re-honing was carried out in case of off-spec. condition.

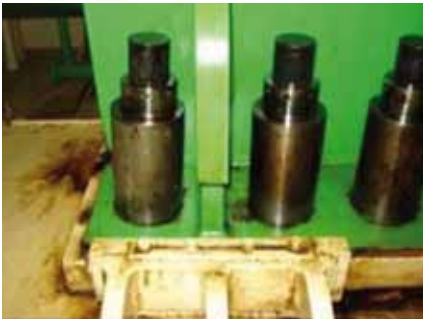
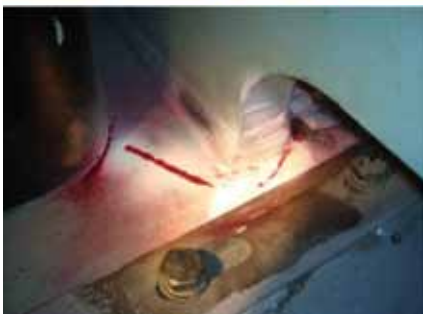
In 2008, cracks in the lifting bracket on K98 bedplates were discovered on engines produced 5-7 years earlier, see Fig. 35. Soon after the first cracks were discovered, a so-called 'Circular Letter' was issued to all owners/operators of K98 engines, see Fig. 36. In this letter we asked for help to inspect for lifting bracket cracks. Furthermore, we informed about preventive countermeasures, which were burr grinding of the weld seams on the aftmost and foremost brackets. Also, a repair procedure was developed when the cracks first occurred. A modified bracket profile has been designed for new engines, see Fig. 37.

Fig. 35: Lifting bracket cracks

Due to the high number of K98 engines in service, these rectifications are still ongoing and, fortunately, we are able to perform this work without disturbing the operation of the vessels involved.

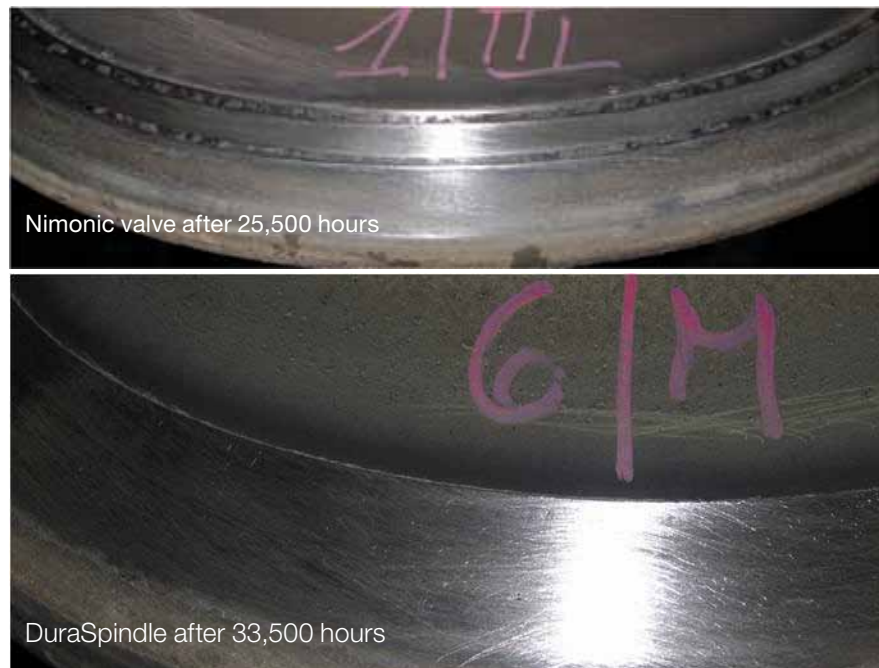
For the exhaust valve, the use of W-seat, see Fig. 43, and either Nimonic valve spindle or DuraSpindle has improved the overhaul intervals to run more than 32,000 hours. Fig. 44 shows examples of an excellent condition without overhaul with combinations of a W-seat/nimonic spindle and a W-seat/DuraSpindle achieved on an S60MC engine after 25,500 hours and 33,900 hours, respectively.

Fig. 44: W-seat in combination with Nimonic spindle and DuraSpindle on an S60MC

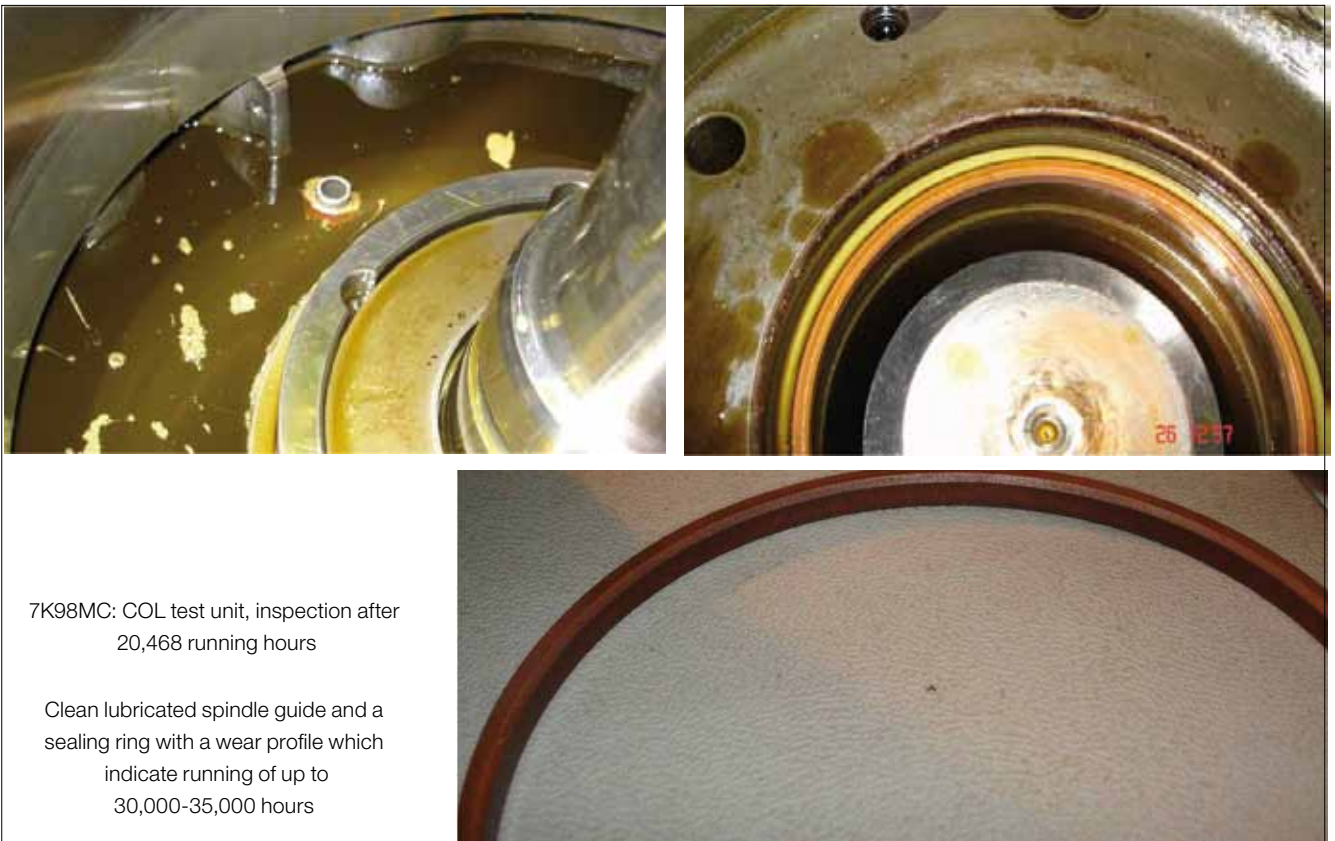
7K98MC: COL test unit, inspection after 20,468 running hours

For the exhaust valve stem seal, the so-called Controlled Oil Level (COL) design, see Fig. 45, indicates that also stem seal overhaul intervals can be extended to 30,000-35,000 hours based on results from several test units on 98, 90 and 60-cm bore engines. This is illustrated by Fig. 46, showing an open-up inspection on a K98.

Clean lubricated spindle guide and a sealing ring with a wear profile which indicate running of up to 30,000-35,000 hours

Fig. 46: Inspection of COL design on a K98MC
