Service Experience of MAN B&W Low Speed Diesel Engines

This paper deals with the latest service experience obtained so far from ME/ME-C engines in service. Early service experience for the 6S40ME-B will also be discussed.

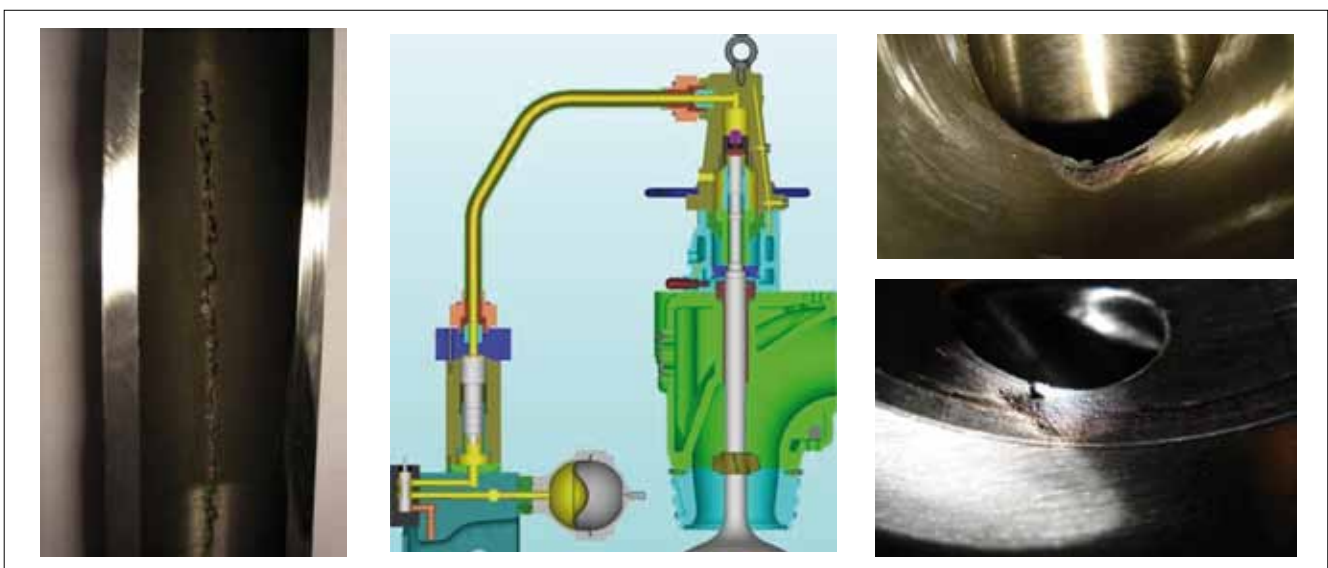
Fig. 1 shows cavitation damage in the high pressure pipe between the exhaust actuator and the exhaust valve. Also cavitation damage in the actuator top cover and in the top of the exhaust valve can be seen. This kind of damage is seen on the large bore versions of the ME engine (80, 90 and 98-cm bore),

however, not to the same extent on all units on the engine. Therefore, damage can be counteracted by relatively small changes.

Fig. 1: Cavitation in hydraulic exhaust actuation system

big changes can be seen. However, the oil pressure fluctuations in the actuator system are modified to some extent, and we expect that this will reduce/eliminate the cavitation damage in the exhaust actuation system.

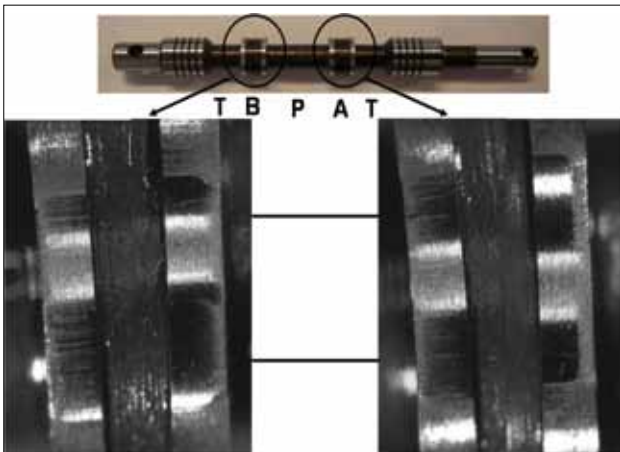
Fig. 7: MAN B&W FIVA: cavitation on Parker valve pilot spool

FIVA valve, see Fig. 6, and the Parker valve on the MAN B&W FIVA valve, see Fig. 7. Presently, this limits the overhaul intervals of the FIVA valves to some 8,000-10,000 hours. Our goal for overhaul intervals on FIVA valves is 32,000 hours.

The cavitation damage on the Parker spools is mainly related to the tank ports for the pilot step. We have therefore designed two (2) service tests, which are currently accumulating hours on two (2) 12K98ME plants. Fig. 8 shows the test

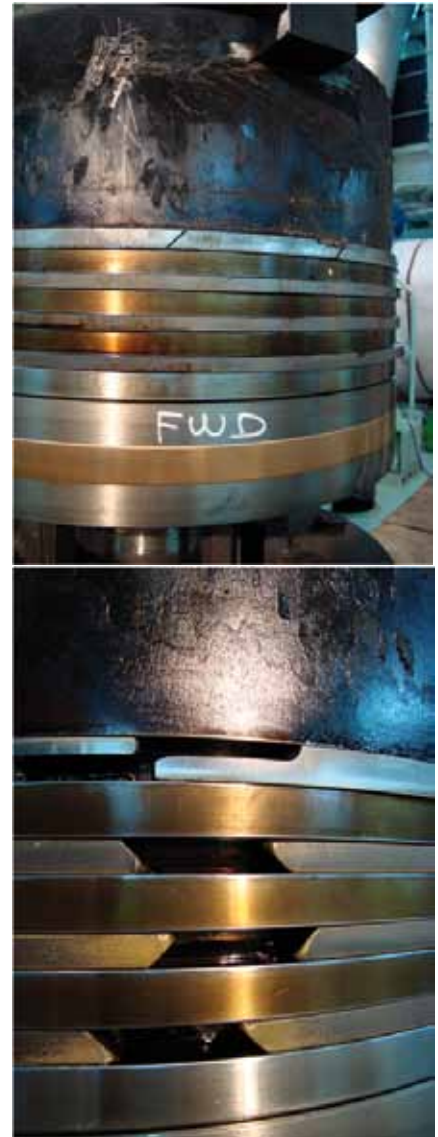
A piston overhaul was carried out after 4,000 running hours to inspect the condition of the new piston design, see Fig. 25, applied on the S40ME-B9 engines. Fig. 26 indicates a very good condition of the piston top-land (light deposits), piston rings (surface without any signs of seizures) and piston skirt (perfect condition of the bronze band).

Fig. 26: ME-B9 piston after 4,000 hrs

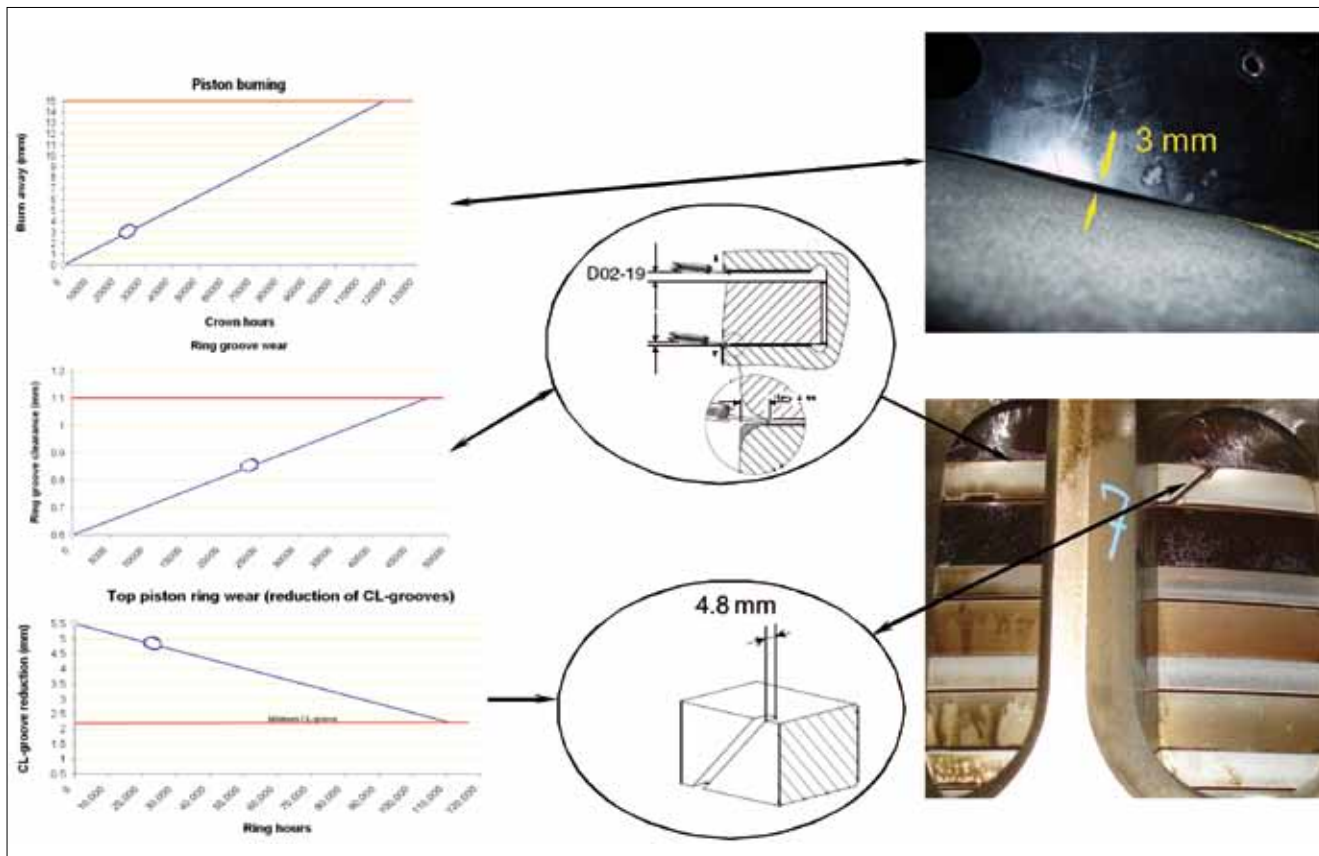
Fig. 42: 10K98MC-C, unit no. 7, at 23,500 hours without overhaul. The condition does not call for piston overhaul

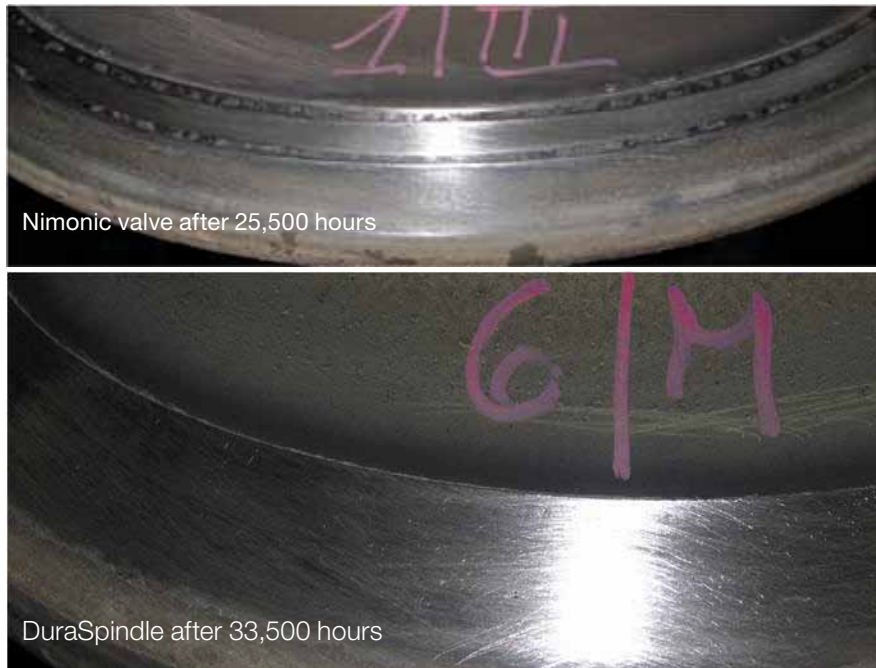
For the exhaust valve, the use of W-seat, see Fig. 43, and either Nimonic valve spindle or DuraSpindle has improved the overhaul intervals to run more than 32,000 hours. Fig. 44 shows examples of an excellent condition without overhaul with combinations of a W-seat/nimonic spindle and a W-seat/DuraSpindle achieved on an S60MC engine after 25,500 hours and 33,900 hours, respectively.

Fig. 44: W-seat in combination with Nimonic spindle and DuraSpindle on an S60MC
