Service Experience

Two-stroke Engines

MAN Diesel & Turbo

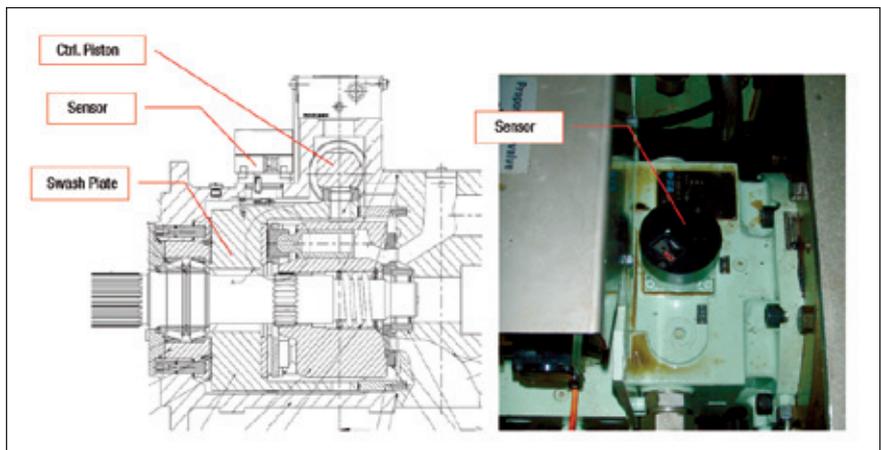
Fig. 3: Hydraulic pump sensor failure

The latest example of a sensor that has created troubles in relation to ME components is the position feedback sensor on the Eaton version of the main hydraulic swash-plate pumps. Fig. 3 shows the arrangement of the position feedback sensor on the Eaton pump. As illustrated in Fig. 3, the sensor connects mechanically via a coupling disc directly to the control arm for the swash plate.

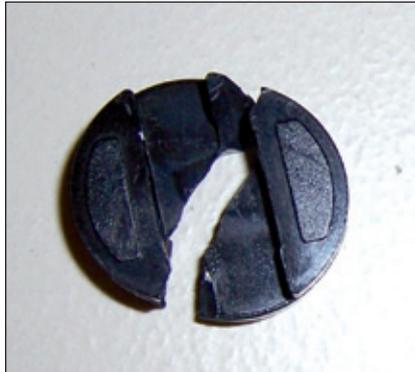
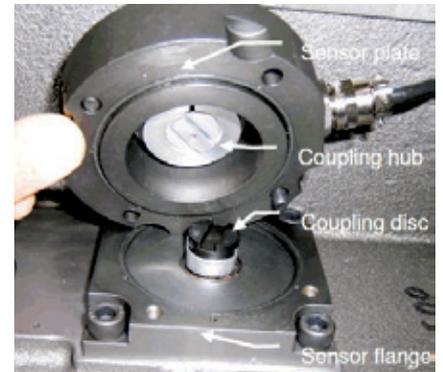
In a number of cases, the coupling disc has broken, see Fig. 4, causing lack of control of the hydraulic pump and, thereby, reduced hydraulic power and reduced engine output.

Fig. 4: Feedback sensor coupling failure

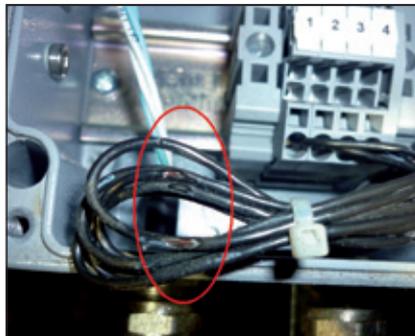
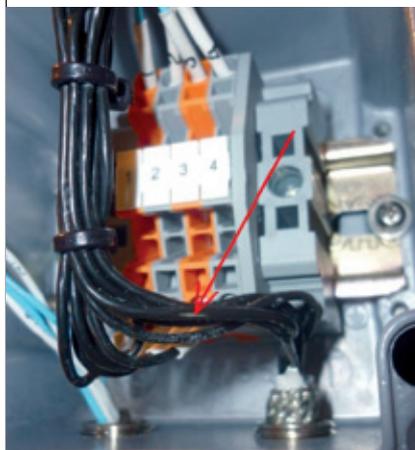
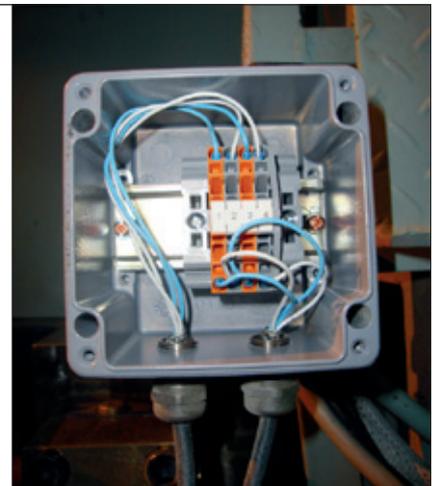
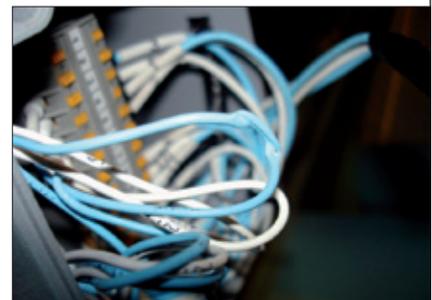
One of the most common causes for electrical failures on the ME engines is isolation errors. Fig. 8 shows examples of installations in junction boxes that can/will cause isolation errors. The examples show wires touching interior surfaces of the junction box, causing rubbing between the box and wire due to vibrations, or wires getting wedged between the junction box and lid.

Fig. 8: Not optimal installations

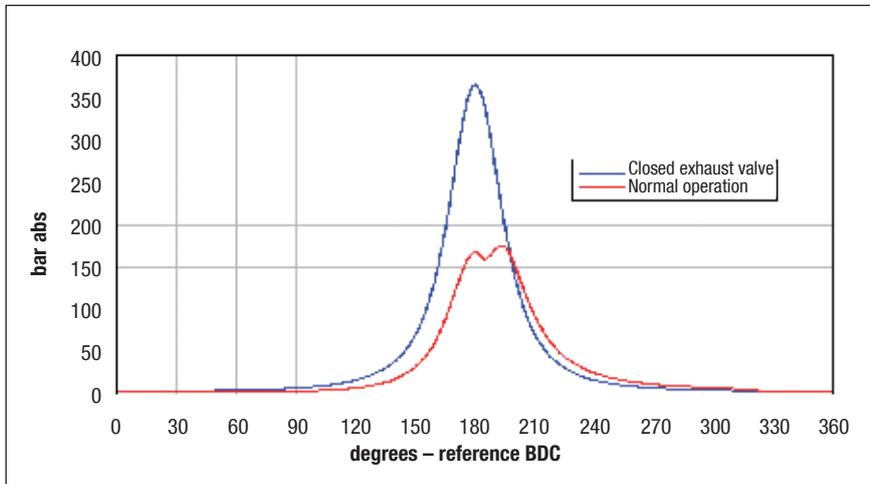
Fig. 10: 12S90ME-C9.2 running at 110% load

Lately, we have experienced one case of cylinder cover lift on our S90ME-C9.2 engine series. The cover lift was caused by untimed exhaust valve closing, see Fig. 10. On Dot 2 engines with two-stroke Miller timing, this situation may cause excessive compression pressures at high loads (in this case 110% load on the test bed) leading to cylinder cover lift. Two-stroke Miller timing consists of high scavenge air pressure, late closing of exhaust valve and small compression volume.

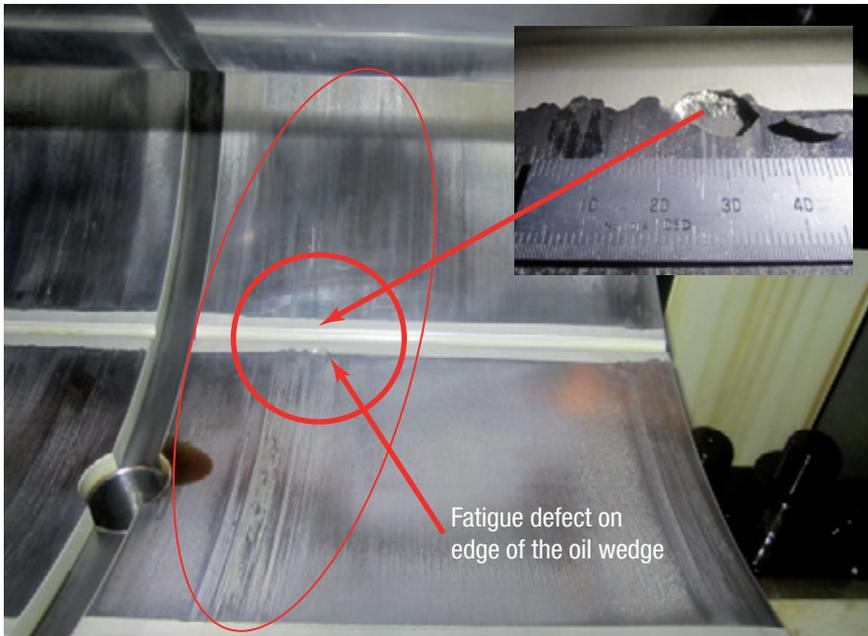
the increased gas pressures at low rpm. On the K98 engine, this has resulted in minor slow-developing fatigue damage on the central pad in the lower crosshead bearing shell, see Fig. 19.

Fig. 19: K98 crosshead bearings and T/C cut-out

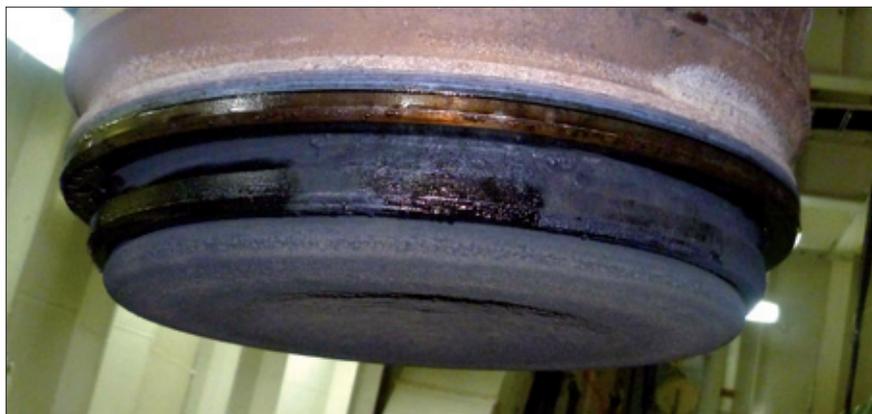
S60MC-C8:	Running hrs.	26,000
Burn away:	> 11 mm	(max. 9 mm)

Fig. 22 shows an exhaust valve spindle disk from an S60MC-C8 operating at low load for a long time. The burn-away level after 26,000 hours is 11 mm. This is above the maximum of 9 mm burn-away for reconditioning of the spindle.

Fig. 22: Burn-away of spindle disc during low-load operation

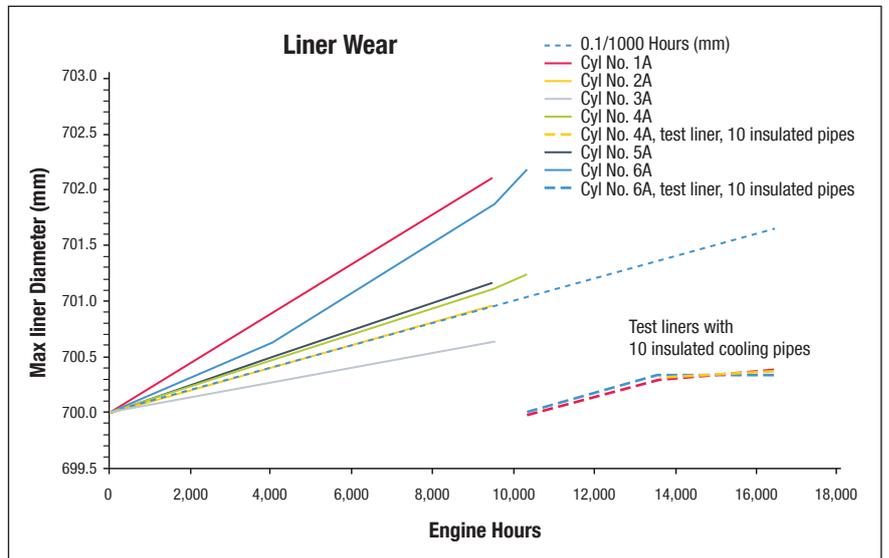
Cylinder liner wear measurements have confirmed the above-described change to be effective against excessive (oval) liner wear, see Fig. 29. Trend curves on cylinders with 2 x 5 insulated cooling pipes are well within acceptable limits.

Fig. 29: S70 semi-high topland (SHTL): cylinder liner wear

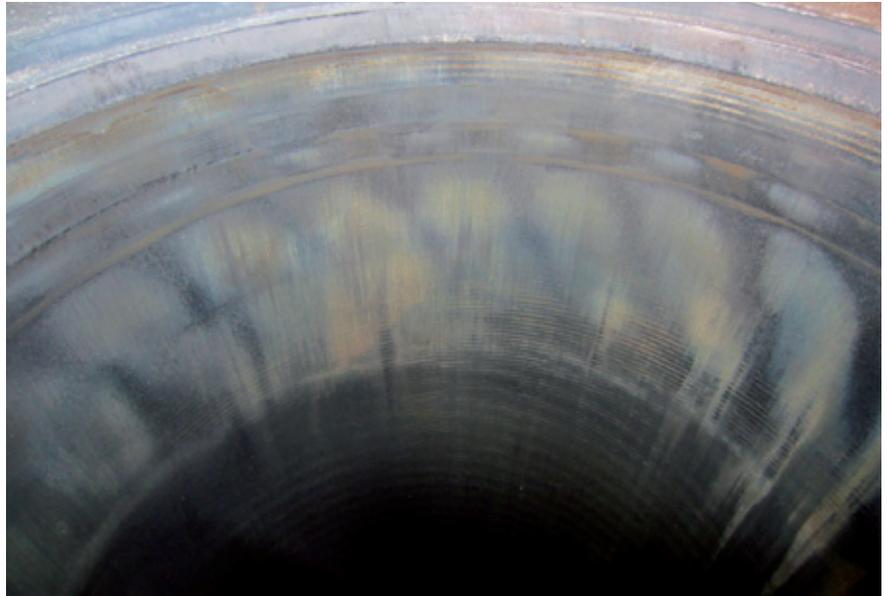
For the new S50ME-C9.2 engine, cold corrosion in the upper part of the cylinder liner was discovered already after sea trial, see Fig. 32. Such an early sign of cold corrosion called for the immediate action of introducing a design change to counteract any further development towards high corrosive liner wear values.

Fig. 32: S50ME-B9.2: cold corrosion, after sea trial

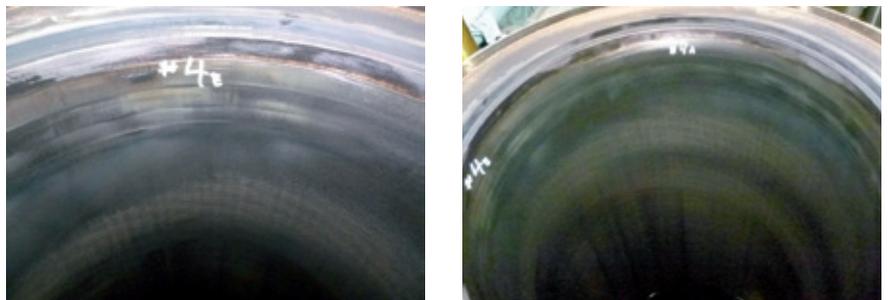
An inspection on a sister vessel after approx. 1,000 hours of operation, see Fig. 33, confirmed the signs of corrosion in the upper part of the cylinder liner. Liner calibration confirmed too high wear levels.

Fig. 33: S50ME-B9.2: cold corrosion, sister vessel inspected after approx. 1,000 hours

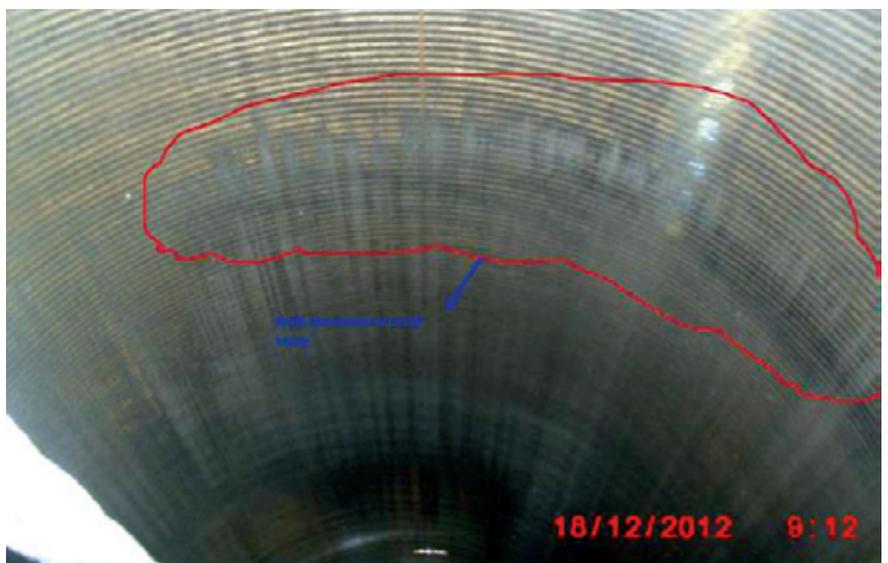
A liner inspection on an engine where countermeasures had been introduced after sea trial, see Fig. 34, showed that

Fig. 34: Solution provided to cold corrosion on S50ME-B9.2

cold corrosion in the liner top had disappeared. This means that the countermeasures introduced to increase the liner wall temperature was successful.

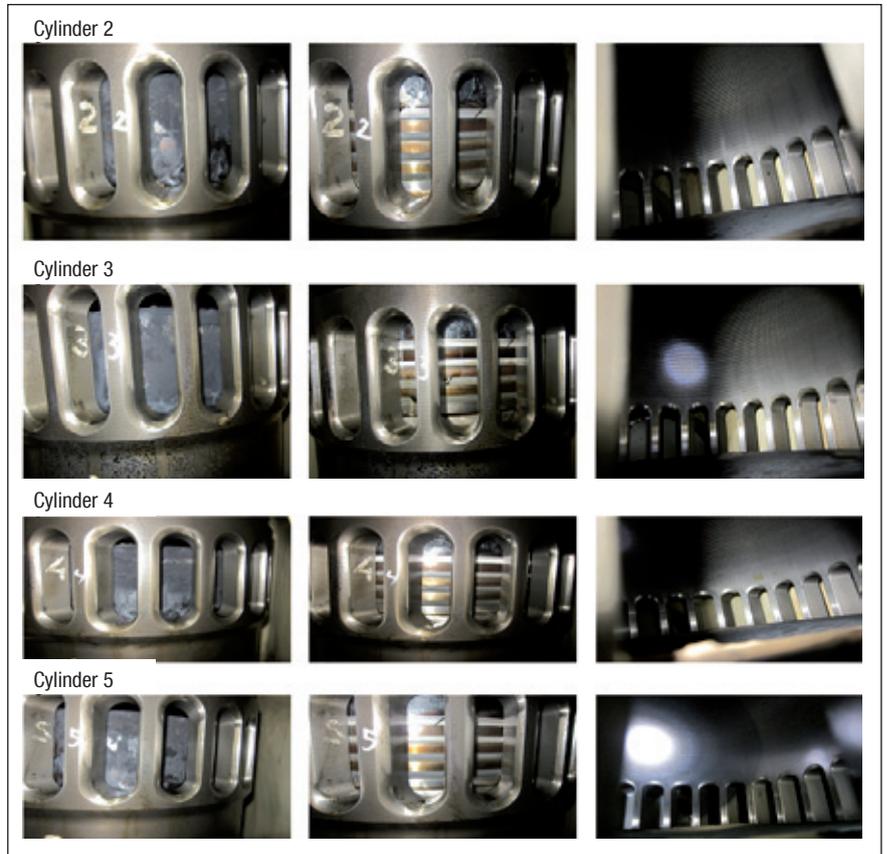
The background for introducing the POP ring pack can be seen, e.g., on the 6S40ME-B prototype engine. At first glance, the cylinder condition looks very satisfactory after nearly 10,000 hours of operation, see Fig. 37. Also the cylinder liner wear is very satisfactory, see Fig. 38. All liners inspected have wear rates below 0.1 mm per 1,000 hours.

Fig. 37: Scavenge port inspection after approx. 10,000 hours with conventional CPR CL rings

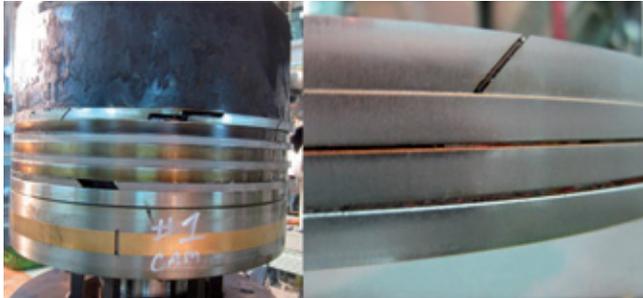
Fig. 39: Piston rings indicating rather high wear rates

However, when looking more closely on the wear condition of the top piston ring it can be seen that unit No. 1 is close to the wear limit due to the CL groove reduction, see Fig. 39.

We now specify POP ring packs for this kind of engine. We have accumulated more than 230,000 service hours on various engine types with the POP rings. One of the service tests has been carried out on all cylinders on a 6S46MC-C engine. After 6,735 hours, the width of the „port-gap” has increased by 1.1 mm, corresponding to a top piston ring wear of 0.55 mm, see Fig. 40. With a wear potential of 2.7 mm, wear-out is estimated to happen after approx. 33,000 hours. Due to the self-stabilising nature of the POP ring, as described above, the estimated lifetime of 33,000 hours is conservative. We can expect even more running hours before wear-out.
