Service Experience MAN B&W Two-stroke Engines

MAN B&W Two-Stroke Engines

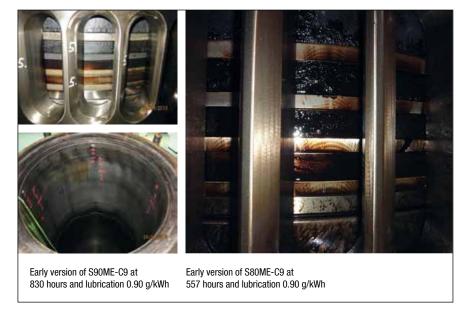
Recently, cold corrosion of cylinder liners has grown to become a major issue for the latest generation of MAN B&W two-stroke engines, see Fig. 1. This has called for measures to control/suppress the cold corrosion, leading MAN Diesel & Turbo to take the following initiatives:

Fig. 1: Poor cylinder condition - recent examples

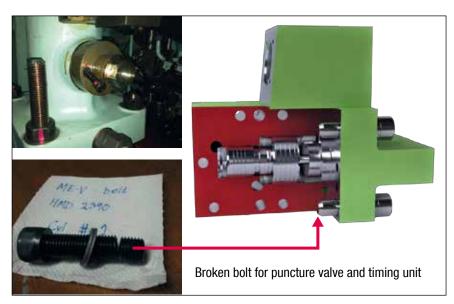
When the dot 3 technology was introduced, we experienced some difficulties with the timing unit system on a number of engines running on test bed, see Fig. 23. High-pressure peaks occurred in the timing unit and in the oil cylinder of the exhaust valve actuator. The high pressure resulted in a number of incidents with broken bolts on the puncture valve and a few cases of broken bolts on the timing unit end cover, see Fig. 24.

Fig. 24: ME-B dot 3 feedback from test bed

Measurements and simulations revealed that the timing piston had a high landing velocity on the return stroke when the timing unit is deactivated. A damper for the timing piston has been introduced as a countermeasure and the landing speed has been considerably reduced, see Fig. 25. Furthermore, this countermeasure reduces the maximum pressure to an acceptable level.

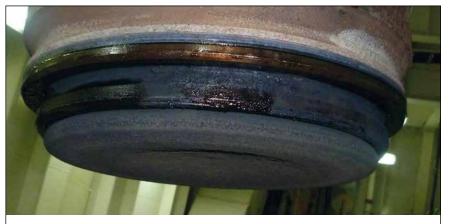
Fig. 32 shows an exhaust valve spindle disk from an S60MC-C8 operating at low load for a long time. The burn-away

level after 26,000 hours is 11 mm. This is above the maximum of 9 mm burnaway for reconditioning of the spindle. So in this case, earlier inspection of the exhaust valve could have made reconditioning possible.

S60MC-C8: Running hour 26,000 Burn away: >11 mm (max. 9 mm)

Fig. 32: Burn-away of spindle disc during low-load operation

The above was mentioned in our first low-load operation Service Letter (SL08-501/SBE, October 2008), and it will require more frequent inspection in-

tervals to be able to judge the so-called "burn-away" of the exhaust valve spindle disk.

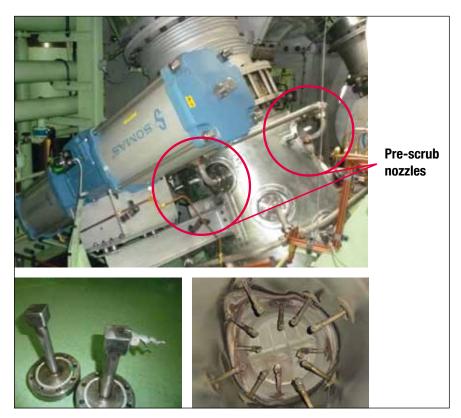
One item which has been observed is "turning" of the upper pre-scrubber nozzles, see Fig. 39. A new welded nozzle-flange design has been introduced to prevent the nozzles from "turning" during operation.

Fig. 39: Pre-scrubber nozzles

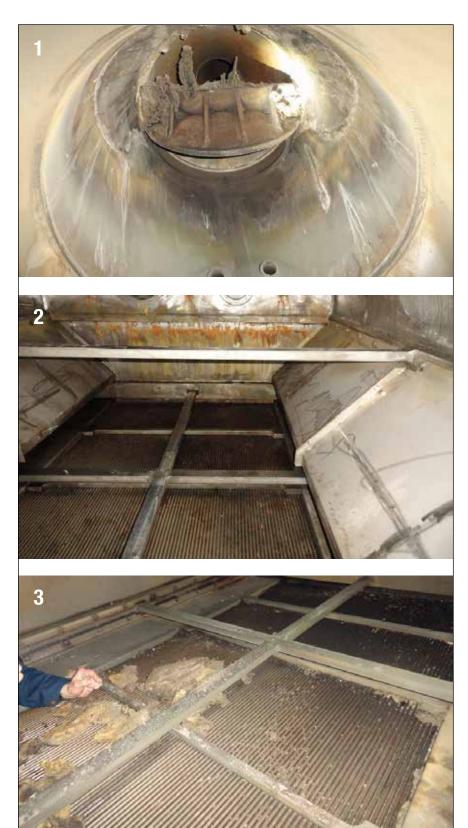
Another observation is the salty deposits (Na₂So₄) created on the turbocharger cut-out valve during EGR operation. When starting non-EGR operation with open T/C cut-out valve, these deposits end on the top of the EGR cooler. When switching back to EGR operation, the deposits on the EGR cooler are dissolved by water. This sequence is illustrated in Fig. 40. In order to eliminate the formation of these salty deposits, we are presently working to change the flow at the T/C cut-out valve.

- 1: During EGR running, scrubber water hits the T/C cut out valve and forms salty deposits.
- 2: During non-EGR running, salty deposits end on top of EGR cooler.
- 3: During the next EGR running period, the salty deposits will be dissolved by water.

Fig. 40: EGR cooler and T/C cut-out valve

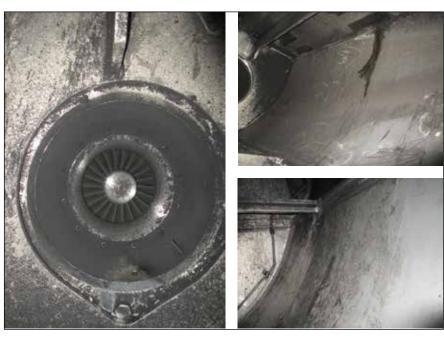
Fig. 43: Suction chamber and blower inlet found in good condition

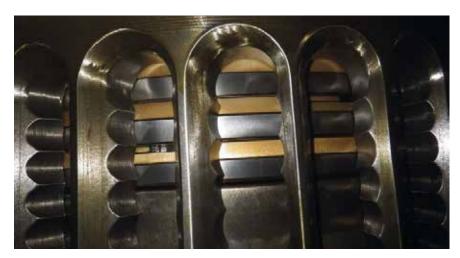
that black carbon deposits are avoided in the combustion chamber, see Fig. 47.

Fig. 47: T/C cut-out test with emergency bypass installed. No black carbon deposits visible.

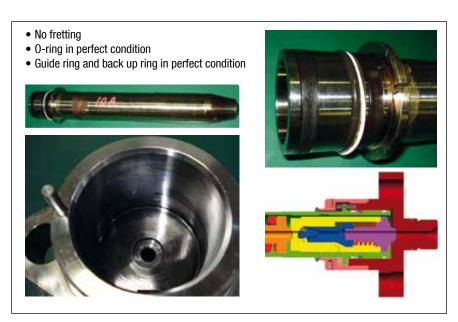
Fig. 50: Fuel valve with guide rings. Inspection after 2,000 hours in service on an S90ME-C9.2

spring packages for tightening down the fuel injector. Results from service testing on an S90ME-C9.2 engine indicate that this new design eliminates the fretting problem. Fig. 50 shows an injector disassembled after some 2,000 hours – no fretting can be seen. If confirmed by further inspections during 2014, we will introduce the new injector design not only on the S90ME-C, but also on other large bore ME/ME-C engines, as example the K98ME/ME-C type engines, suffering from fretting in the upper part of the fuel injectors.

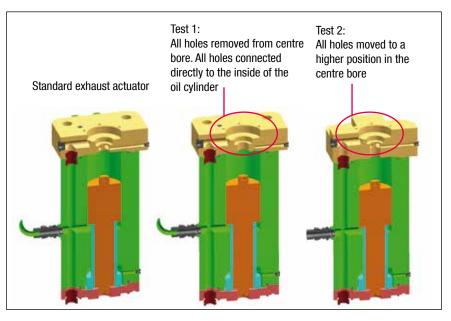
Fig. 53: Tests against cavitations, modified top covers

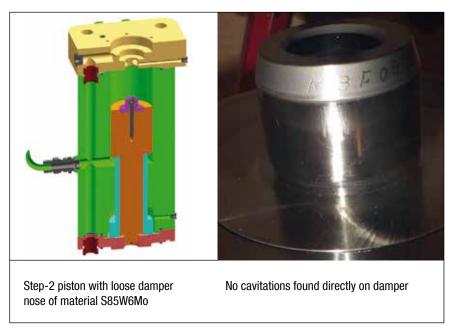
Fig. 55: Tests against cavitations, damper nose of different material

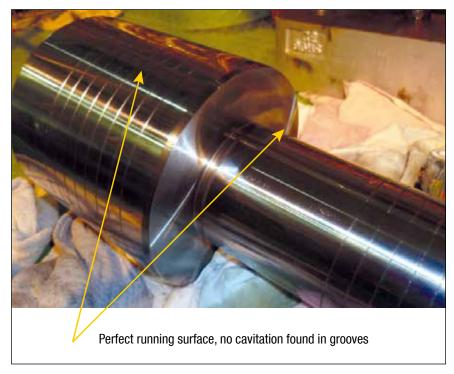
The actuator housing is in perfect running condition, and only minor cavitation has been found on the step-one piston landing surface at the lower base. On the other hand, on the steptwo piston we have found rather heavy cavitation damage on the opening damper at the top of the piston, see Fig. 54. We have tested a piston with a bolted-on "damper-nose" consisting of a harder alternative damper material (S85W6Mo). As can be seen in Fig. 55, this solution has eliminated the cavitation on the damper. Both actuator pistons show excellent condition on the running surface. Fig. 56 shows a typical

condition for the running surface of the step-two piston.

Fig. 56: Exhaust actuator – low-force step-two piston

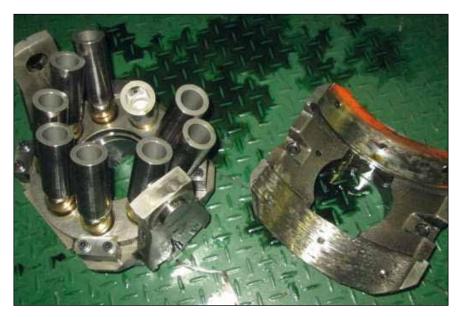
For the bearing shells of the original design, the use of steel shells with a thin layer of polymer has not resulted in sufficiently reliable service experience with satisfactory overhaul intervals. Fig. 57 shows an example of a damaged pump – the root cause of the damage is the steel bearing shells.

Fig. 57: ME engine Eaton main hydraulic pumps. Pump swash plate/piston assembly, bearings and holder damaged
