Service experience

MAN Energy Solutions

Two-stroke technologies

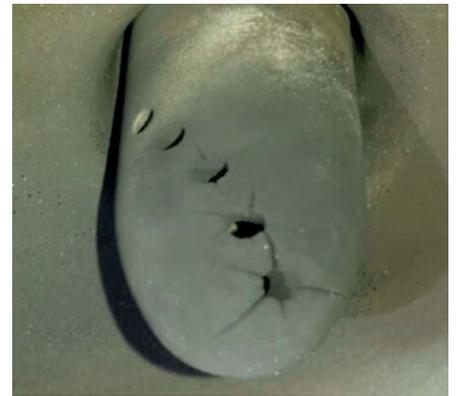
The GIV nozzles have been in focus since a few hundred hours of operation were obtained on the first ME-GI engines in service. Cracks were observed in the nozzles within a short period of operation, see Fig. 7.

Fig. 7: Cracks in the GIV nozzle

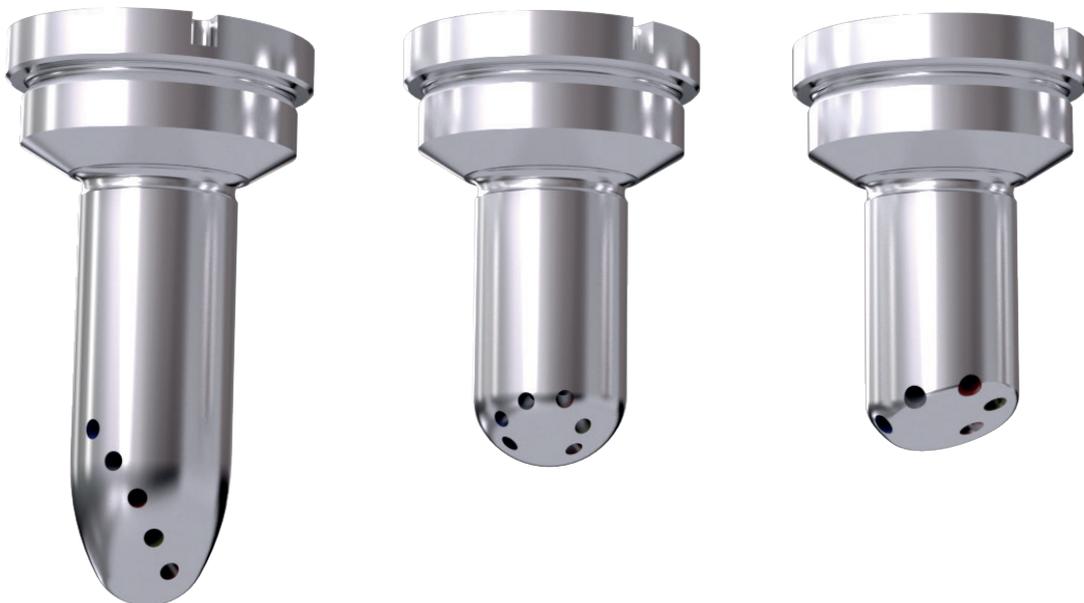
Fig. 8: Gas nozzle design development – latest design to the right

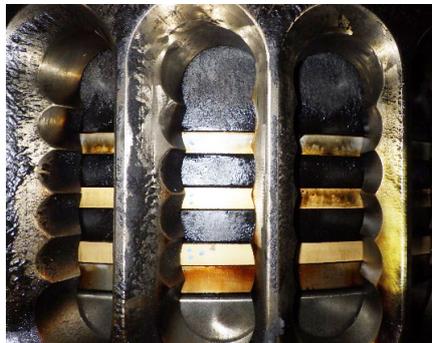
We have gained experience with the cylinder condition when the engine operates continuously on gas. The continuous operation on low-sulphur fuel has given us some ideas about the challenges we will encounter after 2020, when the global sulphur cap comes into force. We have experienced that low base number (low BN) cylinder oils, which should be optimal for continuous low-sulphur fuel operation, did not have sufficient detergency for such operation. A build-up of deposits was seen on ring lands and ring grooves as shown in Fig. 10.

Fig. 10: The continuous operation on low-sulphur fuel and the use of low-BN cylinder oils give insufficient detergency

To address this we issued a circular letter instructing operators of ME-GI engines to alternate between high-BN (100) cylinder oil for cleaning and low-BN (25-40) for counteracting the

too-high addition of calcium. We gave the instructions to operate about 24 hours on high-BN oil and 48 hours on low-BN oil. The intervals can be altered (extended) based on inspections. Clean ring lands and ring grooves can be maintained in this way, see Fig. 11, and a good cylinder condition is generally experienced on the ME-GI engines.

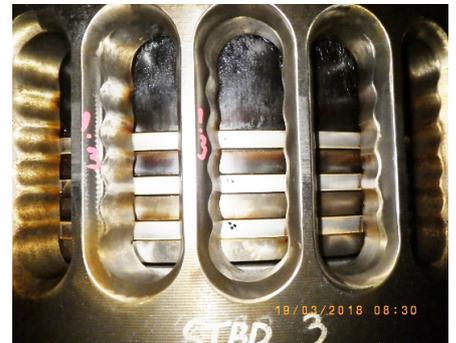
Fig. 11: The continuous operation on low-sulphur fuel and the alternating use of high- and low-BN cylinder oil give sufficient detergency

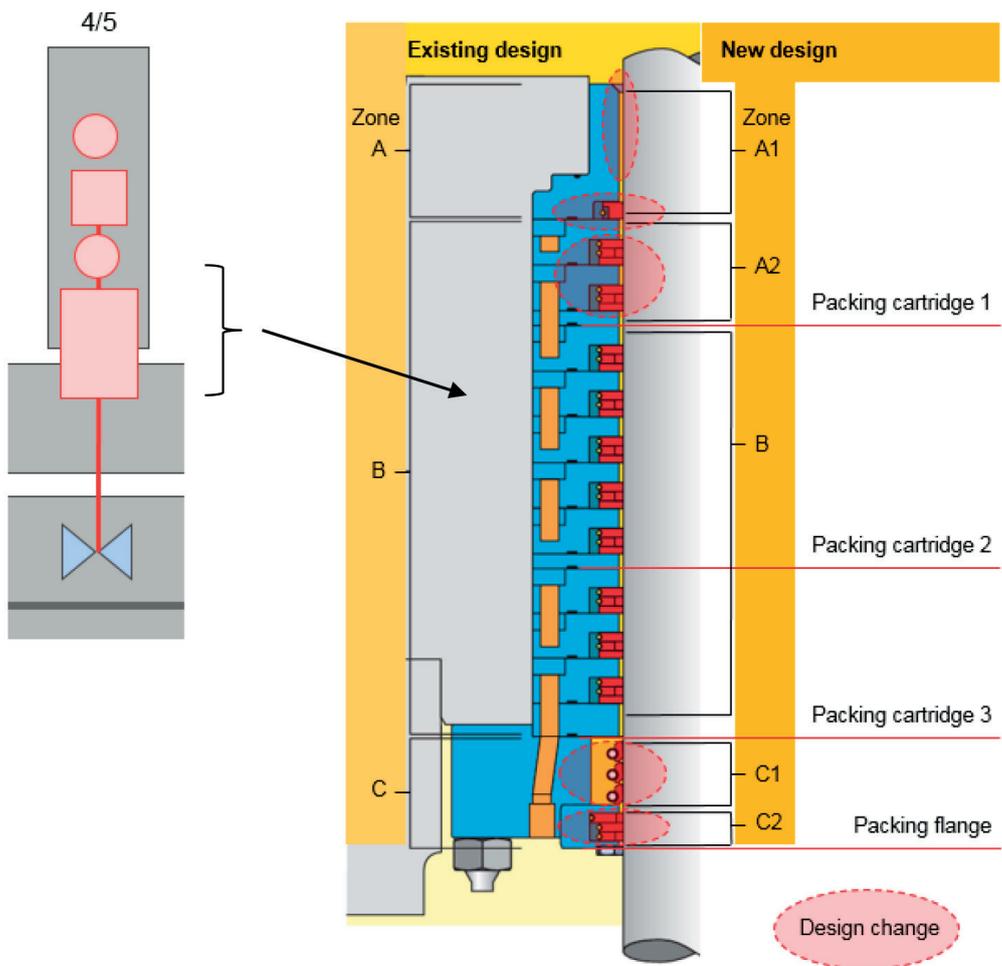
We have experienced a number of issues with these compressors that have been rectified. Wear of the high-pressure piston rod packing in stage 4/5 has been observed and the solution is replacement of the high-pressure packing, see Fig. 15 and the labyrinth piston rod glands.

Fig. 15: Modified high-pressure packing

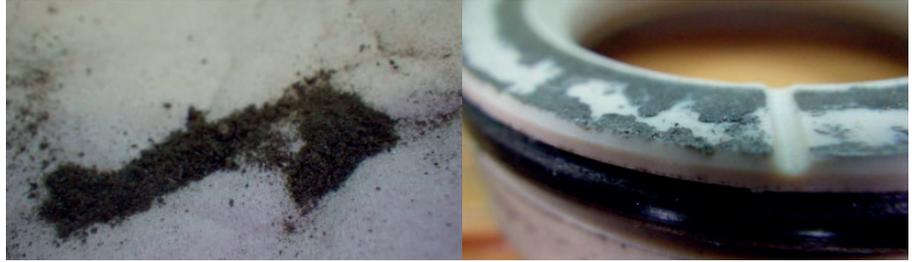
Increased wear occurred on the gas valve seats due to an excessive amount of particles in the gas piping after installation (Fig. 19), caused by the fact that gas supplied from bunker barges and trucks is not as clean as expected and that the valves in the GVT are sensitive to dirt. Because of this, larger 10 micron fine filters were introduced on the gas side before the GVT, see Fig. 20.

Fig. 19: Dirt particles in LNG

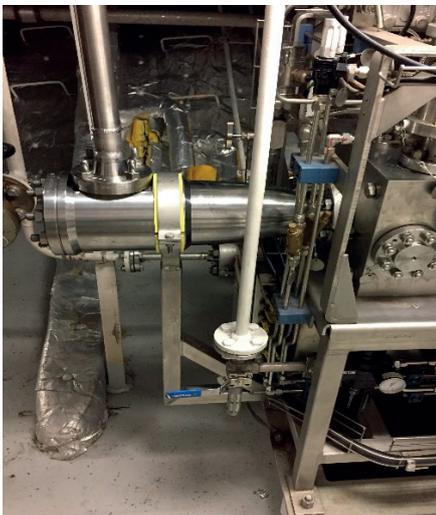
Fig. 20: 10 micron fine filter before the GVT

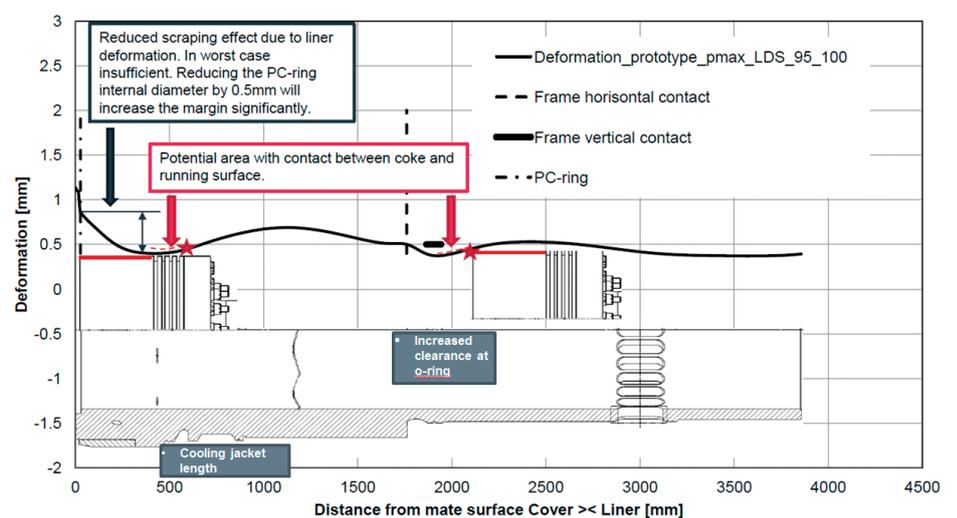
Four main design changes were introduced on the cylinder liners for the G95 engines. In the first inspections of the cylinder liner surface hard contact marks were found as indicated in Fig. 29.

Fig. 29: Cylinder liner deformation and potential contact positions

Firstly, reducing the inner diameter of the PC-ring solved the upper contact problem and increased the clearance between the O-ring and the cylinder frame at the lower contact point, which resulted in an increased PC-ring efficiency. Secondly, a longer liner cooling jacket was introduced to improve both the liner deformation and the cooling of the piston rings, see Fig. 30 (left side). As a third countermeasure the airflow path below the liner was

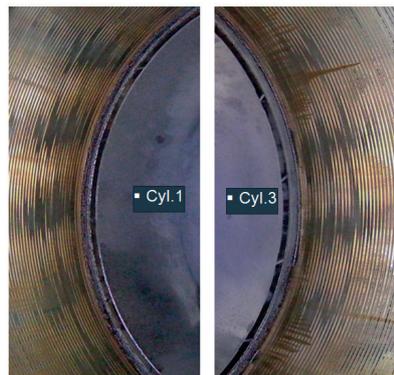
Fig. 31: Cylinder liner contact marks caused by bore distortion

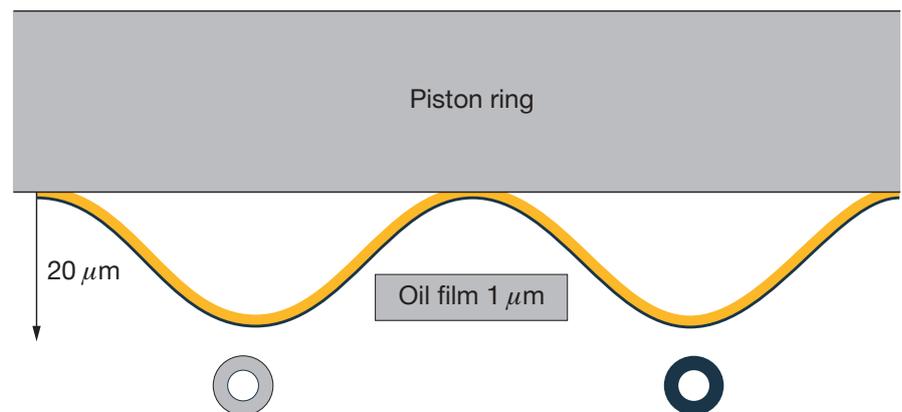
The scuffing observed on the test bed during the shop test is considered closely related to the low-rated RDL liners. The bore distortion of these liners is significantly larger than the oil film thickness, as depicted in Fig. 32. If it gets too large, the piston rings cannot properly adapt to the liner anymore, causing a gas leakage past the rings' running surface.

Fig. 32: Illustration of exaggerated bore distortion and piston ring interaction

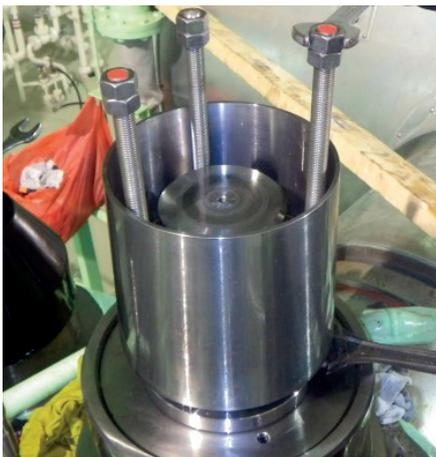
Fig. 54: Stuck measuring cone

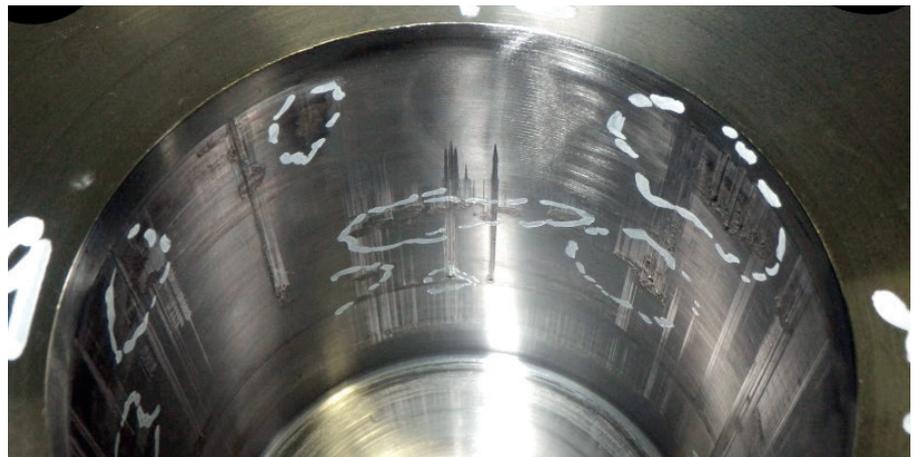
Fig. 55: Fretting inside the measuring cone

The mentioned components have been improved on the Mk. 2 design where the flow area of the tank bores from injection and valve actuation have been increased. Additionally, the newest commercialised version of the TCEV has been improved by separating the injection and exhaust valve tank bores.

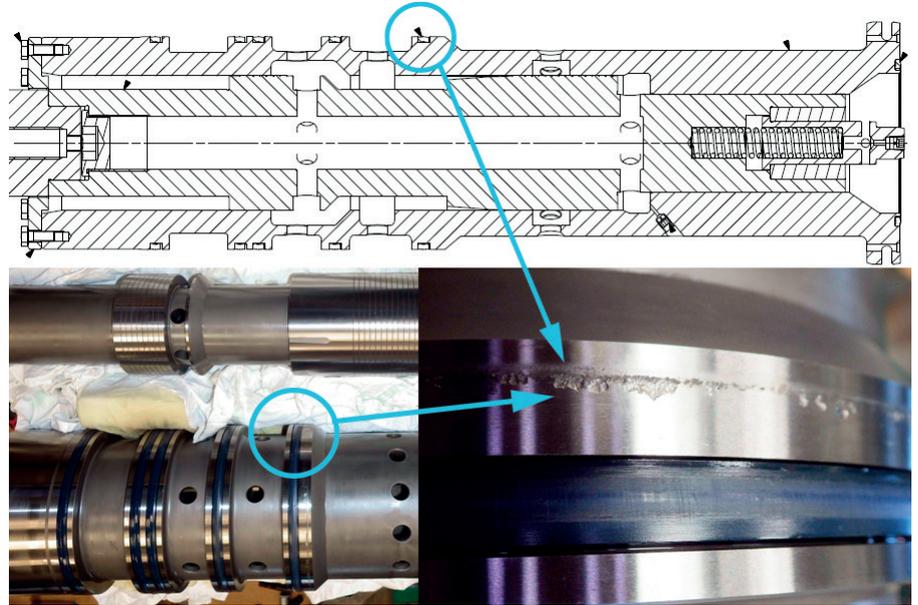
Fig. 56: Cavitation on the outside of the tank control bushing

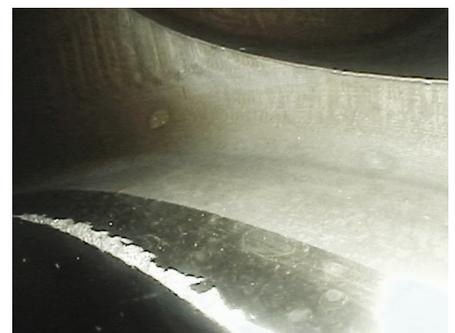
One of the more long-lasting and repetitive issues is PEVA feedback failure alarms, also referred to in Table 2, third inspection. This issue only pertained during ME manoeuvring, and it was concluded that cavitation and sticking of the PEVA main slide was the cause.

Fig. 59: Cavitation on the PEVA housing

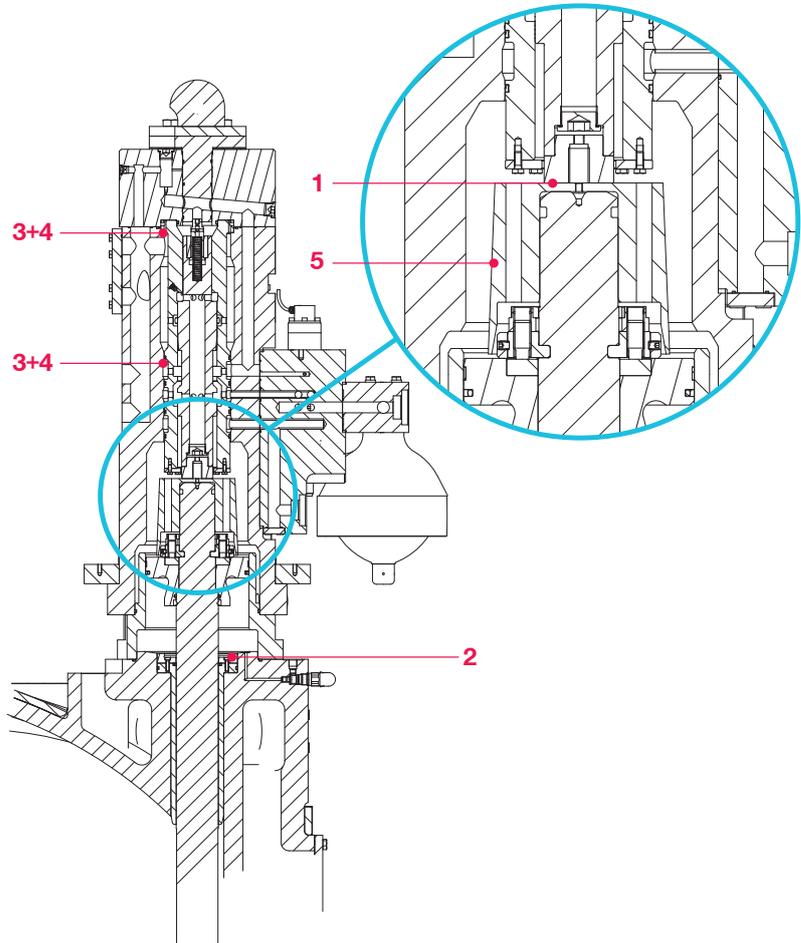
The stem seal was worn down by 23% during the clocked running hours. As a result, the amount of coke deposits inside the spindle guide and air spring chamber were higher than normal. A cause of ring wear can be a too small amount of oil in the controlled oil level (COL) and therefore a lack of preservation of the ring during operation. This may be solved by tuning the safety valve which controls the air

Fig. 60: Minor issues with TCEV Mk. 2

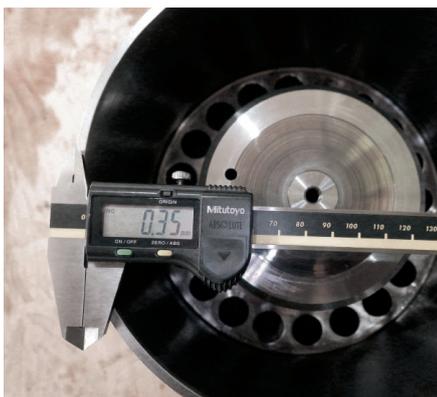
Fig. 61 Imprint from actuator slide pressure piece

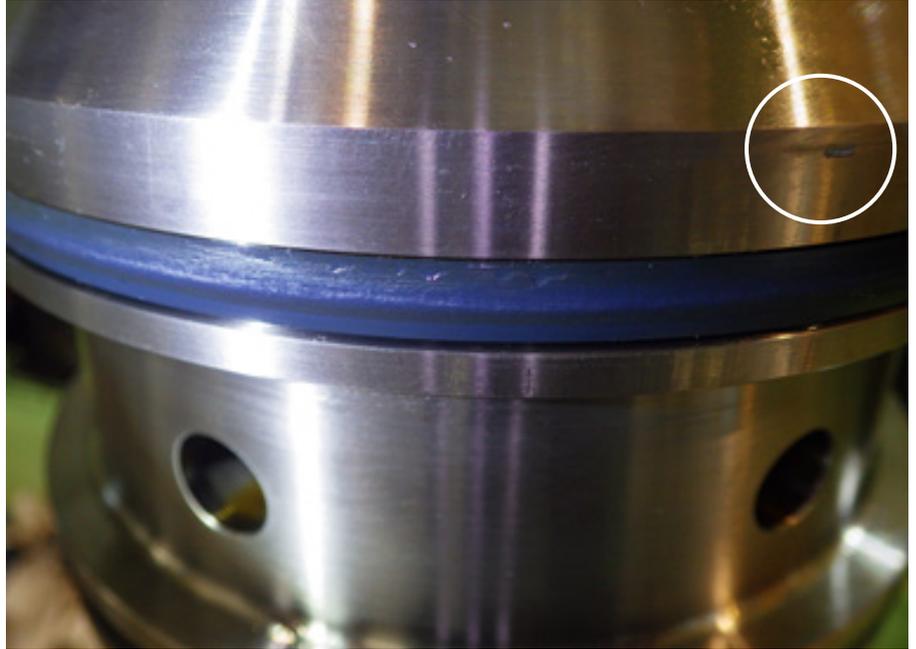
Fig. 64: Imprint from actuator slide pressure piece

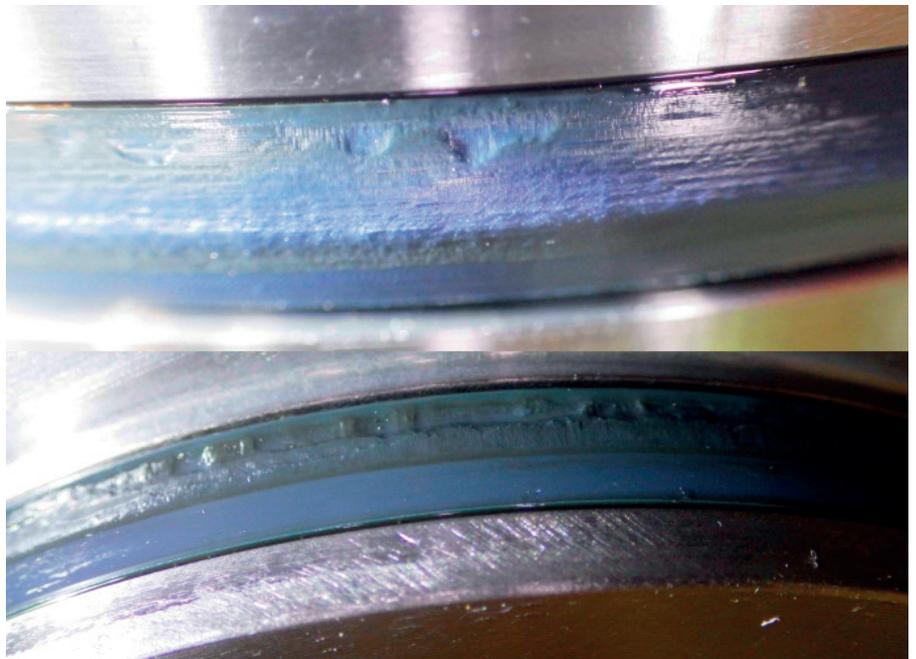
The radial sealing rings on the control bushing were found with some degree of wear, most likely due to the relative motion of the bushing. This is solved in the next iteration by fixating the bushing from the top of the TCEV oil cylinder. In the Mk. 2 version it is kept in place by the TCEV top cover allowing a few tenths of millimetres vertical motion. Fig. 65 displays the wear of the sealing rings.

Fig. 65: Sealing ring wear

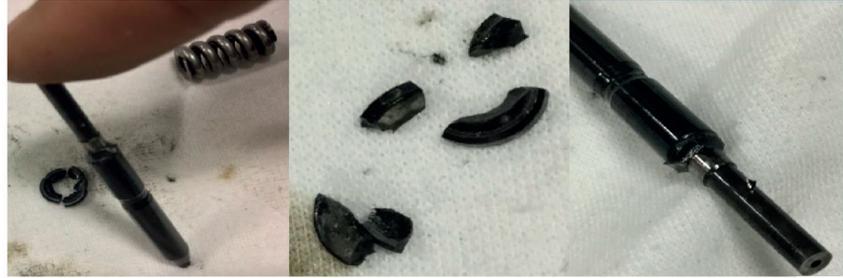
First piston got broken after around 300 hours

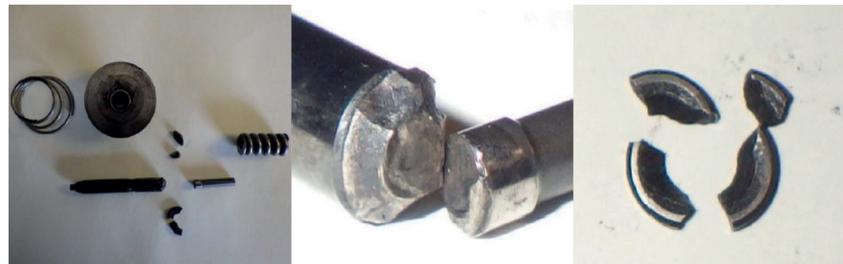
Second piston got broken few hours after the first

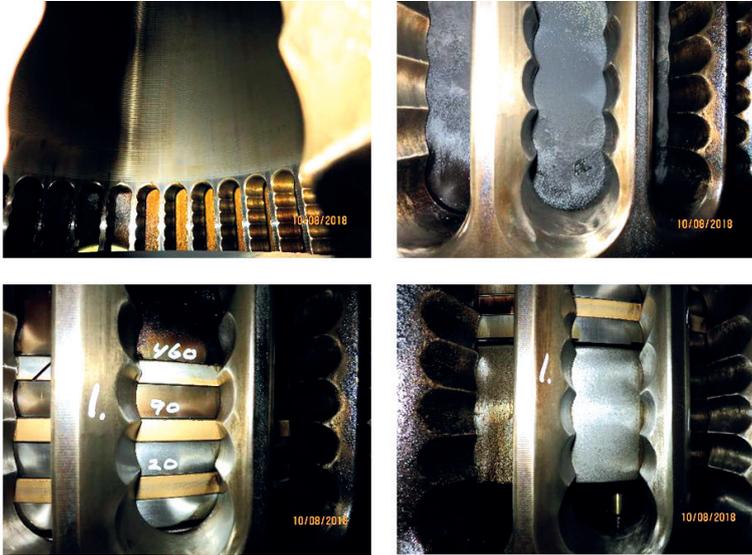
Fig. 85: 7G80ME-C9.5 EGRTC-Eco, good condition of cylinder No. 1

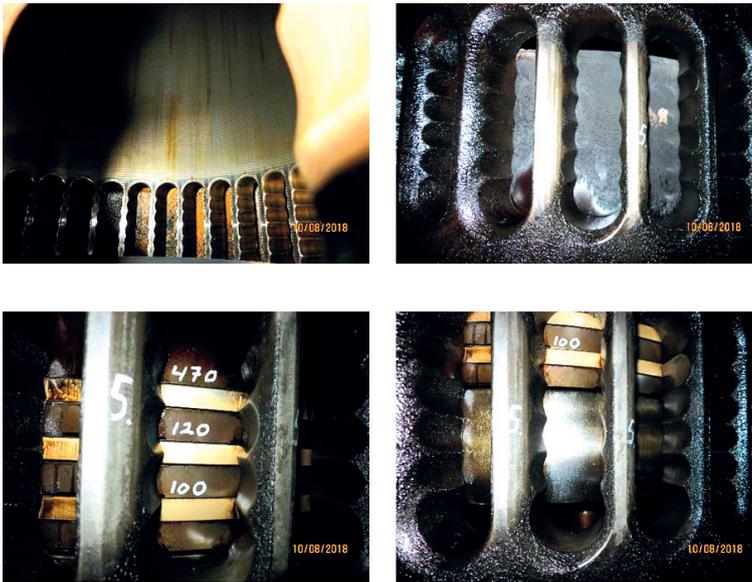
Fig. 86: 7G80ME-C9.5 EGRTC-Eco, good condition of cylinder No. 5
