UNIC control system regular rebooting interval

Date: 2022-01-14

All WinGD/Wärtsilä engines with UNIC engine control system

Updated precautionary measures for minimising ECS-related impacts on engine operation

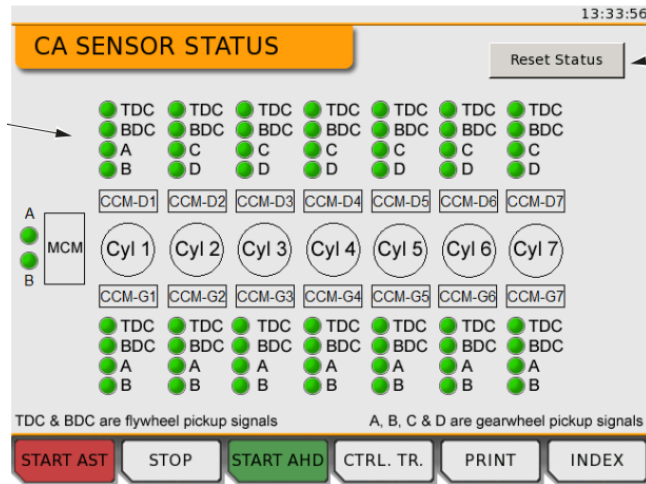
Figure 3-1: LDU (Local Display Unit) Crank Angle (CA) status

Prior to restarting the engine after rebooting the UNIC ECS, it is mandatory to perform at least one full revolution of the engine by using the turning gear. This is to restore the correct Crank Angle (CA). In the respective LDU page the status of the CA system be as shown in Figure 3-1.

For emergency cases after a crank angle loss, when the engine must become operational immediately, an engine start command will initiate the automatic Angle Determination Algorithm (ADA) function. However, this must be used only in an emergency case since there is a potential risk of damaging the scavenge air flaps if the crankshaft stands in an unfortunate position.
