Securing the Antenna Unit's Bottom Cover

Artemis MK5 Engineering Note EN5-15

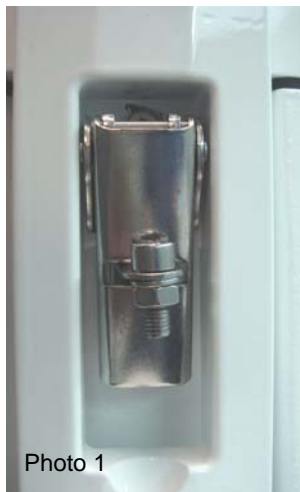
Photo 1

To avoid the snap locks becoming undone some years ago already lockable snap locks were fitted to the Artemis Antenna Unit. The eyelet of this type of snap lock offers the possibility to secure the snap locks by inserting for example a pad lock, a cable tie, a stainless steel M6 socket-head bolt with spring washer and nut (photo 1) or a snap harness (photo 2). The latter has the advantage that no tools are required to remove it, but has the disadvantage that it may damage the paint.

With new delivered Artemis MK5 stations a set of four stainless steel M6x16 mm securing bolts complete with spring washers and nuts will be supplied. For earlier delivered stations these sets are available from our agent Reson at no charge.

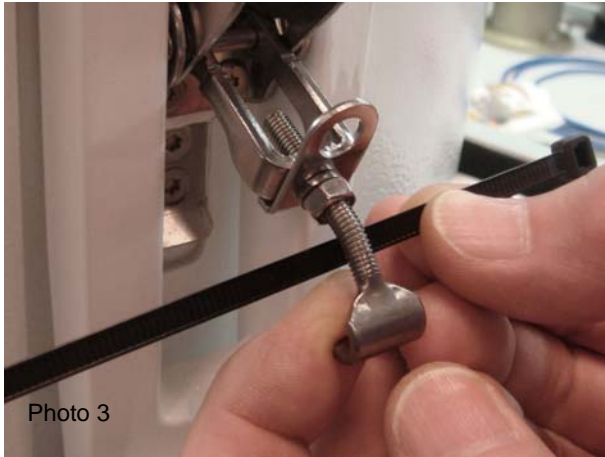
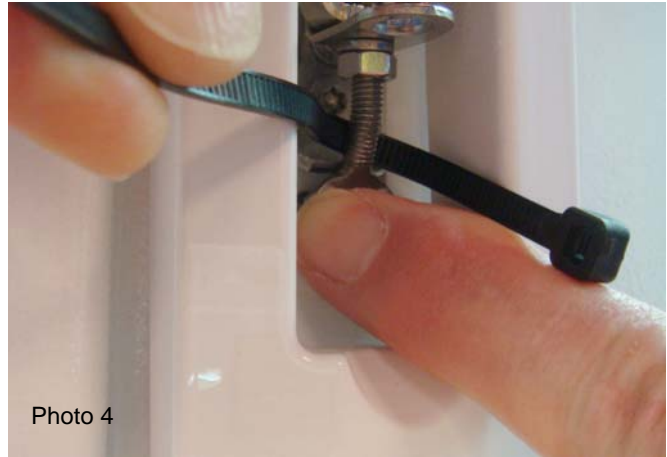
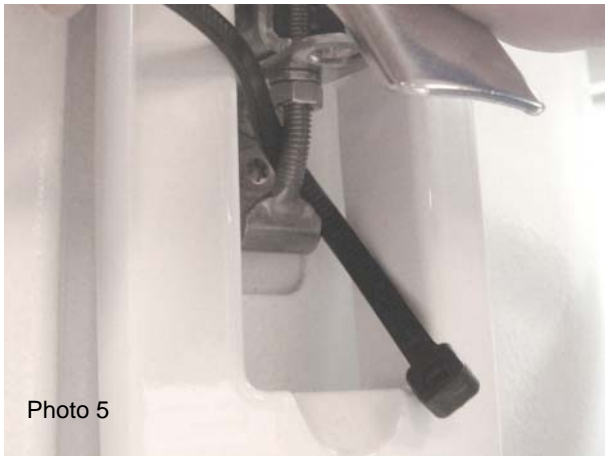
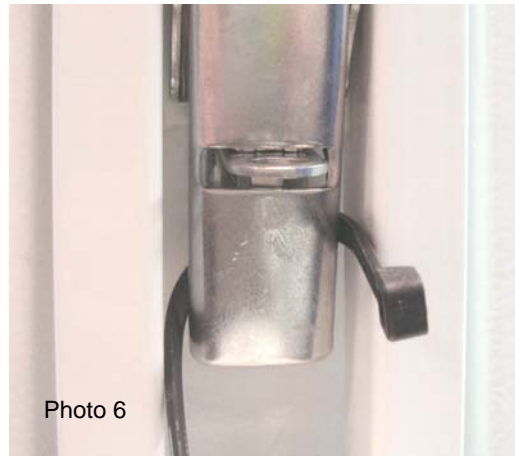
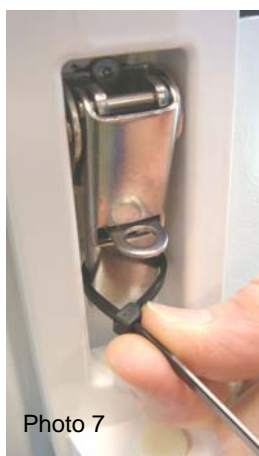
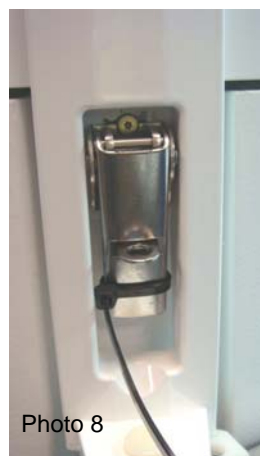
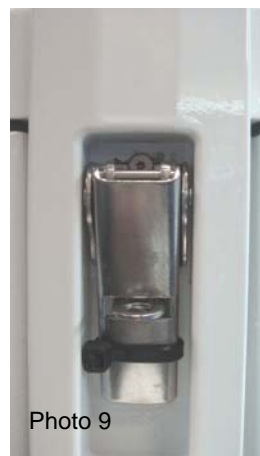
Since the snap locks of older Antenna Units cannot be replaced in the field by lockable snap locks, for these Antenna Units an alternative is the use of a cable tie to secure each snap lock. Photos 3 through 9 on page 2 show how this is done.

Note: The above photos were made of a unit with lockable snap locks as no unit without these was available. The eyelet shown is not present on the snap locks of older units. The snap locks of older units without lockable snap locks may be replaced by lockable snap locks at our factory. To ensure water tightness replacement other than in our factory is not recommended.

Apart from this it is advised to check the tightness of the snap locks yearly and adjust the tightness with the nut shown on photo 3, if necessary. This periodic check and adjustment may be combined with the application of grease to the unit's labyrinth every year as described in Engineering Note EN5-14.
