# Service Experience 2007, MAN B&W Engines

## The ME/ME-C and MC/MC-C Series

### Introduction

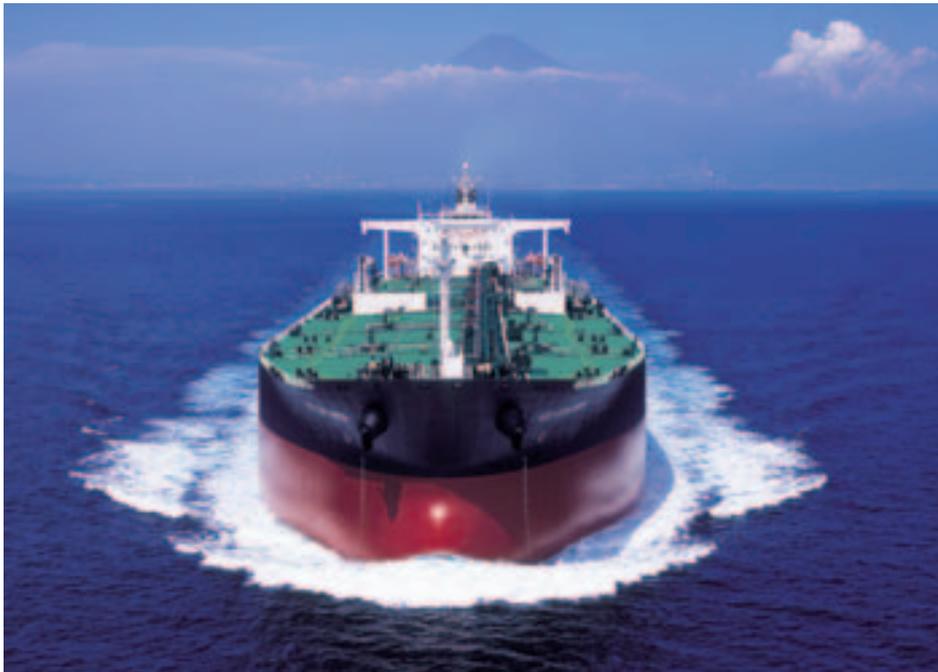
Fig. 1a : Prototype 7S65ME-C, is installed in the tanker *M/T Ice Explorer*, October 2006

The vessel *M/T Ice Explorer*, see Fig. 1a, is equipped with the 7S65ME-C prototype engine, Fig. 1b. The S65ME-C engine is a "pre-runner" of the S/K80ME-C and K90ME/ME-C Mk 9 engines.

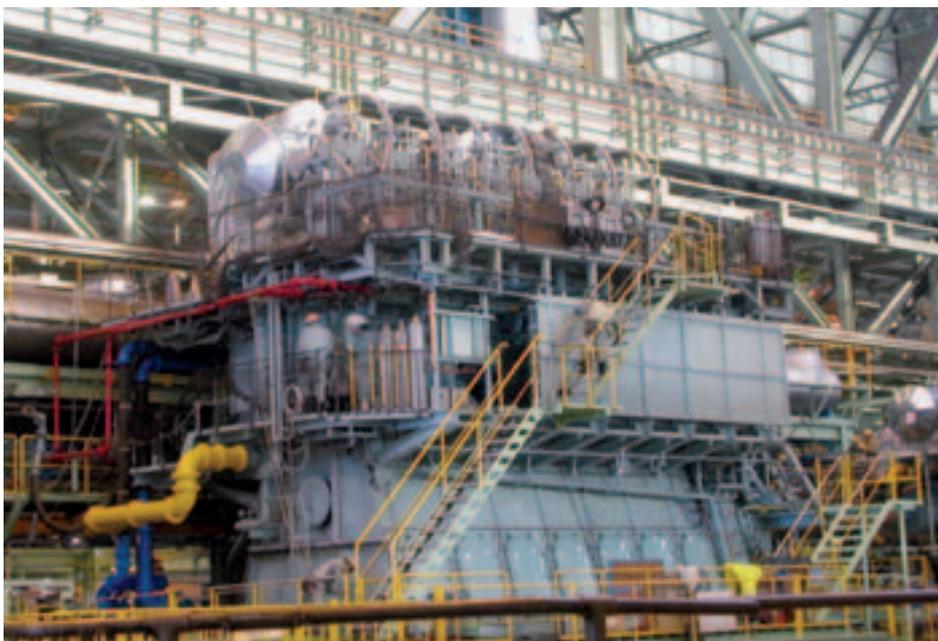
Fig. 1b: Prototype 7S65ME-C on testbed

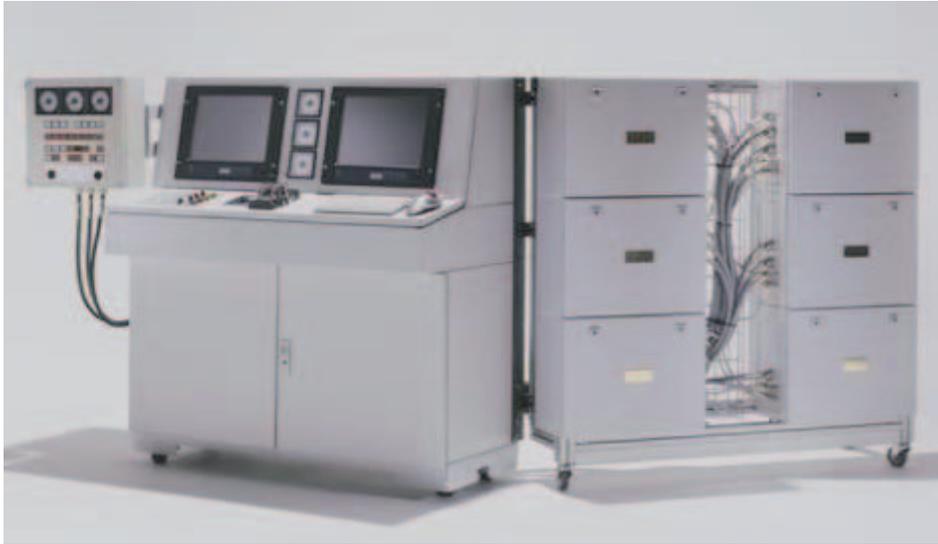
Fig. 10: One of three portable ME simulators in operation

and avoid any confusion and anxiety that could otherwise occur. To facilitate this, MAN Diesel has set up an ME training centre including a complete ME simulator, so that crews can get hands-on training at the MAN Diesel works in Copenhagen. Mobile versions of such ME simulators have been built in order to be able to train crews and customers at other locations than Copenhagen. Presently, three such portable simulators, Fig. 10, are in operation in China, Korea and Japan.

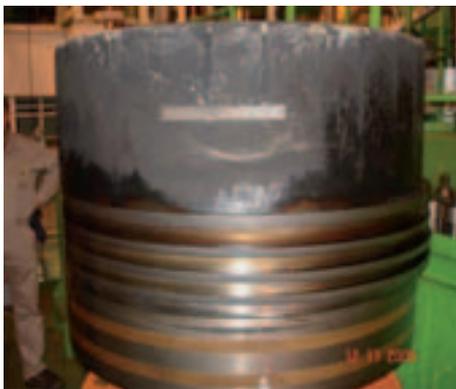
Fig. 11: 12K98ME prototype engine, piston inspected after 10,762 running hours

Fig. 11 demonstrates the cylinder condition on the first 12K98ME after 10,762 running hours, and the condition is perfect, as illustrated by the very clean condition of the ring package. As regards the cylinder condition in particular, observations so far indicate that we can expect an improved cylinder condition in general, probably owing to the fact that the fuel injection at low load is significantly improved, compared to conventional engines.

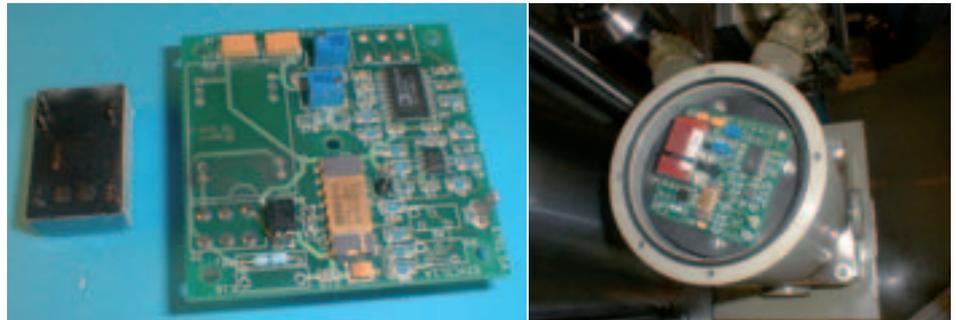
Fig. 12 : ELFI valve, DC-DC converter coming off due to vibration of PCB

On the Print Circuit Board (PCB) components have come loose due to vibrations. Fig. 12 shows a DC-DC converter which has come off. Improvements by means of resilient mountings have been introduced on all vessels in service with ELFI valves, and performance has been good hereafter, see Fig. 13.

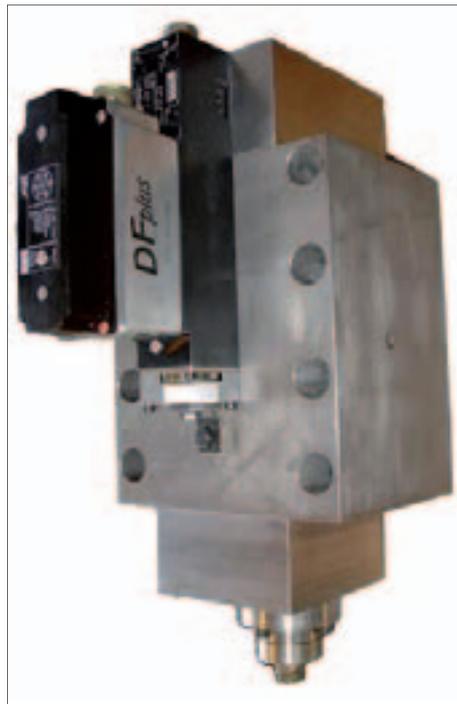
Fig. 17: MAN B&W FIVA valve

At year-end 2006, the combined Fuel Injection and exhaust Valve Actuation (FIVA) control valve were in service on approx. 70 engines. Most of the FIVA valves on these engines are produced by a European sub-supplier. However, in autumn 2006, an in-house designed version of the FIVA valve was launched in full scale service on a series of 12K98ME engines. Before being launched, the MAN B&W FIVA valve, Fig. 17, has undergone substantial tests both on our research engine and in service on individual cylinder units on a K98 engine.

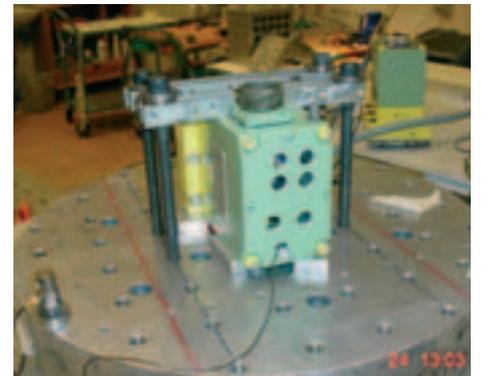
Fig. 19: Control valve, extended vibration testing

- In general, the FIVA valves have seen much fewer vibration-related troubles than the ELFI and ELVA valves. A resilient mounting design, Fig. 18, has been applied from the beginning, and extended vibration testing (up to 1 kHz) has been used, Fig. 19.
- In a few cases, we have seen growth of the main spool in the FIVA valve. Fig. 20 shows a main spool where the diameter has grown 6 micron. The reason has been put down to improper heat treatment of the main spool and the process has been corrected.

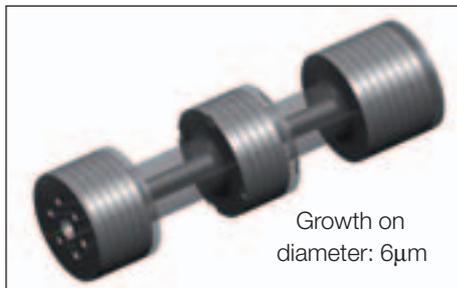
Fig. 20: FIVA valve, growth of main spool

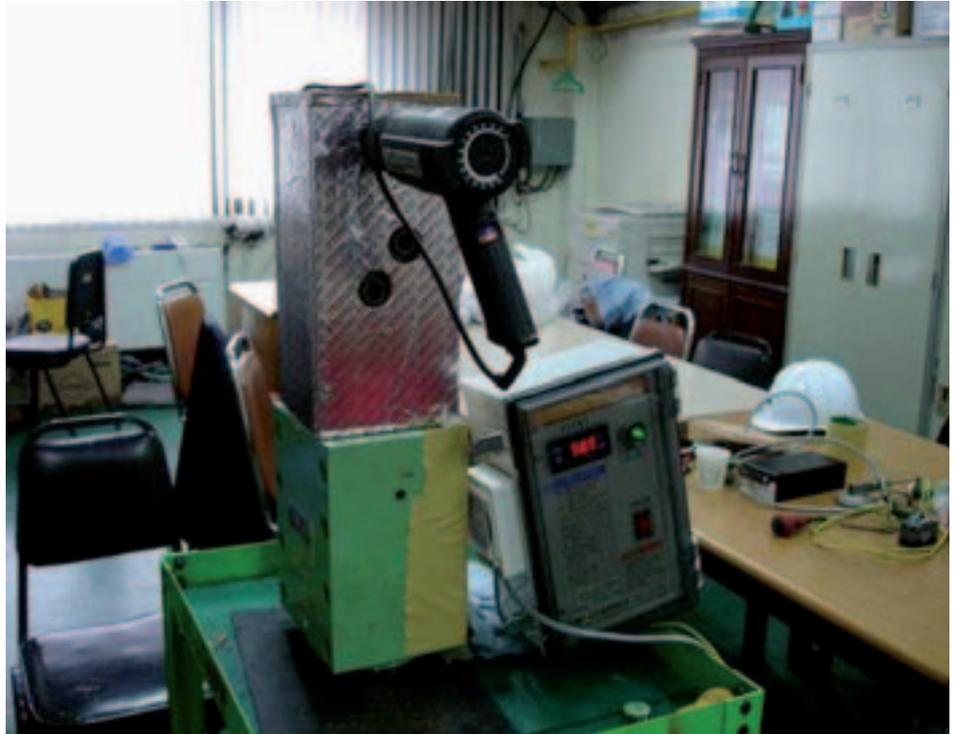
Fig. 22: Temperature test of FIVA valve with mobile equipment, the valve is connected to a CCU during the test

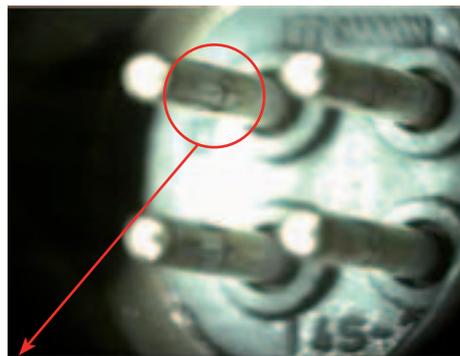
Fig. 24: Scratch marks on connector for exhaust valve feedback sensor

are later tested at the sub-supplier. In a number of cases, visual inspection of the sensors has revealed “scratch marks” on the connector, see Fig. 24. We believe that a new type of connector is needed. A new type of connector is currently being tested, and it is expected that this will soon be introduced as the new standard on the inductive feedback sensors.

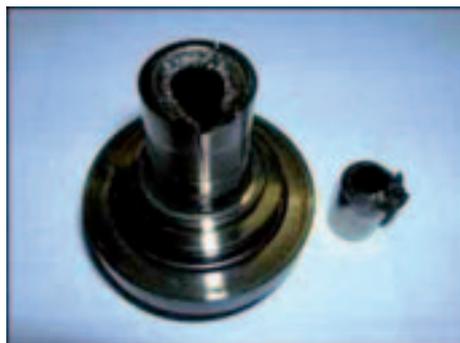
Fig. 26: ME fuel injector: breakage of cut-off shaft and non-return valve

The much higher pressure rate of an ME pressure booster than on a conventional fuel pump means a much higher impact on the fuel injectors on ME engines. This has led to cracking/breakage at the cut-off shaft, Fig. 26, on the non-return valve.

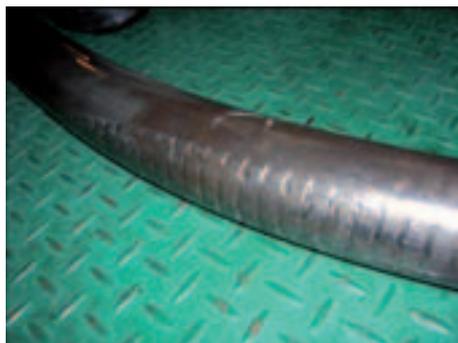
Fig. 28: Exhaust valve high pressure pipe: Serious dent marks has been observed

For the exhaust valve high-pressure pipes we have experienced heavy wear marks on the actual high-pressure pipe, Fig. 28. The reason is that the protection tube touches on the high-pressure pipe and, due to a certain vibration level, wear marks have developed.

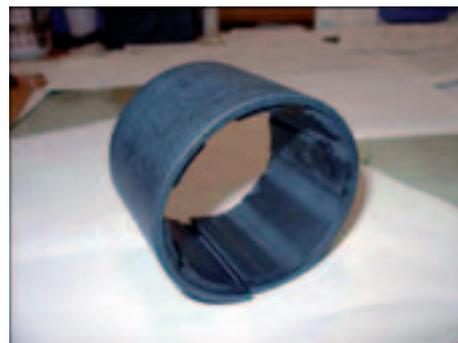
Fig. 29 Exhaust valve high pressure pipe: Chafing guard installed between high-pressure pipe and protective tube

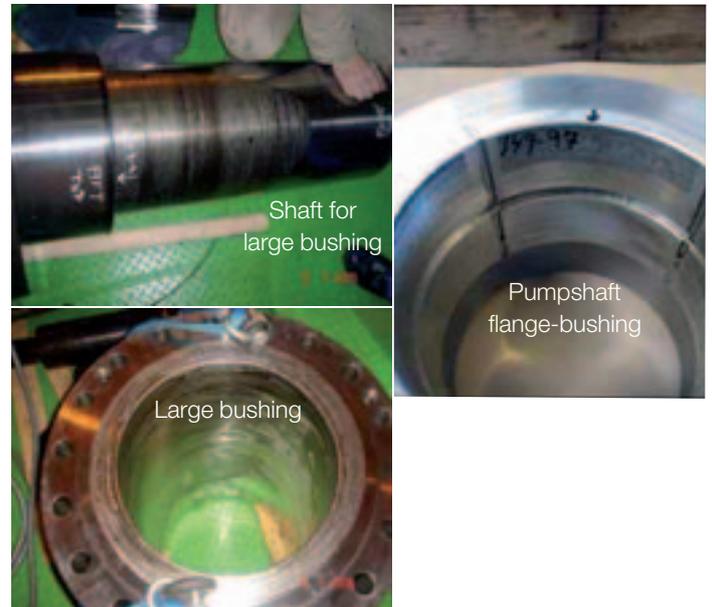
Fig. 31: HPS gearbox: Failed bushings/bearings

The failed bushing/bearing is seen in Fig. 31. In addition to the failure of the major bushing, also wiping of the white metal on the pump shaft flange bushings was seen.

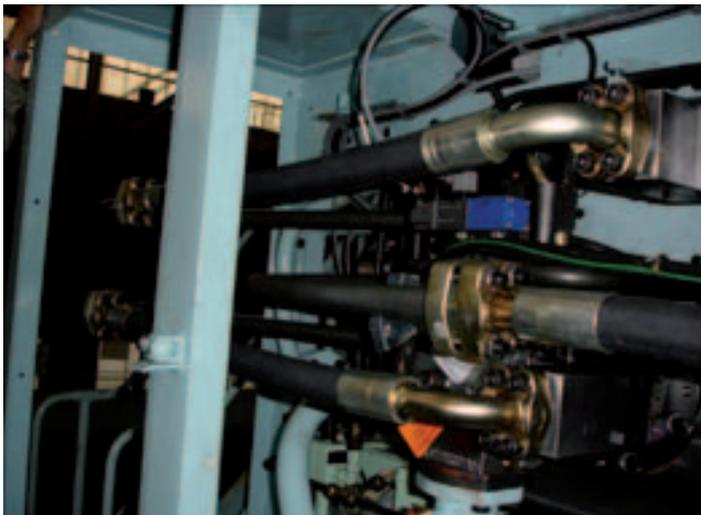
Fig. 33: Flexible hoses on K98

Cases of cracked hydraulic pipes for the servo oil to the swash plate pumps have been seen, and investigations have proved these cracks to occur due to vibrations. To avoid this, the pipe dimension has been changed, and flexible hoses have been introduced as an extra precaution, see Fig. 33.

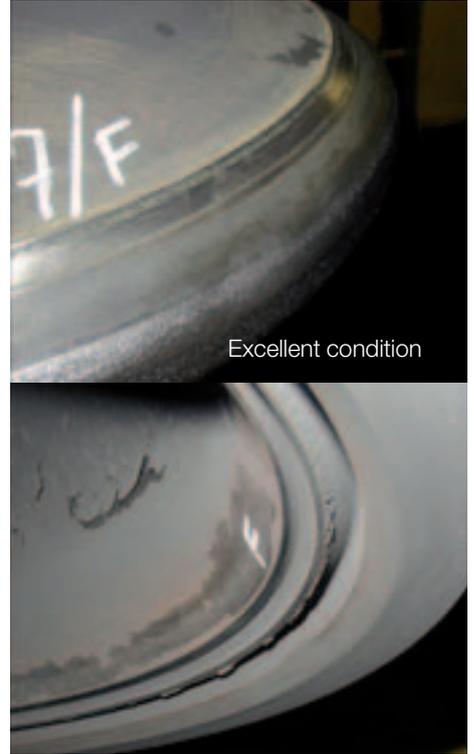
K90MC, W-seat and nimonic spindle at 36,400 hours without overhaul

Fig. 50: Nimonic exhaust spindle and W-seat bottom piece

The exhaust valve condition also gives rise to optimism with respect to the increase of TBOs. Fig. 50 shows a bottom piece of the W-seat design in combination with a Nimonic spindle on a K90MC engine inspected after 36,400 hours without overhaul.

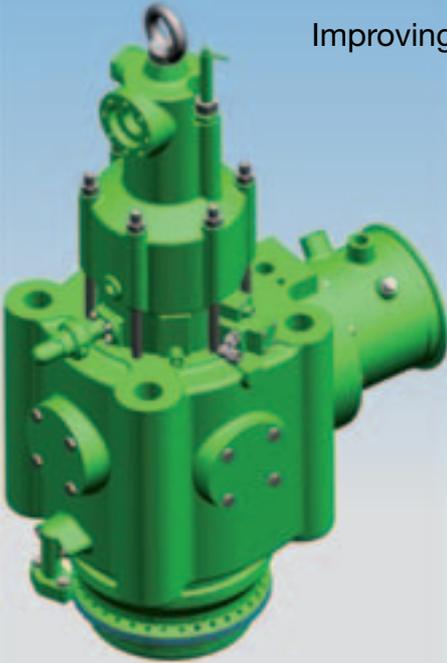
Items	Improved Items
Bottom piece seat	Hardened steel/W-seat
Spindle seat	DuraSpinde/Nimonic
Spindle guide	Cast iron/high spindle guide
Sealing system	Sealing oil Controlled Oil Level (COL)
Viton sealing	U-seal
Spindle stern	HVOF

Fig. 51: Features of present exh. valve standard

Fig. 51 outlines the features of the present exhaust valve design.

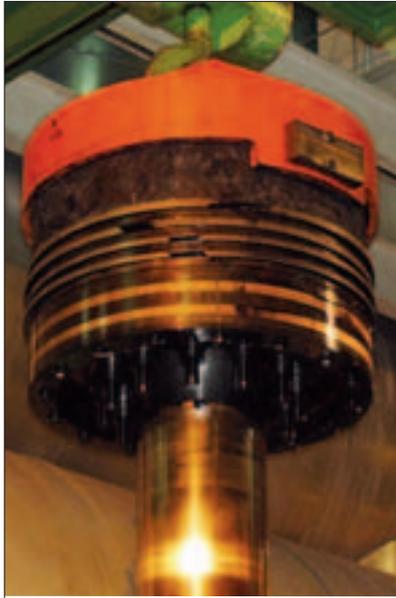
K98MC Prototype Engine  
Condition-based overhaul (Container vessel)

Fig. 54: 7K98MC, condition-based overhaul piston No. 1 overhauled first time after 42,500 hrs

For container carrier operators, another more condition based philosophy will pay off. Such a philosophy is practised on the K98MC prototype engine on board *M/V Antwerpen Express*. Fig. 54 shows that on this engine, unit No. 1

was overhauled after 42,250 hours of operation, seen Fig. 54.

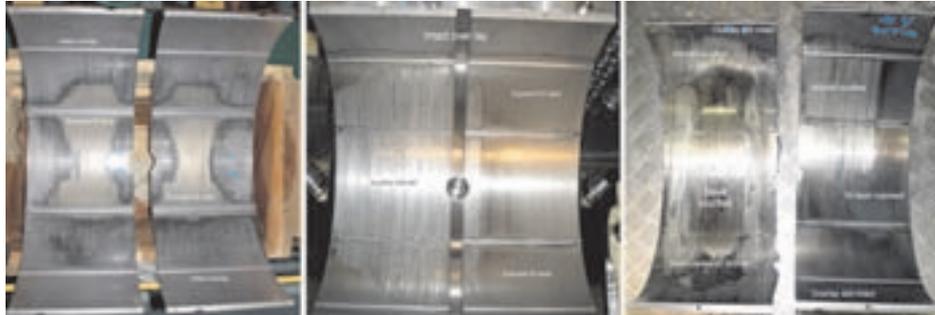
Partially corroded overlay, not yet scuffed

Overlay completely corroded, away, Ni 100% exposed, partial scuffing between Ni-layer and pin

Fig. 56: Crosshead bearing overlay corrosion

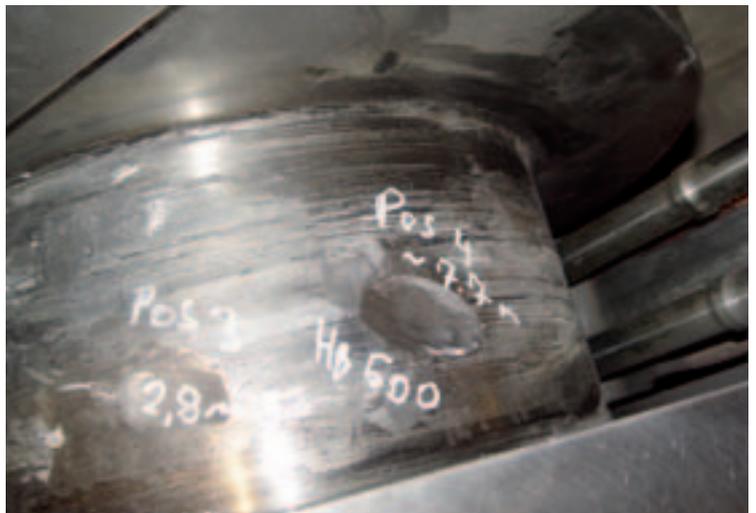
Fig. 60: Main bearing journal as result of steel-to-steel contact

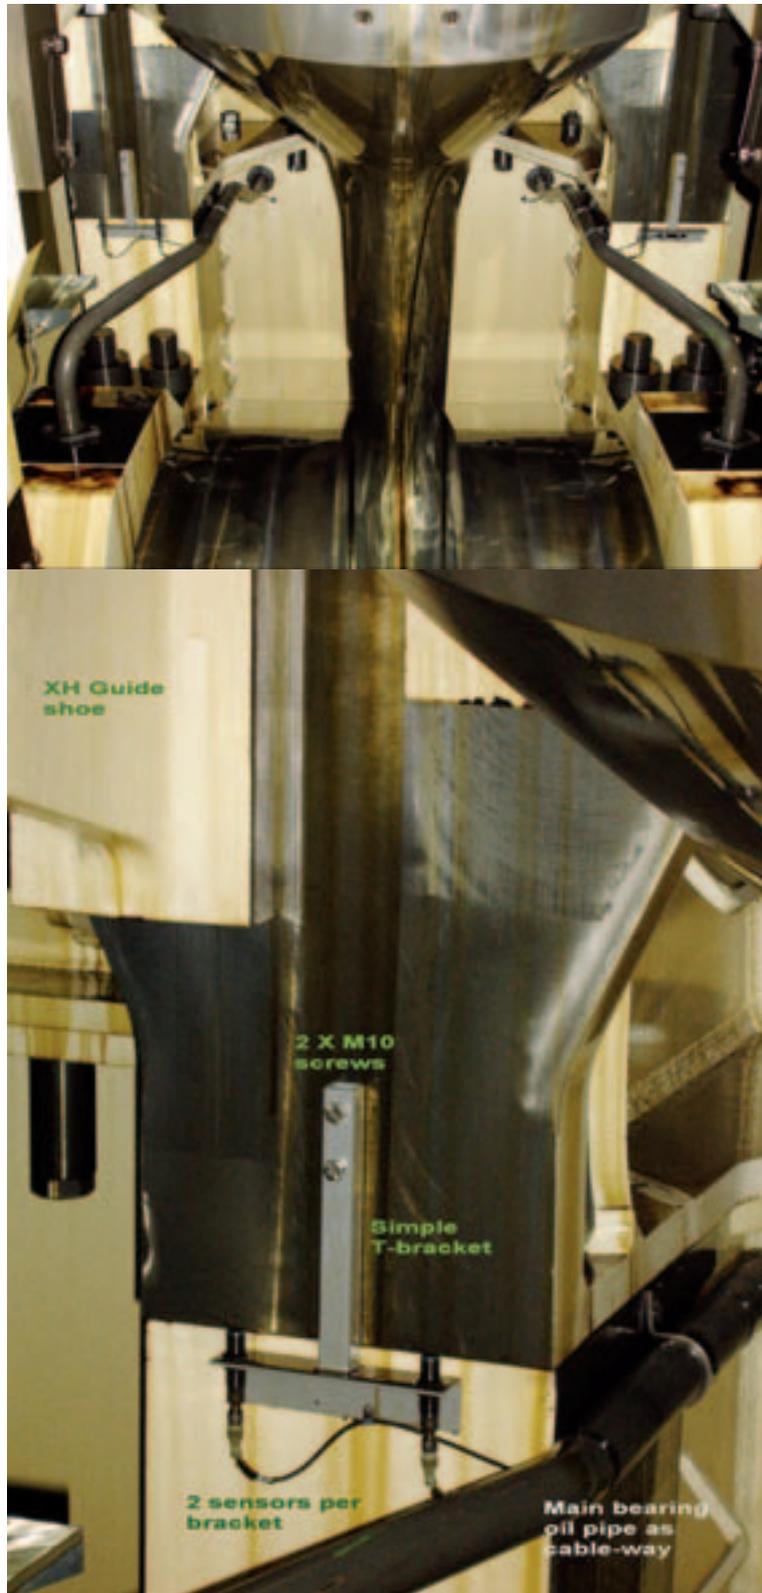
Fig. 61: BWM installation on a K98MC-C

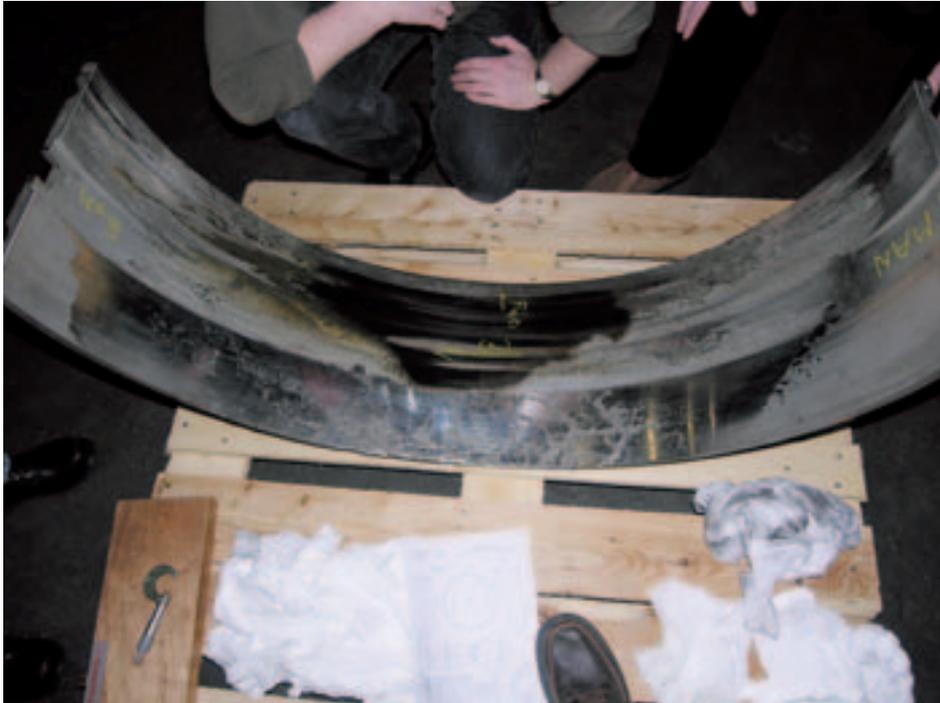
*Fig. 62: K98MC-C, crankpin bearing upper shell damaged by foreign material entered through the oil way*

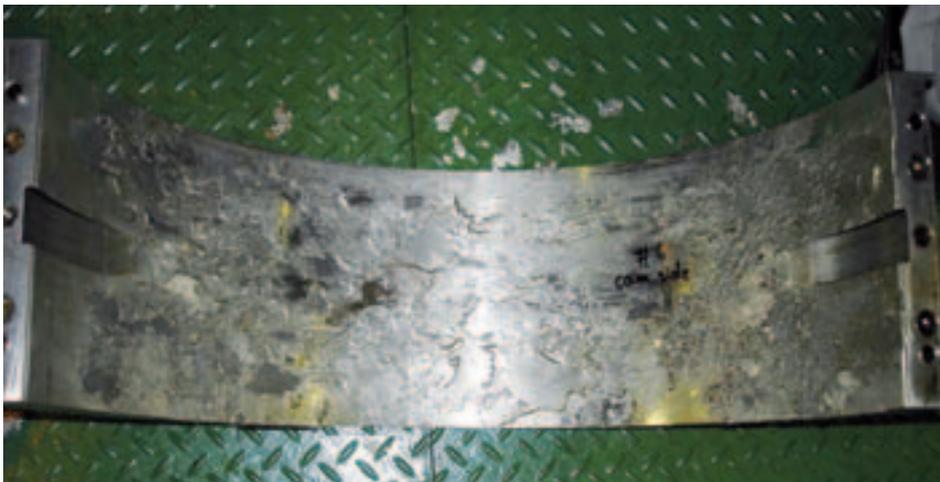
*Fig. 63: Thick shell main bearing severely, but not yet critically, damaged. Bearing lining worn, but not yet worn away*
