Service Experience 2006, ME and MC Engines

Introduction

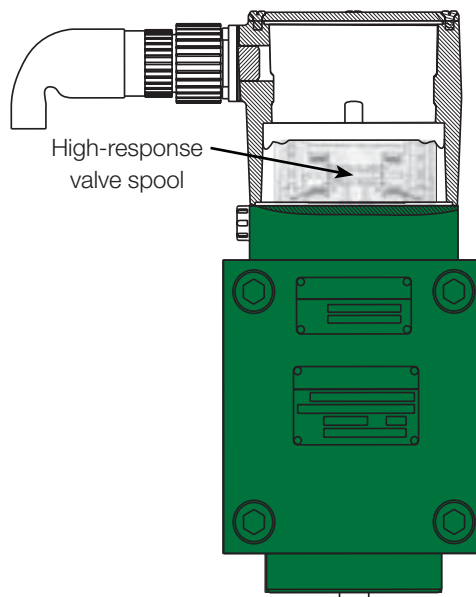
Early service experience proved that low ambient temperatures, as often experienced during shop tests in the winter season, gave rise to sticking high-response valve spools in the ELVA valve due to low hydraulic oil temperatures. The diameter of the spool was reduced in order to obtain correct functioning of the high-response valve as shown in Fig. 16.

Fig. 16: ELVA valve, location of high-response valve spool

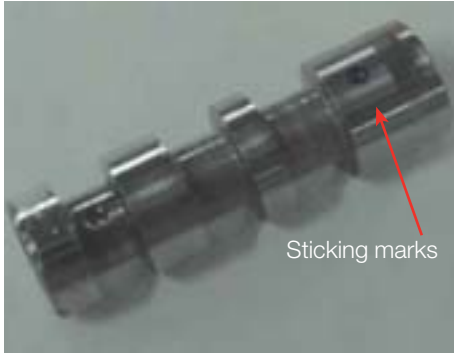
Fig. 17: ELVA valve, sticking high- response valve spool

However, a quality problem with too small clearances between the spool and the housing in the high-response valve has been encountered in service. This has led to a sticking spool, Fig. 17. In such a case the control system encounters improper lifting of the exhaust valve and fuel is, as a consequence, stopped to the unit in question. Engine

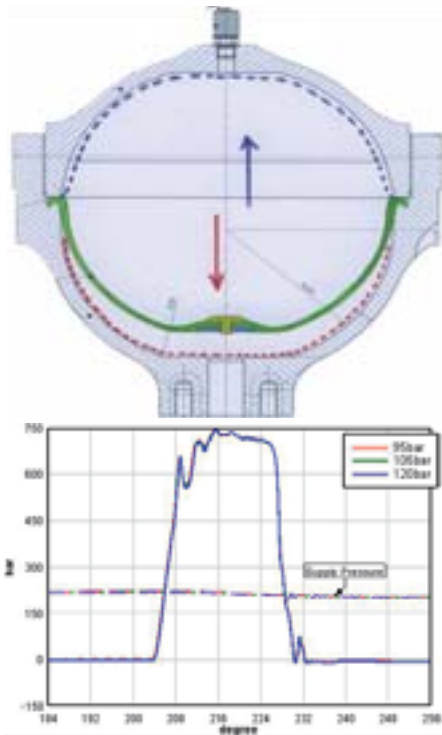
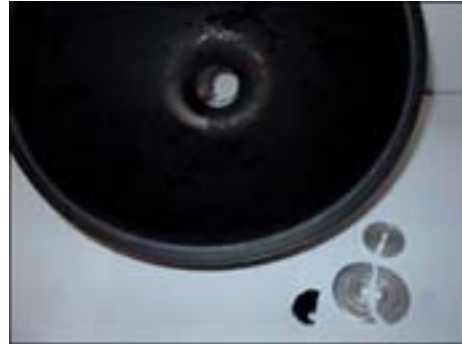
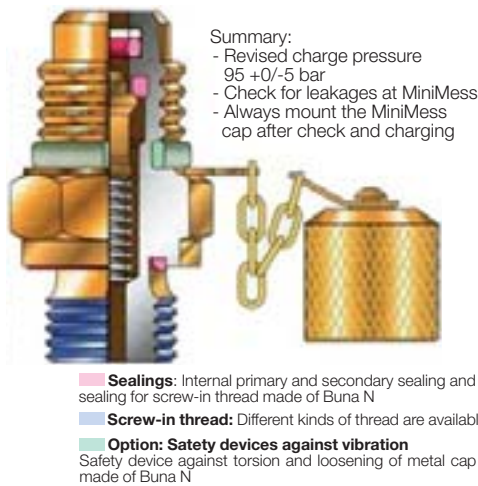
Fig. 26: Maintenance of accumulators

Regarding accumulators, we have seen cases of damage to the diaphragms inside the accumulators. Maintenance of accumulators was the subject of the first dedicated Service Letter for ME engines. Fig. 26 summarises our recommendations, which are to adjust the nitrogen pressure to 95 bar, check MiniMess for leakages and apply the

MiniMess cap after check and charging. Furthermore, it is recommended to check the nitrogen pressure with six months intervals.

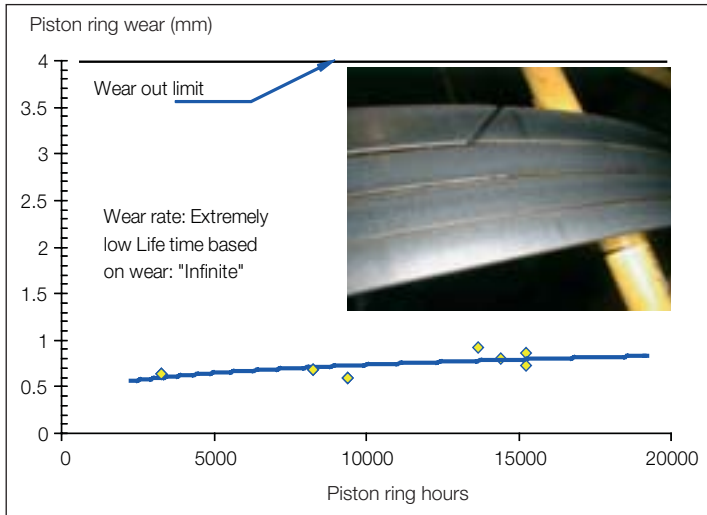
6S90MC-C engine), piston overhauls have been carried out successively from 8,000 hours and upward, see Fig. 42. The piston ring wear is extremely low, and from this point of view indicates 'infinite lifetime'.

Fig. 42: Piston ring wear measurements, prototype 6S90MC-C (M/T Maria A. Angelicoussis)

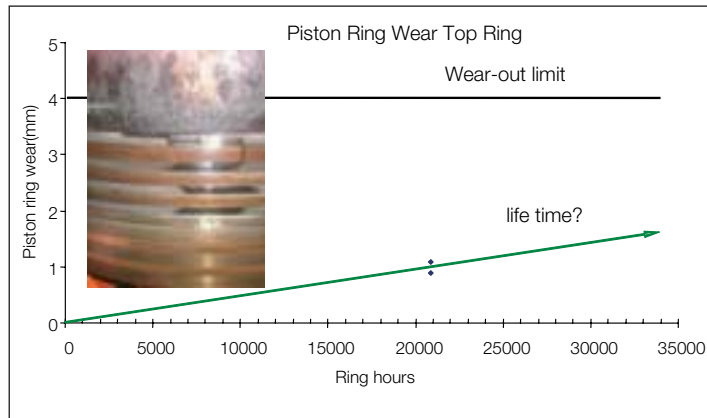
The vessels *M/T Kos* and *M/T Astro Cygnus* are also both equipped with Hyundai-built 6S90MC-C engines. In these engines, the pistons have been pulled between 20,000-21,000 hours and 22,000-24,000 hours, respectively. The pulling of pistons on both these engines was caused by 'internal coking' of the pistons. The reason for this was fuel oil contamination of the system oil,

Fig. 43: Piston ring wear measurements, 6S90MC-C (M/T Kos)

in both cases caused by leaking fuel pumps. Apart from this specific problem, both engines have shown excellent cylinder condition with low piston ring wear rates, Fig. 43.

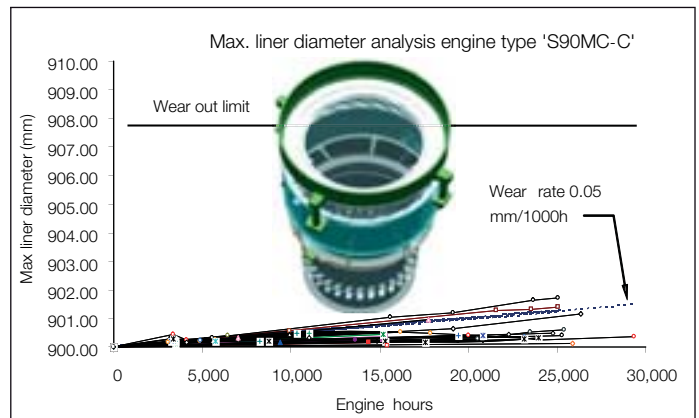
Fig. 45: 6S90MC-C, cylinder liner wear

1. Cylinder liner wear rates: 0.02-0.07 mm/1,000 hours (Fig. 45)
2. Piston ring wear rates: Predicted lifetime: 50,000 hours (Fig. 46)
3. Piston ring groove wear rates: Predicted time between reconditioning: 40,000 hours (Fig. 47)

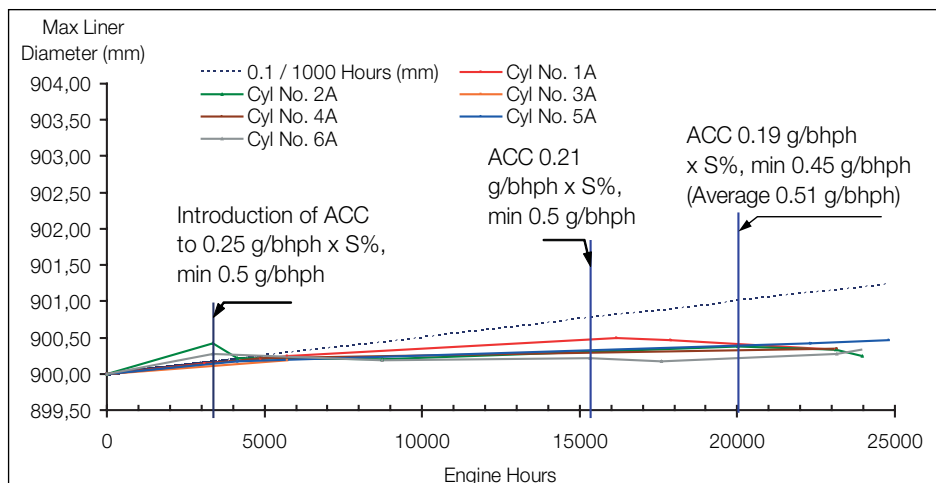
Fig. 44: Cylinder liner wear, cylinder oil reduction test, 6S90MC-C (M/T Astro Cygnus)

The engine onboard *M/T Astro Cygnus* has been a 'test-vehicle' for the further cylinder oil consumption testing according to the so-called Alpha ACC principle (ACC=Adaptive Cylinder oil Control). As can be seen in Fig. 44, this test has been extremely successful and it indicates further potential for reduction in the cylinder oil consumption.

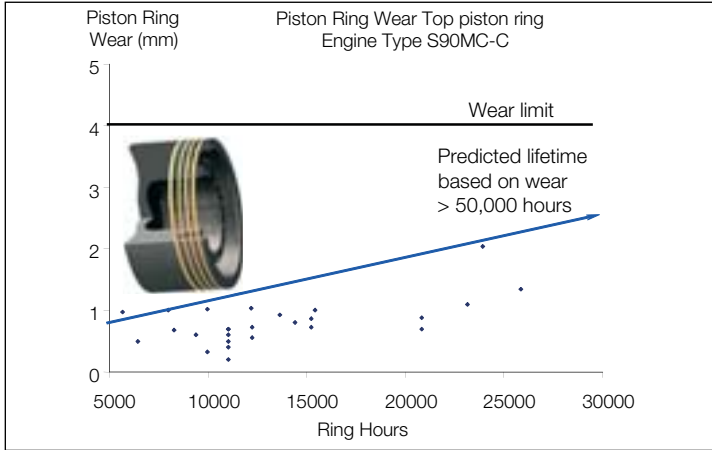
Fig. 46: 6S90MC-C, Piston ring wear

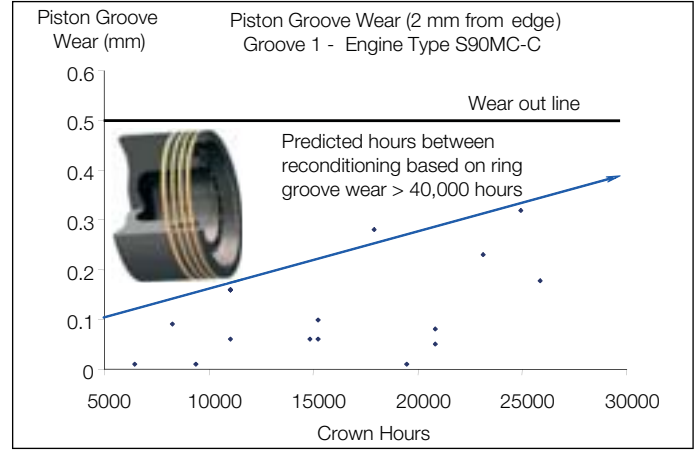
Fig. 47: 6S90MC-C, Piston ring groove wear

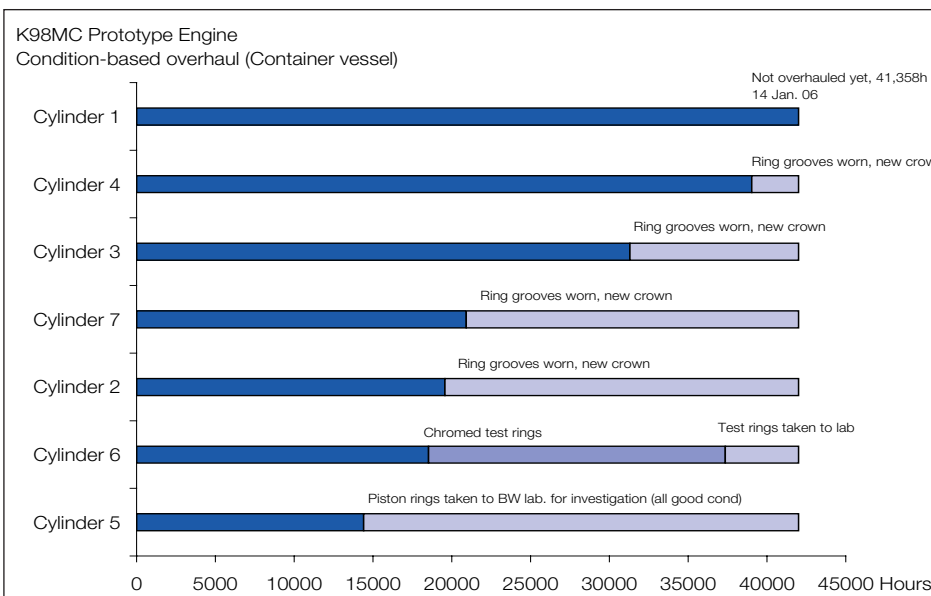
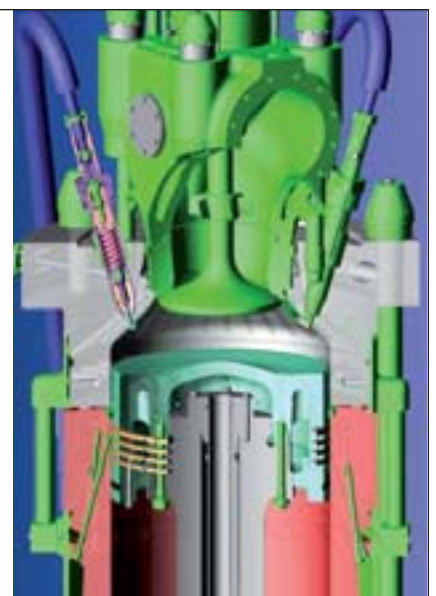
For container carrier operators another, more condition-based philosophy, will pay off. Such philosophy is practised on the K98MC prototype engine on board *M/V Antwerpen Express*. Fig. 52 shows

Fig. 52: 7K98MC, condition-based overhaul

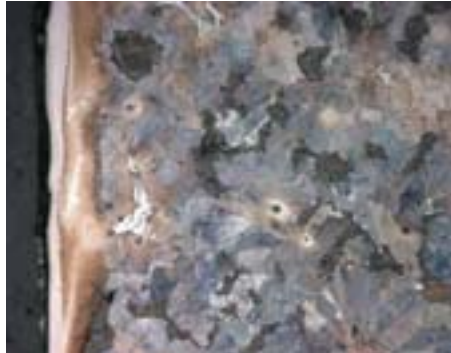
Fig. 53: Piston ring with 'white layer'

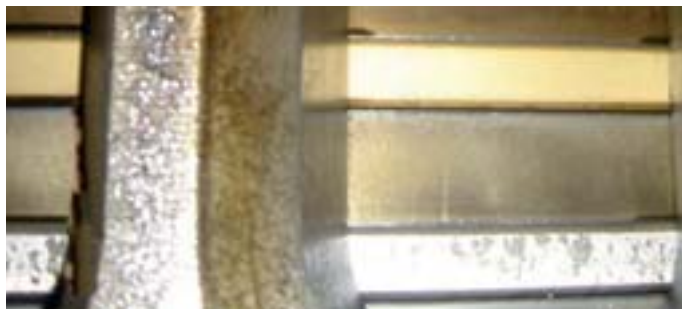
Fig. 58: Cylinder unit 8 rings, Port Klang

unit 8 and in the last hours before Port Klang, the liner temperature was stabilised as a result. In Port Klang, the rings of cylinder unit 8 were photographed through the scavenge port and minor damage to the hard-coat could be seen, see Fig. 58. Later records showed a stable cylinder unit 8.

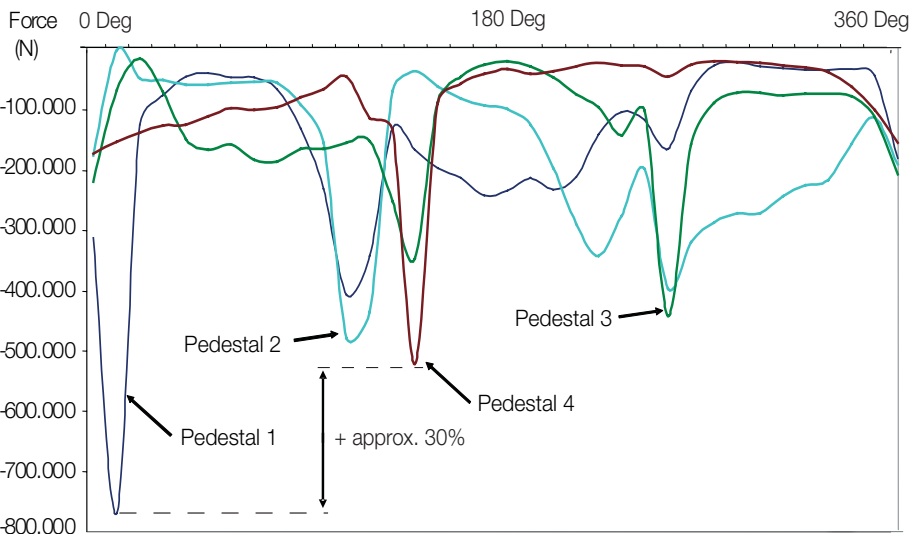
Fig. 66: Crack in camshaft bearing pedestal

Cracks in the camshaft housing for a number of K98MC-C engines have been detected over the last six months. At the time of writing, six (6) engines have been affected. In all cases but one, the cracks were found in the camshaft bearing pedestal No. 1. Analyses have shown that bearing pedestal No. 1 is approx. 30% more loaded than other camshaft housing bearing pedestals, Fig. 64.

Fig. 65 outlines on a drawing where the crack path is. An example of crack detection can be seen in Fig. 66. At the time of writing, 90 engines have been checked and we intend to inspect all engines in order to know the precise extent of the problem.

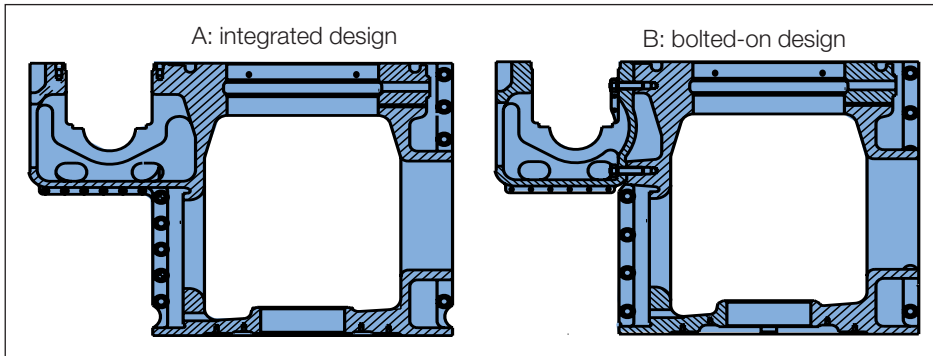
Fig. 67: Cylinder frame camshaft housing design

two (2) different designs for camshaft housings on the K98 engines, Fig. 67:

Cracks have been detected in both cases. However, repair methods differ somewhat. The following scenarios have been considered:
