Service Experience 2008, MAN B&W Engines ME/ME-C and MC/MC-C Engine Series

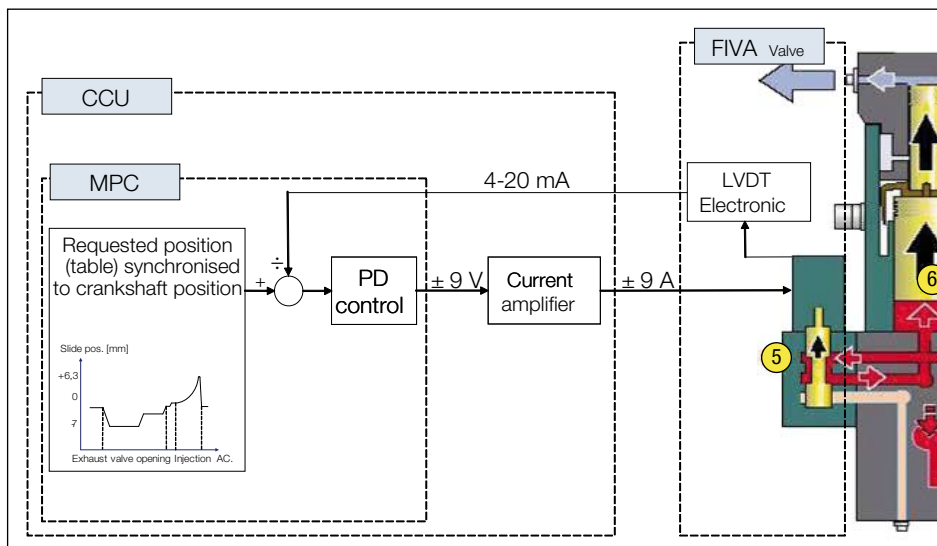
Fig. 8.3: FIVA valve position control

The feedback loop of the FIVA valve position control, Fig. 8.3, has caused untimed injection and untimed exhaust valve operation owing to various reasons. These reasons are related to the FIVA valve itself in some cases, and in other cases to the part of the feedback loop in the multi purpose controller (MPC), see multi purpose controller chapter.

In the original version, the electronics on the printed circuit board (PCB) in the Curtiss Wright FIVA valve showed thermal instability causing untimed actuation of the valve. The reason was an analogue voltage regulator generating

an excessive amount of heat raising the temperature by 35°C on the PCB. In some cases, this caused a temperature shutdown of the LVDT converter in the feedback loop, resulting in the above-described unstable function of the FIVA valve. The solution was to exchange the analogue voltage regulator with a switch mode regulator, Fig. 8.4. Hereby, the temperature of the PCB was lowered by approx. 35°C.

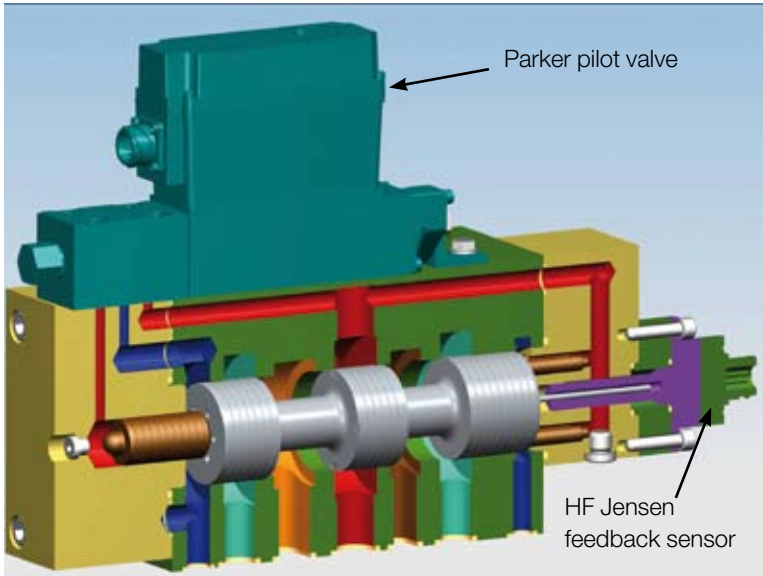
Fig. 8.7: MAN B&W FIVA valve

The MAN B&W FIVA valve can be seen in Fig. 8.7. It consists of a valve main body on which the Parker pilot valve and the H. F. Jensen feedback sensor are mounted. For the Parker valve, we

have seen a number of units failing because of:

- A: Broken bushing for the pilot slide, Fig. 8.8a. This item was rectified during the prototype testing period
- B: Earthing failure owing to damage of a flexible wire strip inside the valve, Fig. 8.8b
- C: Malfunction owing to failing operational amplifier, Fig. 8.8c

Parker valves with certain serial numbers have been replaced in service.

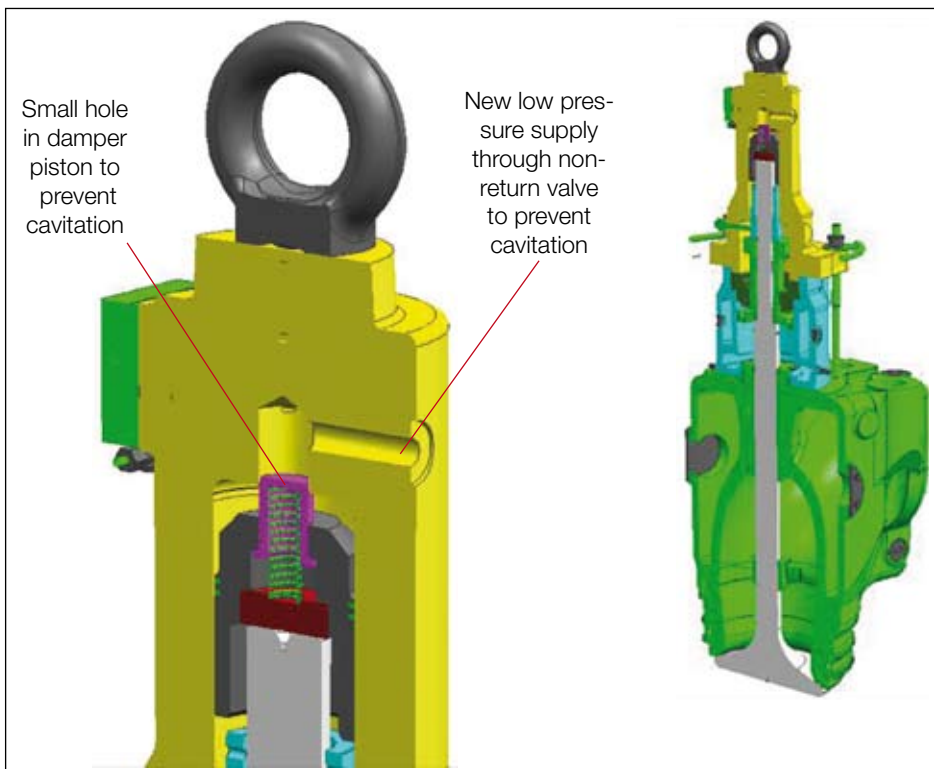
Fig. 8.13: Exhaust actuation system, scheduled test rig tests

Furthermore, damage to the oil inlet non-return valves on the actuator top cover indicates excessive pressure fluctuations in the exhaust valve actuation system.

- A: Reduced braking of the exhaust valve by introduction of an orifice (small hole) in the damper piston, Fig. 8.13.
- B: Low-pressure oil supply in the top of the exhaust valve, Fig. 8.13. It is considered to move one of the low-pressure supplies on the actuator, Fig. 8.14, to the top of the exhaust valve.

Whether (A) or (B), or both, is necessary to completely eliminate cavitation damage will be decided in the coming months.

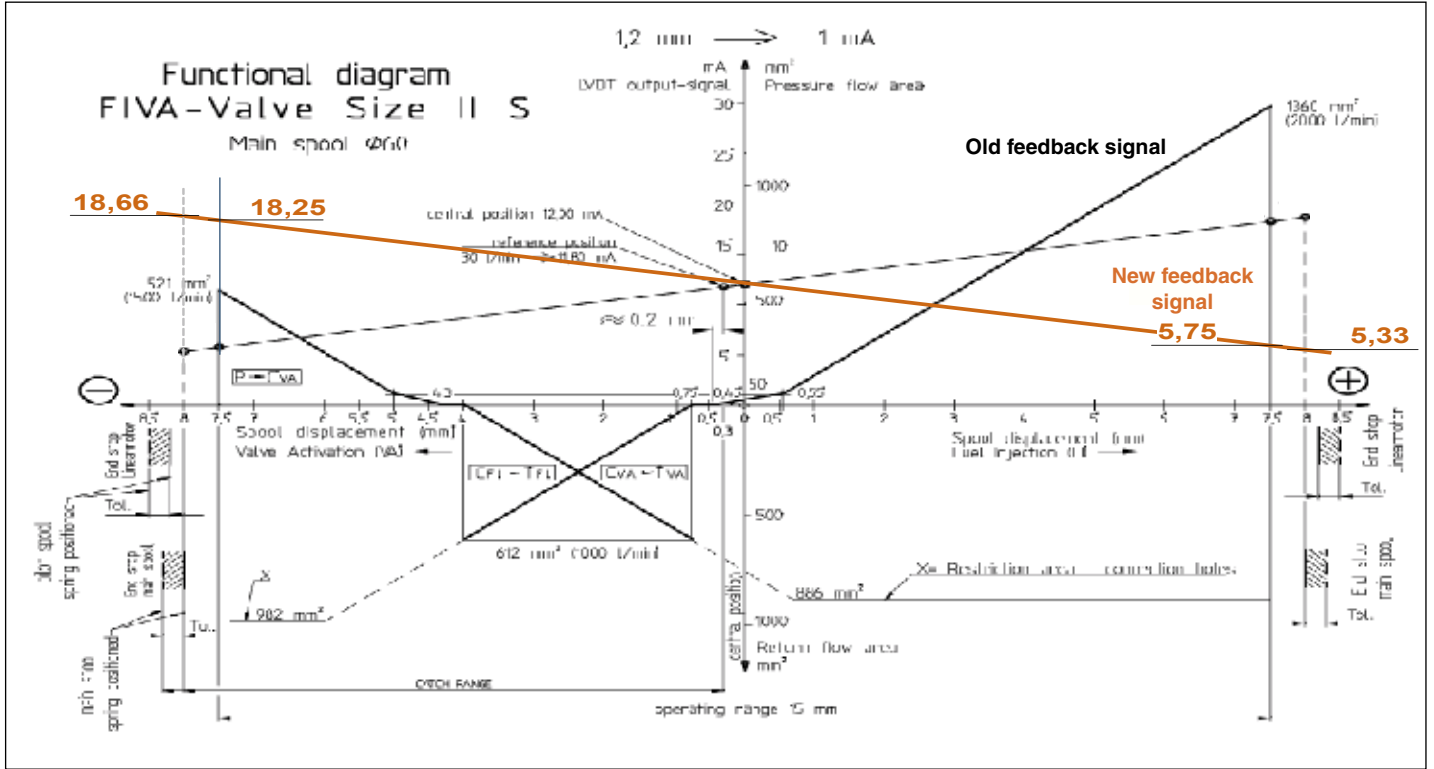
Fig. 8.16: FIVA valve flow area diagram

Secondly, it was concluded from tests that the reason why the error in the feedback loop of the MPC caused an untimed injection was that the feedback signal froze on a low value. When the closed loop control tried to rectify the position of the main slide in the FIVA valve, it moved the main slide towards

fuel injection and continued to do so until injection (untimed) was accomplished. This was done because of the frozen low-value feedback signal.

Based on this knowledge, it was decided to invert the feedback signal, Fig. 8.16. By doing this, a frozen low value feedback signal will result in a FIVA main slide movement towards untimed opening of the exhaust valve. This is considered to be “failing into safe mode”.

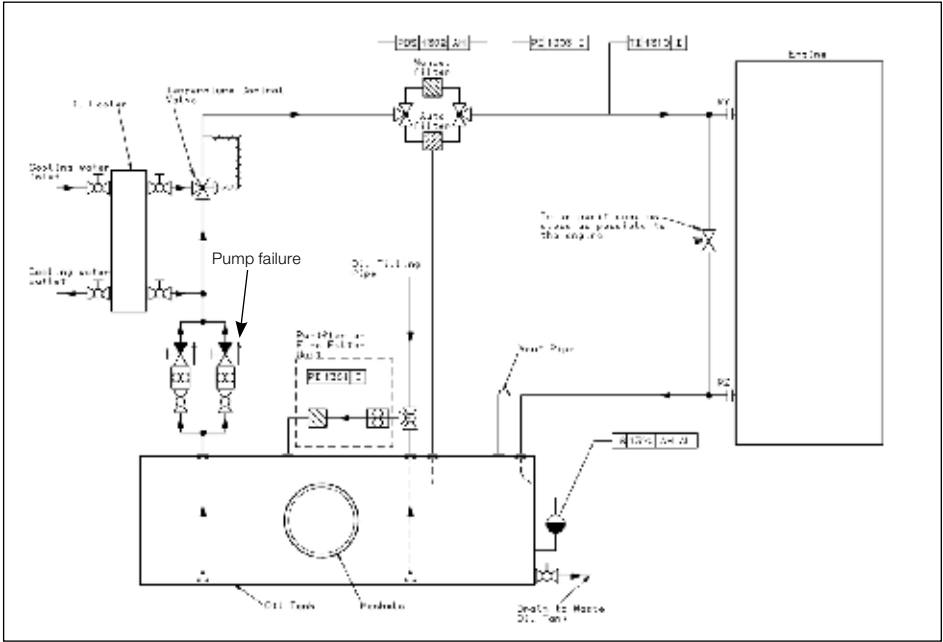
Fig. 8.20: Separate hydraulic oil system, initial version

- A: A standard system where engine system oil is processed through a 6-10 μm full-flow fine filter and then led into the hydraulic pumps of the HPS.
- B: An optional system where a separate servo oil system with a separate tank system is used, Fig. 8.20. The oil is cleaned by a cleaning unit (filter or purifier) mounted on the separate oil tank.

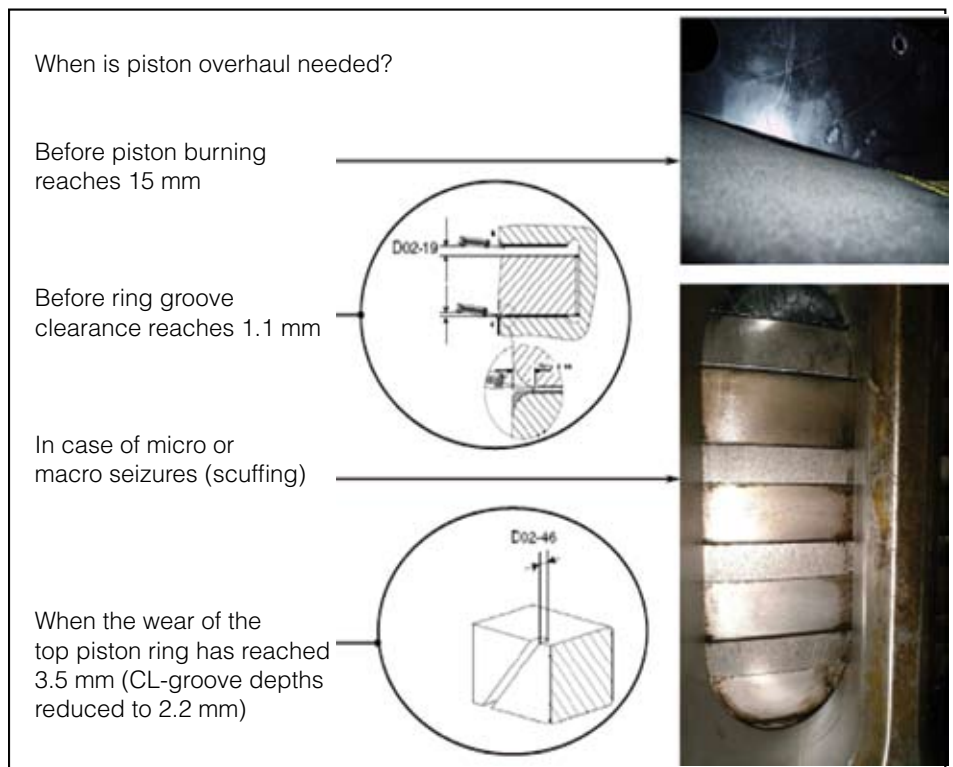
Fig. 8.23: K98 example. The four (4) important factors for piston overhaul

The most important factors for piston overhauls are, Fig. 8.23:

- Piston ring wear
- Max. amount of hot corrosion of piston top allowed on the centre part (where it is normally highest) is 9/12/15 mm on, respectively, 80/90/98-bore engines
- Ring groove clearance
Max. recommended clearance is 1.0 mm on the 80 and 90-bore engines, and 1.1 mm on 98-bore engines
- Sticking, broken or collapsed piston rings or leaking pistons
- Macro-seizures on piston ring running surfaces.

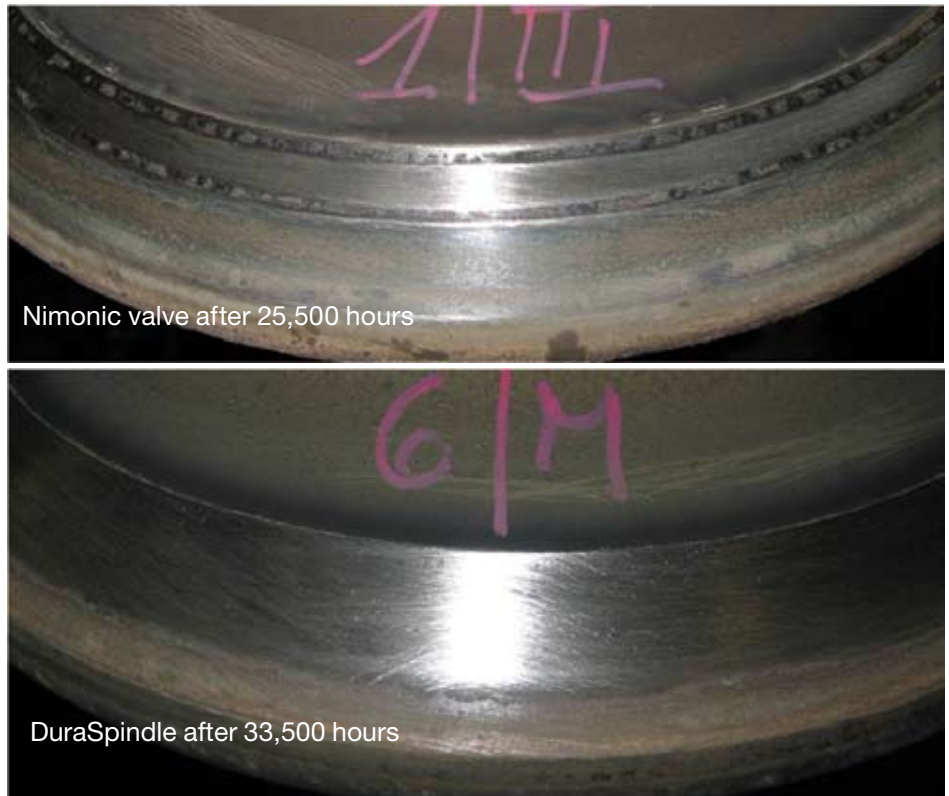
Fig. 8.32: W-seat in combination with nimonic spindle and DuraSpindle

For the exhaust valve, the use of W-seat, Fig. 8.31, and either nimonic valve spindle or DuraSpindle has improved the overhaul intervals to longer than 32,000 hours. Fig. 8.32 shows examples of an excellent condition without overhaul with combinations of a W-seat/nimonic spindle and a W-seat/DuraSpindle achieved on an S60MC engine after 25,500 hours and 33,900 hours, respectively.

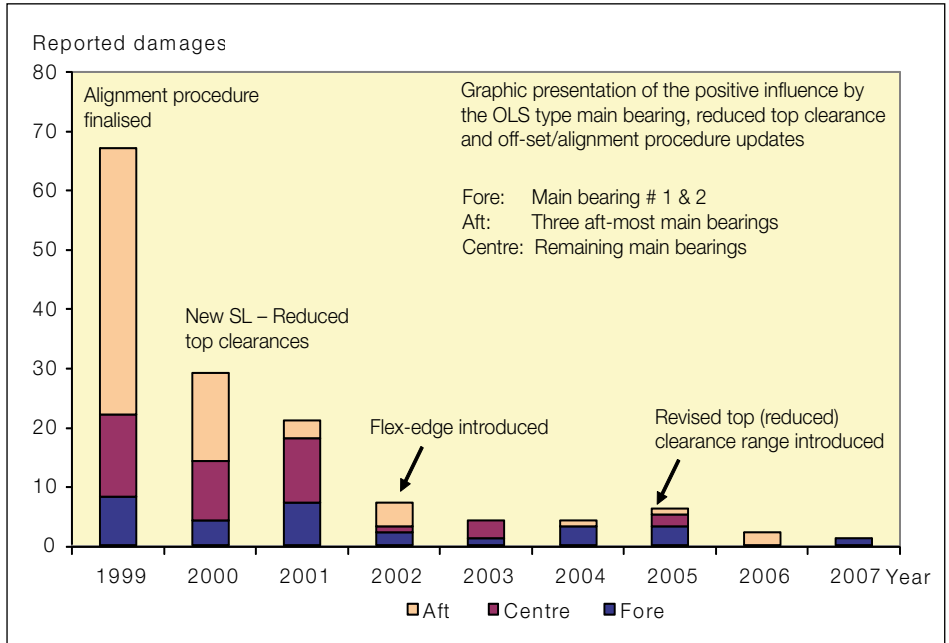
Fig. 8.36: Thick shell main bearing damage statistic

Since the late 1990s, a positive development with respect to main bearing damage has been seen. Despite the heavy increase in the number of main bearings on MC/MC-C engines, Fig. 8.35, the reported damage frequency remains very low, see Fig. 8.36.
