Service Experience of MAN B&W Two Stroke Diesel Engines

Stig Baungaard Jakobsen

MAN Diesel, Low Speed, Copenhagen (Denmark)

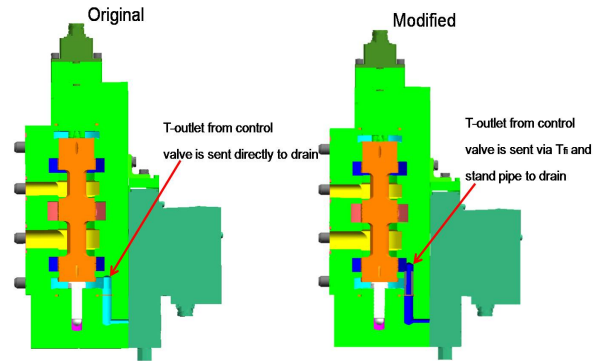
Figure 8 – MAN B&W FIVA: Cavitation countermeasure test 1

The cavitation damage on the Parker spools is mainly related to the tank ports for the pilot step. We have therefore designed two (2) service tests, which are currently accumulating hours on two (2) 12K98ME plants. Fig. 8 shows the test FIVA with the pilot tank port connected to the FIVA main spool pressurized tank port. Fig. 9 shows the other FIVA valve with the pilot tank port connected to a completely pressure-less drain.

On the basis of these test results, we will conclude final countermeasures in order to extend overhaul intervals to an acceptable time span. Preliminary inspection results from the service test indicate that cavitation countermeasure test 1, the pressurized submersed drain, is the most successful solution. However, more service hours are needed to make the final conclusion.

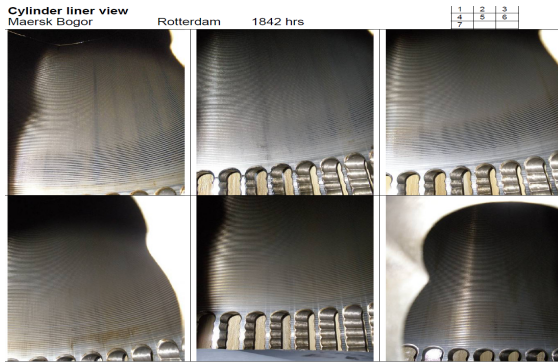
Figure 17 – Pitch-honed liner

Scavenge port inspection has been carried out after 1,842 running hours. The results can be seen in Figs. 15 and 16 for piston ring and piston skirt condition, respectively. Fig. 17 shows the pitch-honed liner from the scavenge ports. All inspection areas indicate that very successful running-in has taken place and that cylinder condition for all units is excellent.

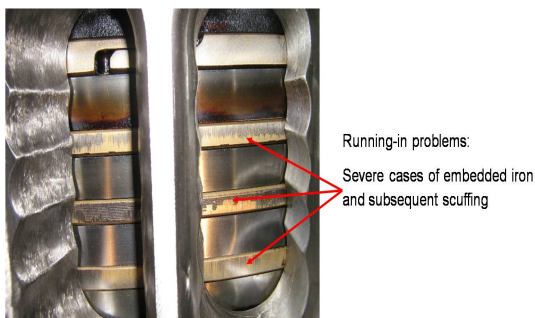
Lately, we have had to focus on running-in problems, typically at running hours between 500 and 1,000. The reason for the running-in problems is the piston ring quality in combination with the cylinder liner surface quality. Figure 19 shows a severe case of running-in problems due to embedded iron on the outside of the running-in alu-coat layer, peeling-off of the alu-coat/iron layer and subsequent scuffing. A detailed analysis of such problems has led to increased focus on:

Figure 19 – Increased focus on piston ring quality and liner surface quality

- Piston ring quality
- Liner surface quality/finish.

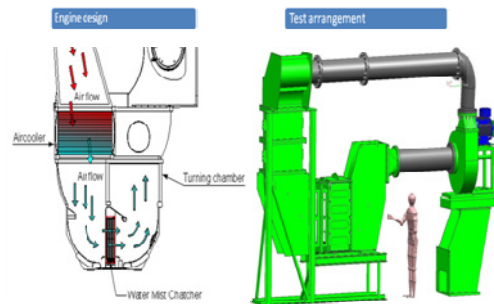
Figure 22 – Full scale test installation

Another recent focus area has been design and efficiency of water mist catchers. Figure 22 shows a full scale test installation for water mist catcher. We have made a full scale test on various water mist catcher designs, including some subsupplied designs, which have been applied in big numbers in our large bore engines. Figure 23 shows three (3) of the designs tested and Figure 24 shows an example of the results obtained. In this case, the water mist catching efficiency is shown as a function of air velocity and very big deviations in efficiency is seen. On the basis of

these results and an update of the mechanical design, we have now fully re-specified the water mist catcher design, and we expect that this will limit water ingress related scuffing.

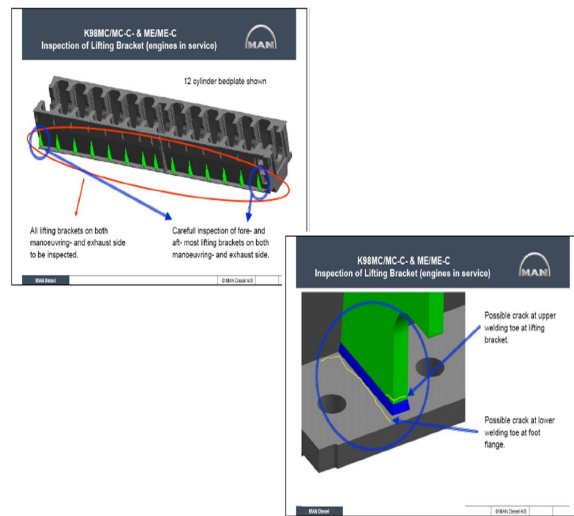
Figure 26 – Circular letter: K98 lifting bracket cracks

In 2008, cracks in the lifting bracket on K98 bedplates were discovered on engines produced 5-7 years earlier, Fig. 25. Soon after the first cracks were discovered, a so-called ‘Circular Letter’ was issued to all owners/operators of K98 engines, see Fig. 26. In this letter we asked for help to inspect for lifting bracket cracks. Furthermore, we informed about preventive countermeasures, which were burr grinding of the weld seams on the aftmost and foremost brackets. Also, a repair procedure was developed when the cracks first occurred. A modified bracket profile has been designed for new engines, Fig. 27.

Due to the high number of K98 engines in service, these rectifications are still ongoing and, fortunately, we are able to perform this work without disturbing the operation of the vessels involved.

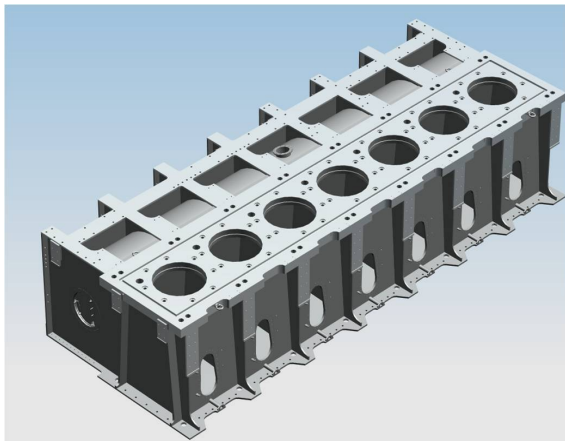
Figure 28 – Welded cylinder frame with integrated scavenge air receiver

As an alternative to cast iron cylinder frames, a welded version of the cylinder frame has been introduced. Fig. 28 shows a 7-cylinder welded cylinder frame with an integrated scavenge air receiver. The first generation of the welded cylinder frame showed, in some cases, cracks originating from the stay bolt covers, Fig. 29. A new bent type stay bolt cover has been designed, and attachment to the main cylinder frame structure at a position with lower stress level has been realised.

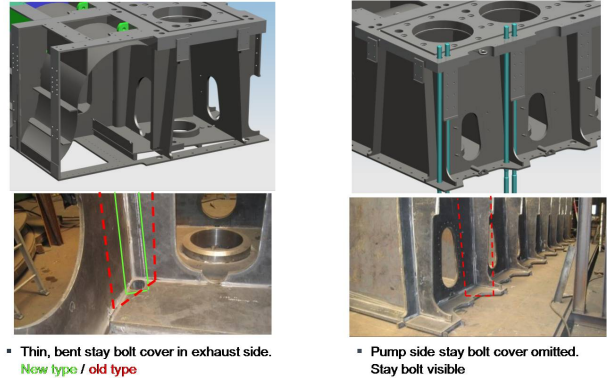
Figure 30 – Welded cylinder frame: old and new type stay bolt cover designs

Figure 30 shows the newest version of the welded cylinder frame for a K80ME-C Mk 9 engine. On the exhaust side, the bent type stay bolt cover is applied, and on the pump side the stay bolt cover is omitted.

We are confident that the crack problems related to the stay bolt cover plates have now been eliminated. For engines in service with first generation welded cylinder frames, repair work is in progress.

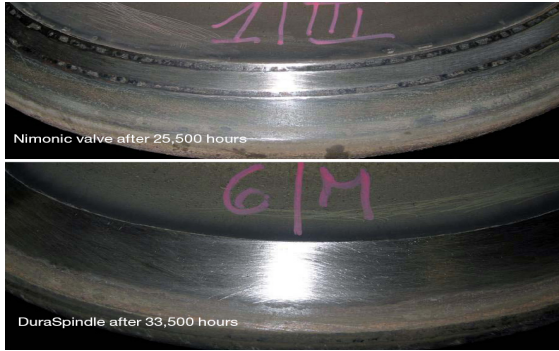
Figure 40 – W-seat in combination with nimonic spindle and DuraSpindle

For the exhaust valve, the use of W-seat, Fig. 39, and either nimonic valve spindle or DuraSpindle has improved the overhaul intervals to run more than 32,000 hours. Fig. 40 shows examples of an excellent condition without overhaul with combinations of a W-seat/nimonic spindle and a W-seat/DuraSpindle achieved on an S60MC engine after 25,500 hours and 33,900 hours, respectively.

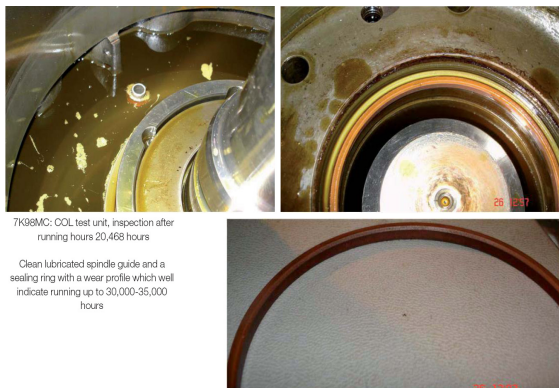
Figure 42 – Inspection of COL design

For exhaust valve stem seal, the so-called controlled oil level (COL) design, Fig. 41, indicates that also stem seal overhaul intervals can be extended to 30,000-35,000 hours based on results from several test units on 98, 90 and 60-cm bore engines. This is illustrated by Fig. 42, showing an open-up inspection on a K98.

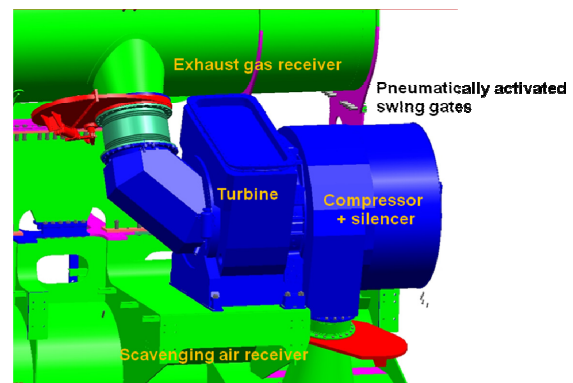
Figure 57 – Pneumatically activated swing gates

A flexible T/C cut-out system assisted by an arrangement of so-called swing-gate valves, Fig. 57, has been tested successfully on a 12K98ME engine with three (3) turbochargers.

The middle turbocharger was retrofitted with swing-gate valves. In late December 2009, the engine and especially the turbocharger subjected to T/C cut-out were inspected. During this inspection the T/C cut-out system had been in operation for 1,637 hours and out of these hours cut-out mode were realised in 1,270 hours. During the T/C cut-out operation the turbocharger was at standstill lubricated and sealing air applied. Both axial and radial bearings in the turbocharger were in normal good condition.

The service test described above indicates that flexible T/C cut-out systems is an option when optimizing low load operation and that with a limited number of countermeasures it is possible to leave the T/C rotor at standstill in the turbocharger.
