Service Experience

MAN B&W Low Speed Diesel Engines

Service Experience of MAN B&W Low Speed Diesel Engines

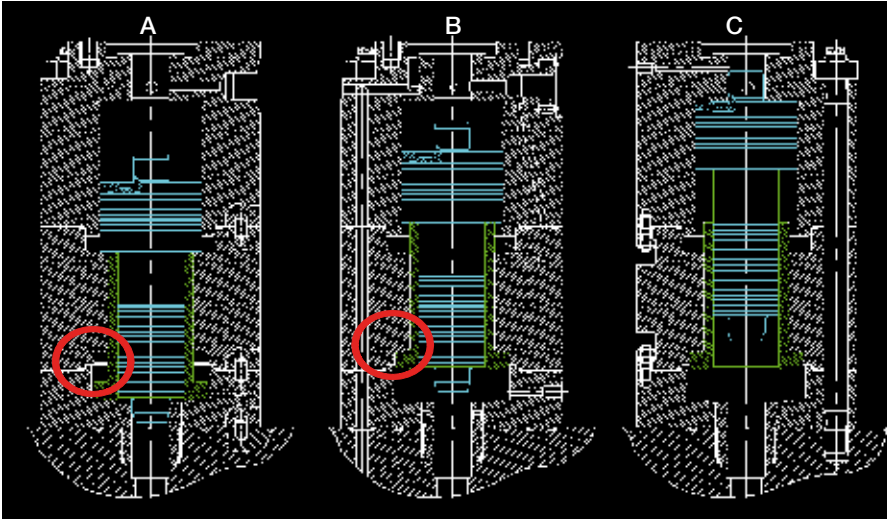
Fig. 3: Exhaust actuator

The exhaust actuator for the ME engines is a two-step actuator. The principle of function is shown in Fig. 3. Fig. 3 (A) shows both pistons (step 1 and step 2) in bottom position. Fig. 3 (B) illustrates

how the step 1 piston is stopped in the “damper” as the step 2 piston continues its movement upward. In Fig. 3 (C), the step 2 piston has arrived at its top position caught by another “damper”.

On a few actuators for the original 200 bar hydraulic system, we have seen breakage of the step 1 piston collar, Fig. 4. We are convinced that this problem relates to delayed “take-off” of the step 1 piston from the bottom position, Fig. 3 (A). This is caused by a “glue” effect, which exists from time to time. When the step 1 piston is delayed it will create very high pressures in the “damper” chamber and hereby increased load on the piston collar is generated. Various means to avoid the “glue” effect can be introduced by generating a force by the oil pressure under the step 1 piston. An example of retrofit is illustrated in Fig. 5. Such design modifications will eliminate the trouble with step 1 piston breakage.

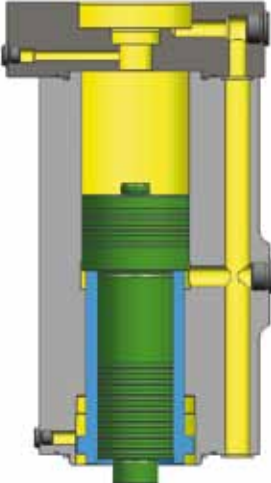
Area of contact causing glue effect

Problem	Countermeasure
“Glue” effect between piston step No. 1 and distributor block, causing a launch delay for piston No. 1.	Grinding grooves in piston No. 1 for easy relief. Grooves: 8 x R 0.5 mm w. depth of approx. 0.3 mm.

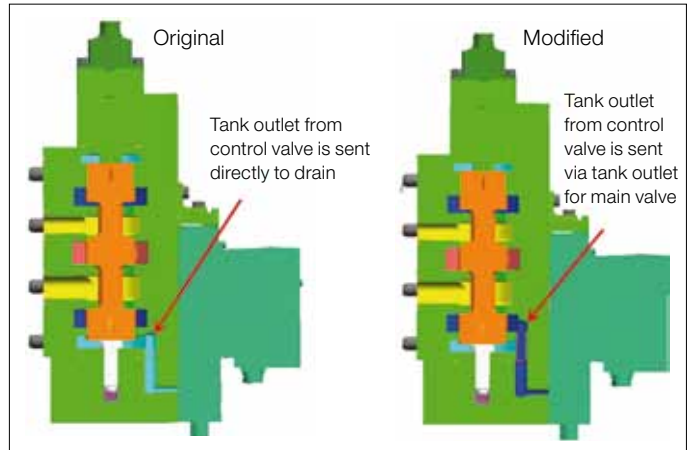
Fig. 8: MAN B&W FIVA: Cavitation countermeasure test 1

The cavitation damage on the Parker spools is mainly related to the tank ports for the pilot step. We have therefore designed two (2) service tests, which are currently accumulating hours on two (2) 12K98ME plants. Fig. 8 shows the test

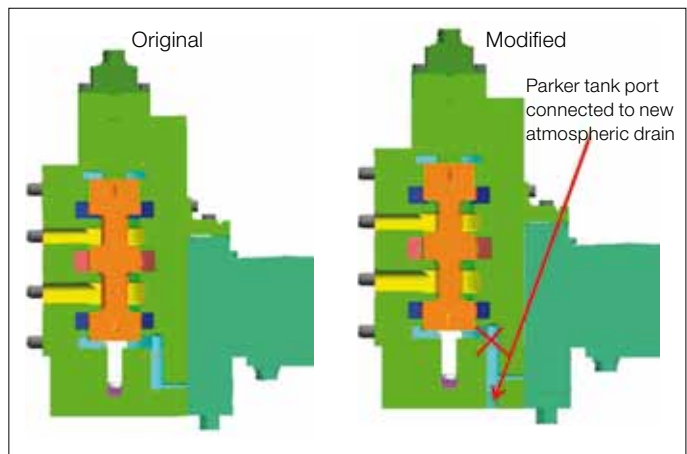
Fig. 9: MAN B&W FIVA: Cavitation countermeasure test 2

FIVA with the pilot tank port connected to the FIVA main spool pressurised tank port. Fig. 9 shows the other FIVA valve with the pilot tank port connected to a completely pressure-less drain.

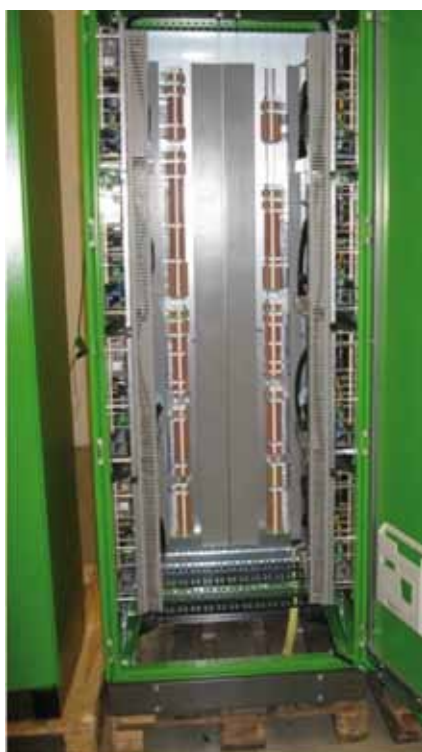
Fig. 13: Large cabinet with MPCs suited for engine

As an alternative to the MPCs located on the engine, we have introduced a design where the MPCs are located in larger cabinets, see Fig. 13, which can be located away from the engine, e.g. in the engine control room, in a switch-board room or directly in the engine room. From now on, we will gain experience with respect to i.a. lifetime of the MPCs. Also, possible production benefits of the alternative execution can be measured in the future.

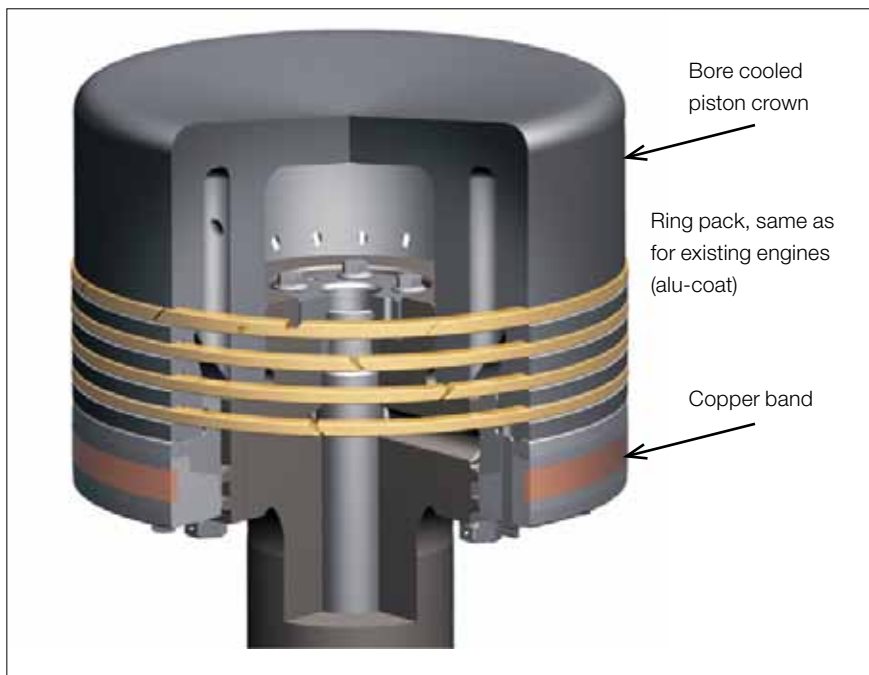
Fig. 25: ME-B9 piston design

A piston overhaul was carried out after 4,000 running hours to inspect the condition of the new piston design, see Fig. 25, applied on the S40ME-B9 engines. Fig. 26 indicates a very good condition of the piston top-land (light deposits), piston rings (surface without any signs of seizures) and piston skirt (perfect condition of the bronze band).

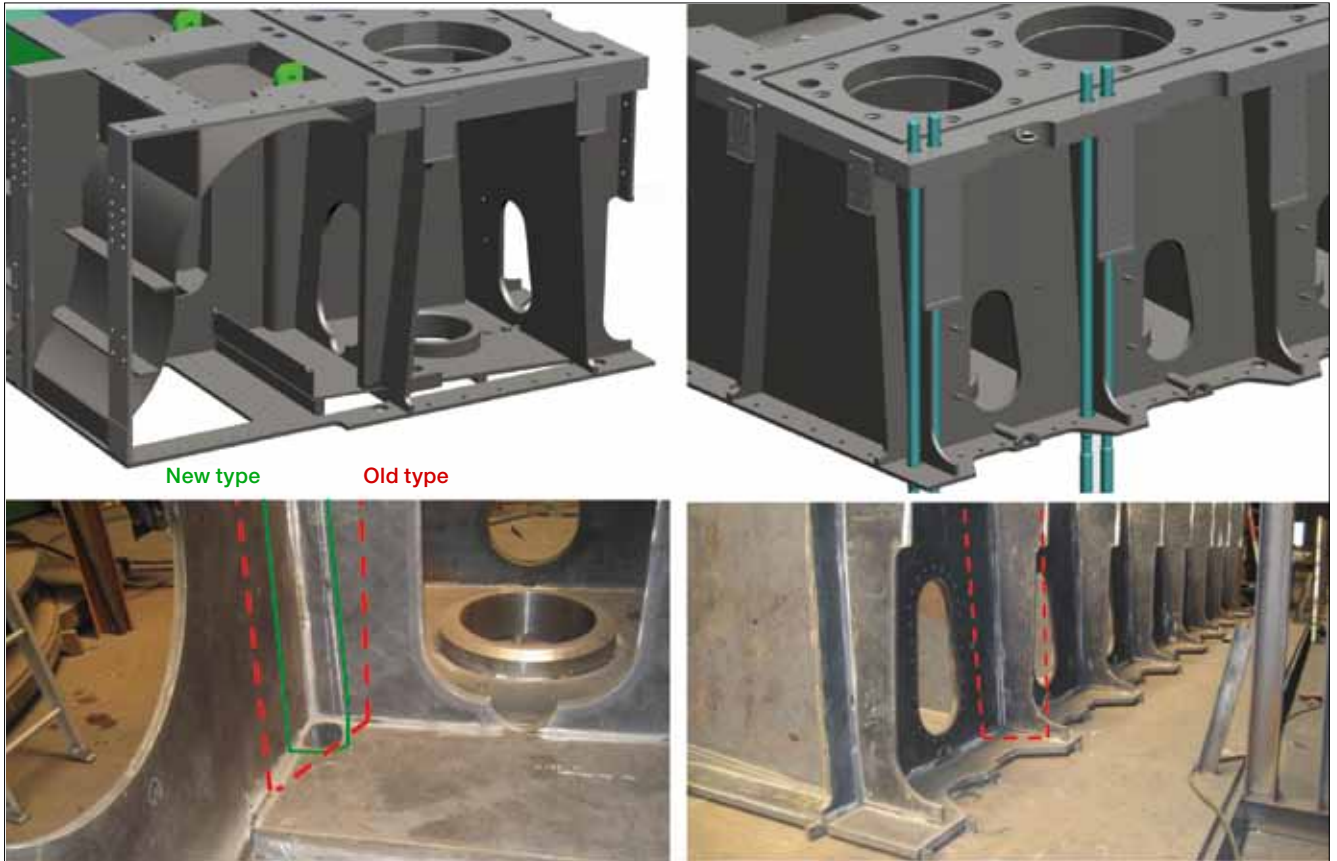
As an alternative to cast iron cylinder frames, a welded version of the cylinder frame has been introduced. Fig. 38 shows a 7-cylinder welded cylinder frame with an integrated scavenge air receiver. The first generation of the welded cylinder frame showed, in some cases, cracks originating from the stay bolt covers, see Fig. 39. A new bent type stay bolt cover has been designed, and attachment to the main cylinder frame structure at a position with a lower stress level has been realised.

Thin, bent stay bolt cover in exhaust side. **New type/old type**
 Fig. 40: Welded cylinder frame: old and new type stay bolt cover designs

Pump side stay bolt cover omitted. Stay bolt visible

We are confident that the crack problems related to the stay bolt cover plates have now been eliminated. For engines in service with first generation welded cylinder frames, repair work is in progress.

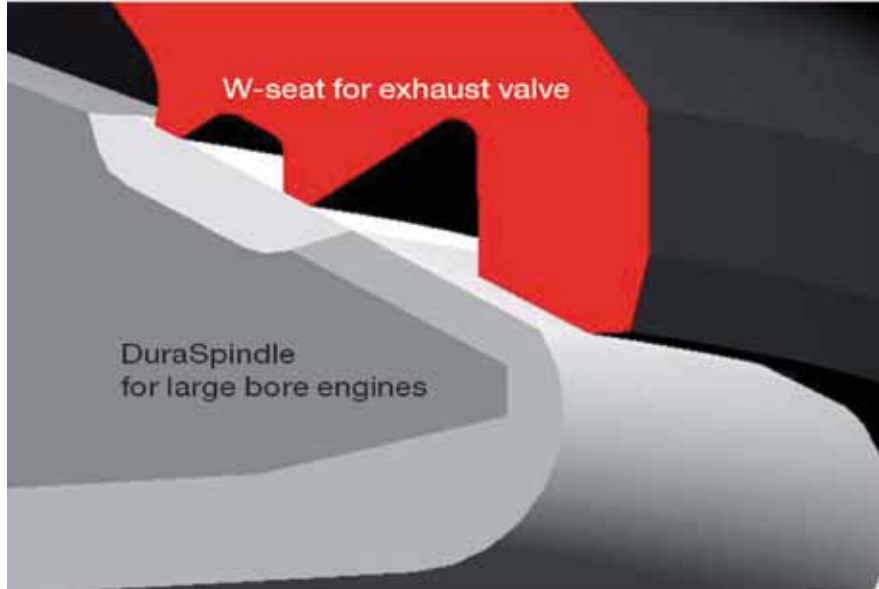
Fig. 43: W-seat and DuraSpindle combination

For the exhaust valve, the use of W-seat, see Fig. 43, and either Nimonic valve spindle or DuraSpindle has improved the overhaul intervals to run more than 32,000 hours. Fig. 44 shows examples of an excellent condition without overhaul with combinations of a W-seat/nimonic spindle and a W-seat/DuraSpindle achieved on an S60MC engine after 25,500 hours and 33,900 hours, respectively.

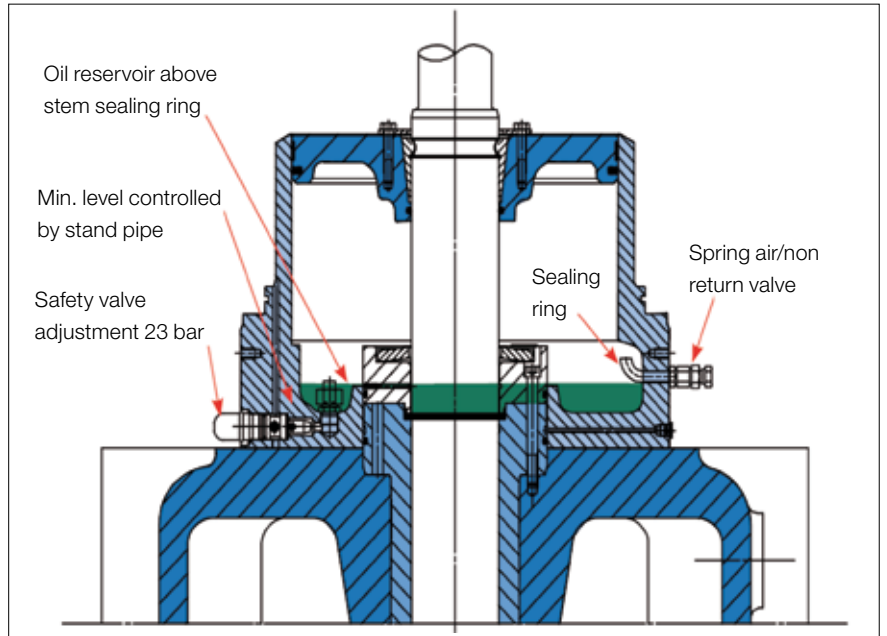
Fig. 45: Controlled Oil Level (COL) design

For the exhaust valve stem seal, the so-called Controlled Oil Level (COL) design, see Fig. 45, indicates that also stem seal overhaul intervals can be extended to 30,000-35,000 hours based on results from several test units on 98, 90 and 60-cm bore engines. This is illustrated by Fig. 46, showing an open-up inspection on a K98.
