Service Experience of MAN B&W Low Speed Diesel Engines

This paper deals with the latest service experience obtained so far from ME/ME-C engines in service. Early service experience for the 6S40ME-B will also be discussed.

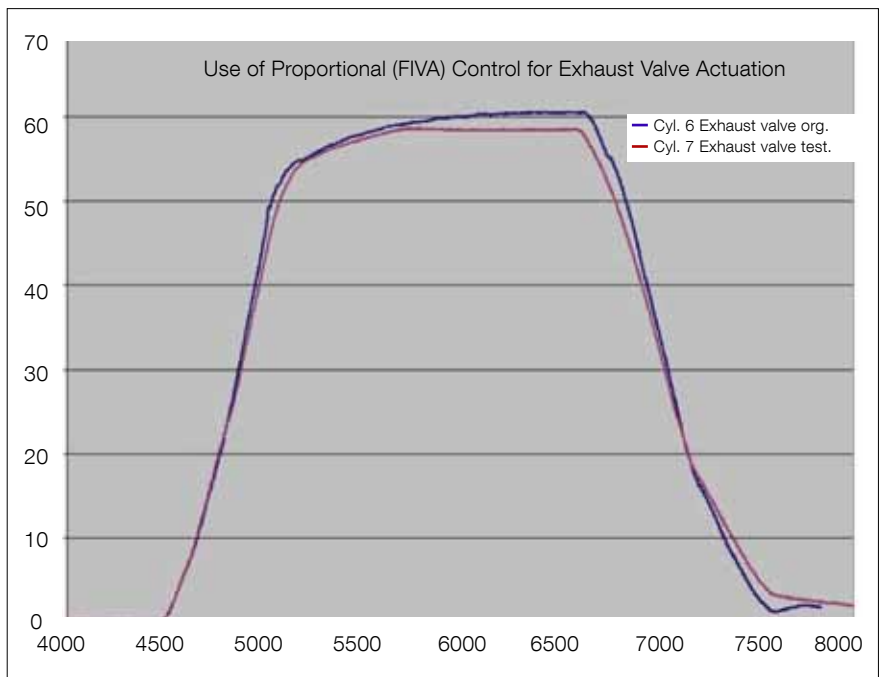
Fig. 2: Use of proportional (FIVA) control for exhaust valve actuation

presently ongoing. So far, we have only used the proportional control of the FIVA valve for injection rate shaping, but now we also use it in order to open and close the exhaust valve gently. Fig. 2 shows the original lifting curve and the modified lifting curve of the exhaust valve. No

big changes can be seen. However, the oil pressure fluctuations in the actuator system are modified to some extent, and we expect that this will reduce/eliminate the cavitation damage in the exhaust actuation system.

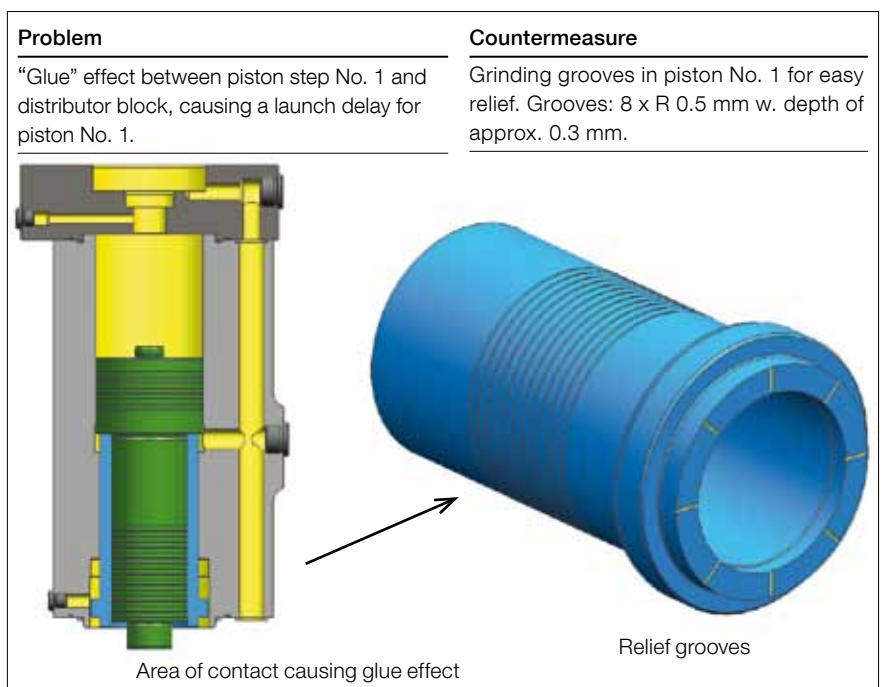
Fig. 5: Example of retrofit

On a few actuators for the original 200 bar hydraulic system, we have seen breakage of the step 1 piston collar, Fig. 4. We are convinced that this problem relates to delayed “take-off” of the step 1 piston from the bottom position, Fig. 3 (A). This is caused by a “glue” effect, which exists from time to time. When the step 1 piston is delayed it will create very high pressures in the “damper” chamber and hereby increased load on the piston collar is generated. Various means to avoid the “glue” effect can be introduced by generating a force by the oil pressure under the step 1 piston. An example of retrofit is illustrated in Fig. 5. Such design modifications will eliminate the trouble with step 1 piston breakage.

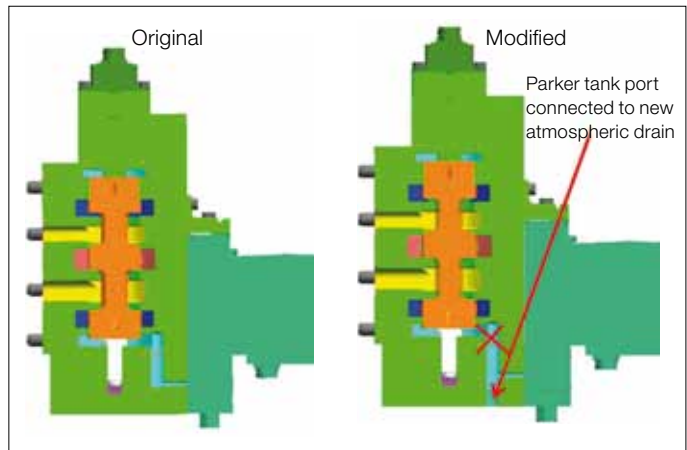
Fig. 9: MAN B&W FIVA: Cavitation countermeasure test 2

FIVA with the pilot tank port connected to the FIVA main spool pressurised tank port. Fig. 9 shows the other FIVA valve with the pilot tank port connected to a completely pressure-less drain.

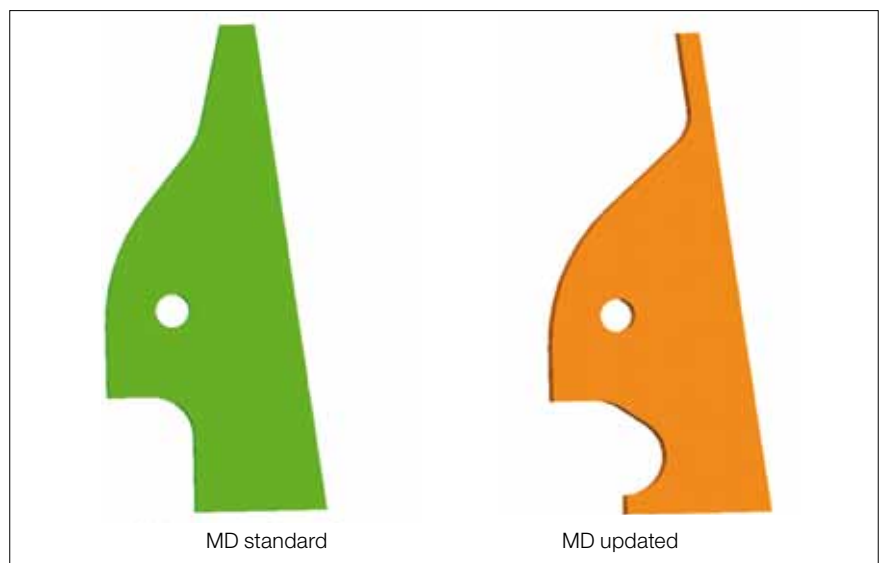
Fig. 37: Lifting bracket cracks: design update

In 2008, cracks in the lifting bracket on K98 bedplates were discovered on engines produced 5-7 years earlier, see Fig. 35. Soon after the first cracks were discovered, a so-called 'Circular Letter' was issued to all owners/operators of K98 engines, see Fig. 36. In this letter we asked for help to inspect for lifting bracket cracks. Furthermore, we informed about preventive countermeasures, which were burr grinding of the weld seams on the aftmost and foremost brackets. Also, a repair procedure was developed when the cracks first occurred. A modified bracket profile has been designed for new engines, see Fig. 37.

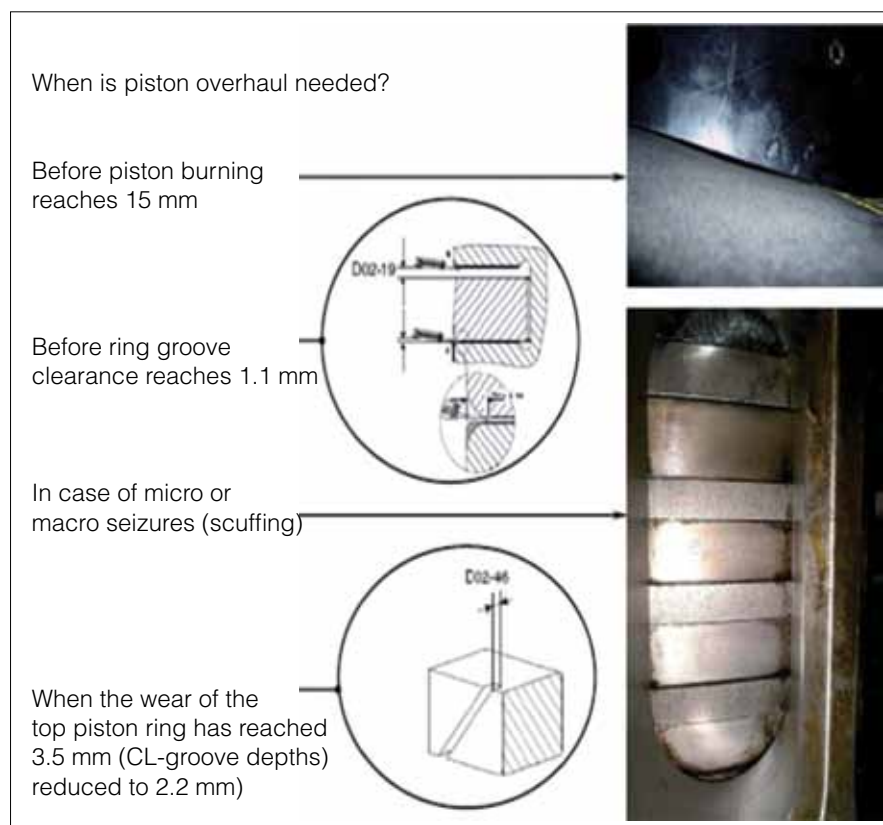
Fig. 41: K98 example. The four (4) important factors for piston overhaul

The most important factors for piston overhauls are (see Fig. 41):

- Piston ring wear
- Max. amount of hot corrosion allowed on piston top on the centre part (where it is normally highest) is 9/12/15 mm on, respectively, 80/90/98-cm bore engines
- Ring groove clearance. Max. clearance recommended is 1.0 mm on 80 and 90-cm bore engines, and 1.1 mm on 98-cm bore engines
