Service Experience

Two-stroke Engines

MAN Diesel & Turbo

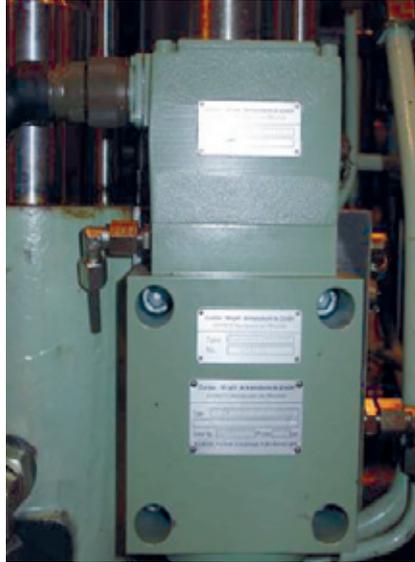
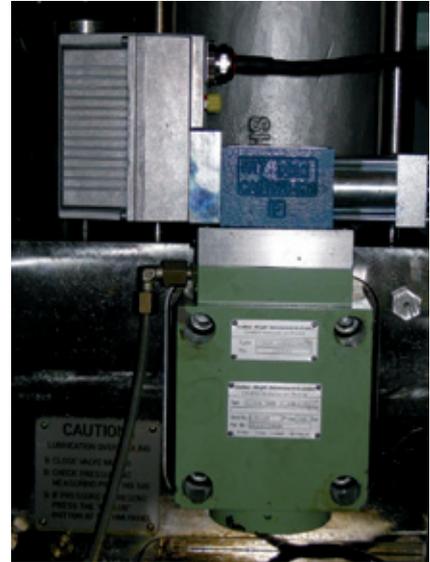
Fig. 2: ELVA valves (left: original - right: new)

MAN Diesel & Turbo (MDT) therefore decided to introduce an alternative control valve (make: Moog) on all 18 vessels, after successful service testing of the Moog-ELVA valve. Fig. 2 shows the original ELVA valve and the new ELVA valve version.

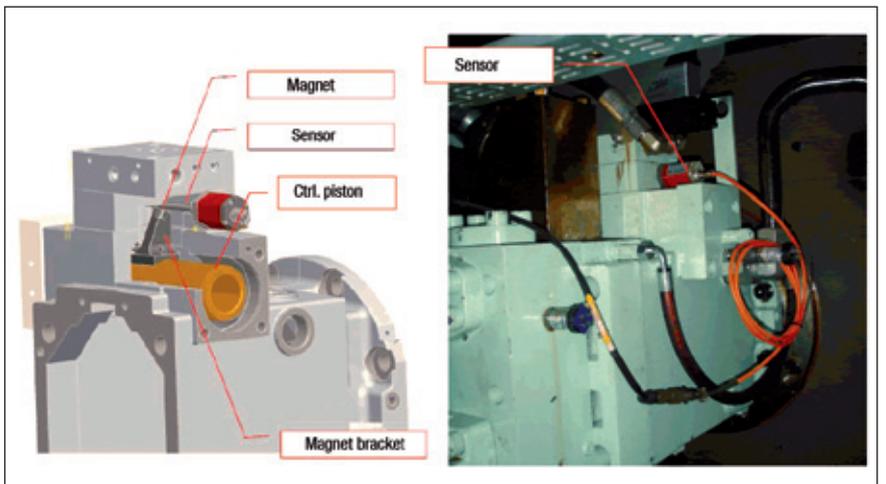
Fig. 5: New touchless feedback sensor

New touchless position feedback sensors sensing on the control piston of the pump, Fig. 5, instead of on the swash plate control arm are being developed and tested in order to have a reliable feedback sensor system for the Eaton hydraulic pumps.

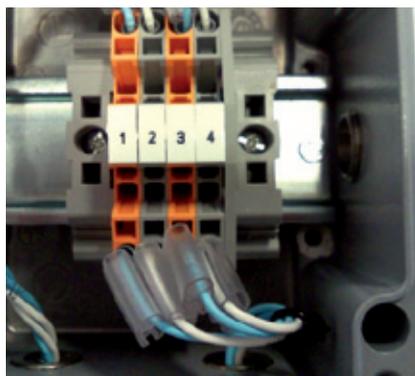
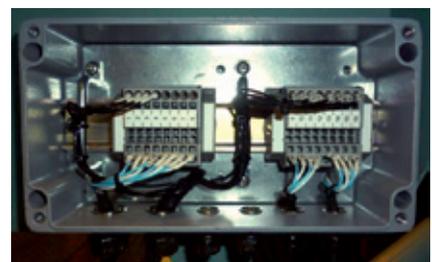
Fig. 9: Correct junction box installations

Fig. 9 shows a correct cable/wire installation in junction boxes. The characteristics of a correct installation are mentioned below:

We are confident that with the new Production Specification in place we will see fewer failures on the ME engines caused by improper cabling installation.

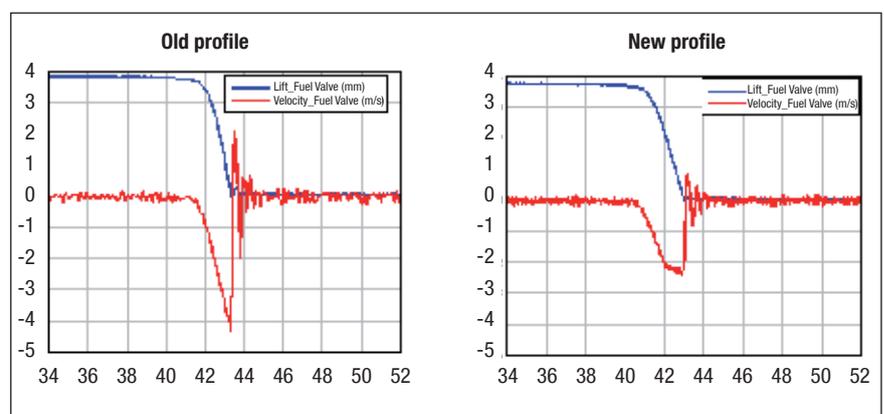
Fig. 11: Fuel valve needle landing speeds

On our 300-bar hydraulic pressure ME engines, we have experienced cases of malfunction of the fuel injectors. This matter has been cured by introducing softer closing profiles for fuel injection, see Fig. 11. Needle landing speeds have typically been reduced from above 4 m/s to below 2.5 m/s. The range of needle landing speeds below 2.5 m/s is a well-known range on our MC/MC-C engine types.

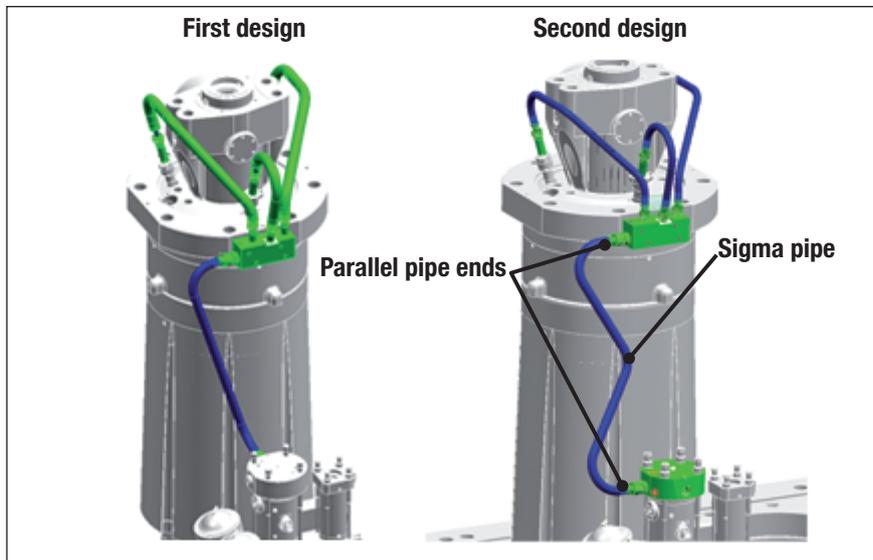
Fig. 12: 6S80ME-C9 high-pressure pipe

Fuel injection closing profiles also have an impact on the structural integrity of the high-pressure fuel pipes. This is illustrated in the following with an S80ME-C9.2 engine design as the example. Fig. 12 shows the first design of high-pressure fuel pipes on the left-hand side and the second design with the so-called sigma pipe between the fuel booster and distributor block on the right-hand side.

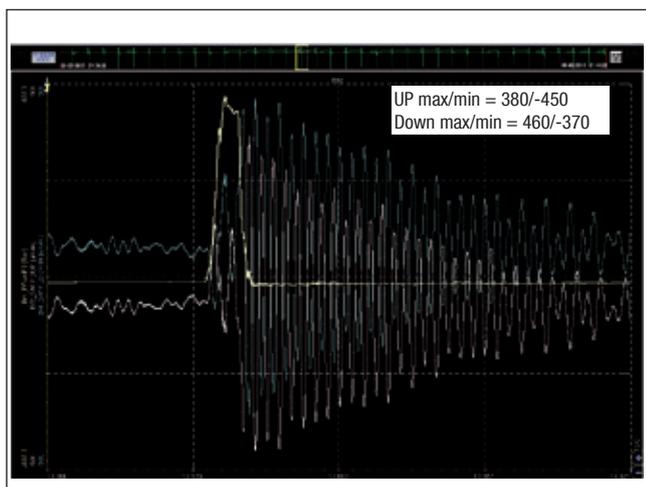
Fig. 13: 6S80ME-C9 300-bar 100% load – original injection closing profile

Fig. 13 shows strains measured at 100% load with the original injection closing profile. It can be noted that

large dynamic bending stresses are introduced when injection is closing.

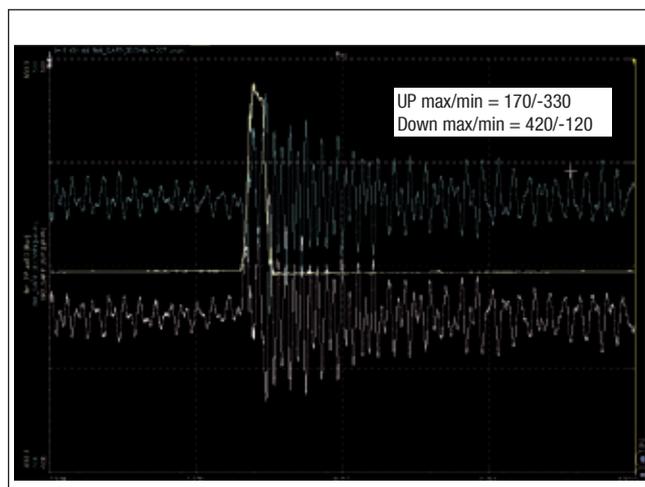
Fig. 14: 6S80ME-C9 300-bar 100% load – softer injection closing profile

on the S80ME-C9.2 engine. Dynamic stresses are seen to be reduced to a level less than 60% with the sigma pipe design and the softer injection closing profile.

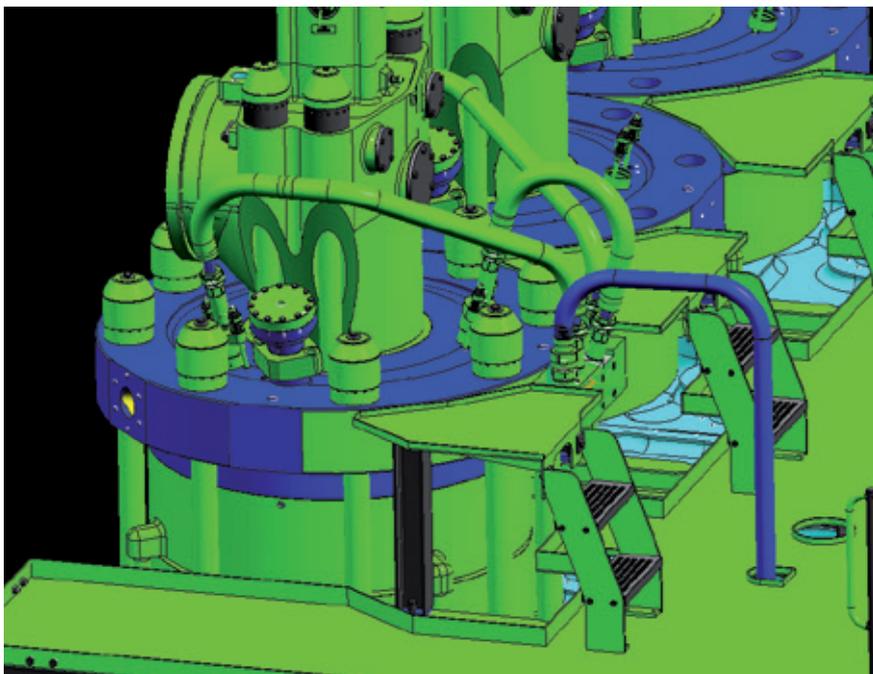
Fig. 16: New stick-type pipe design

A third design of the common high-pressure fuel pipe from the fuel booster to the distributor block has been introduced on coming S80ME-C9.2 engines. Fig. 16 shows the future so-called stick pipe design, which has

a dynamic stress level reduced by a further 30% compared with the sigma pipe design.

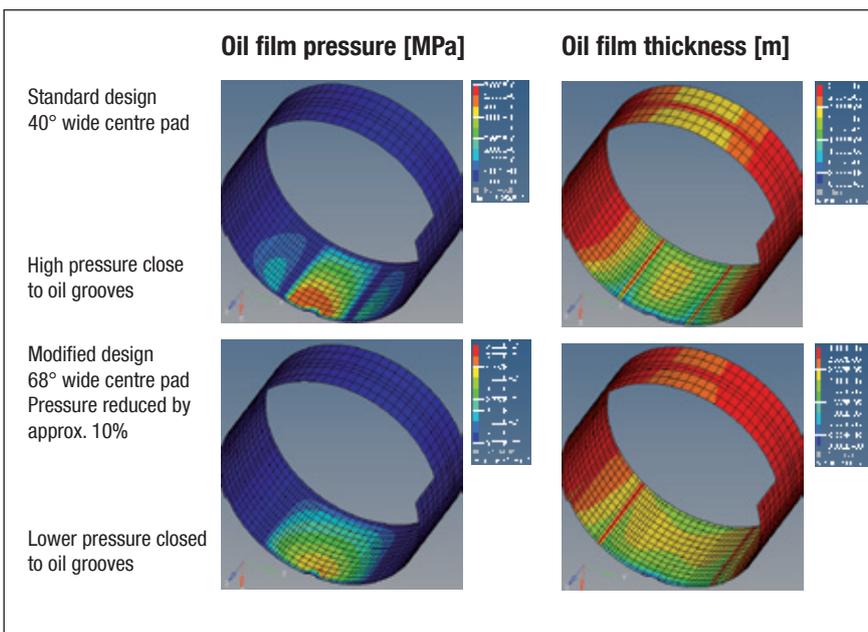
Fig. 20: K98 crosshead bearings and T/C cut-out: modified bearing shell design

vice. However, these will not be concluded quickly as the development of fatigue damage takes two years typically. Fig. 20 shows elasto-hydro dynamic (EHD) bearing calculations of one of the designs being tested, i.e. the design with increased circumferential distance between the axial oil grooves. Larger oil

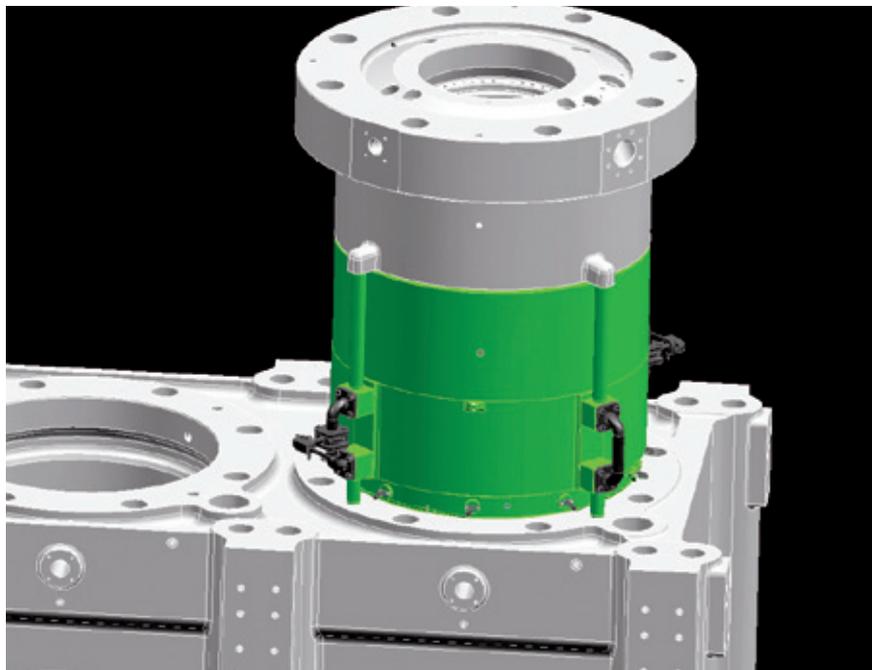
Fig. 21: Jacket cooling water bypass on K98 engine

We have, in a few cases, seen excessive cold corrosion in the top of cylinder liners when operating at low load in T/C cut-out mode. This has been seen especially in cases where one of two T/Cs has been cut out. In such a case, a very large scavenge air pressure increase is obtained at low load, resulting in rather high pressures and low temperature exposure for the cylinder liner top.

As a countermeasure, the jacket cooling water bypass was introduced, as described in the section of this paper related to cold corrosion in general. On K98 engines, the cooling water bypass can be arranged as shown in Fig. 21.

With this system, normally up to 75% of the jacket cooling water will be bypassed the cylinder liner cooling bores.

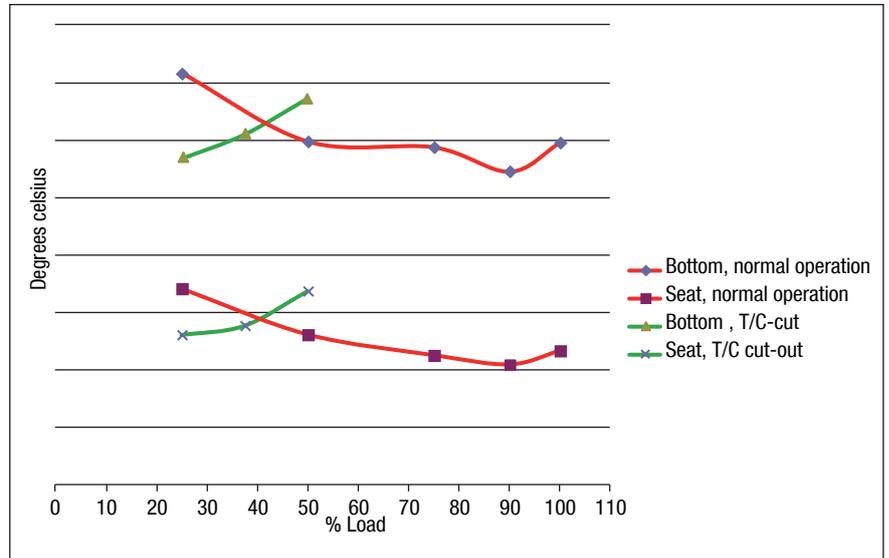
Fig. 24: Low-load operation with and without turbocharger cut-out on an 8K90MC-C

We are preparing a service letter on exhaust valve condition during low-load operation. Examples showing the influence of T/C cut-out, see Fig. 24, any operation down to 10% load as well as the cut-in point for the auxiliary blowers, see Fig. 25, indicate that strict guidelines cannot be given when considering low-load operation in general. The exhaust valve condition must be evaluated on the basis of inspections.

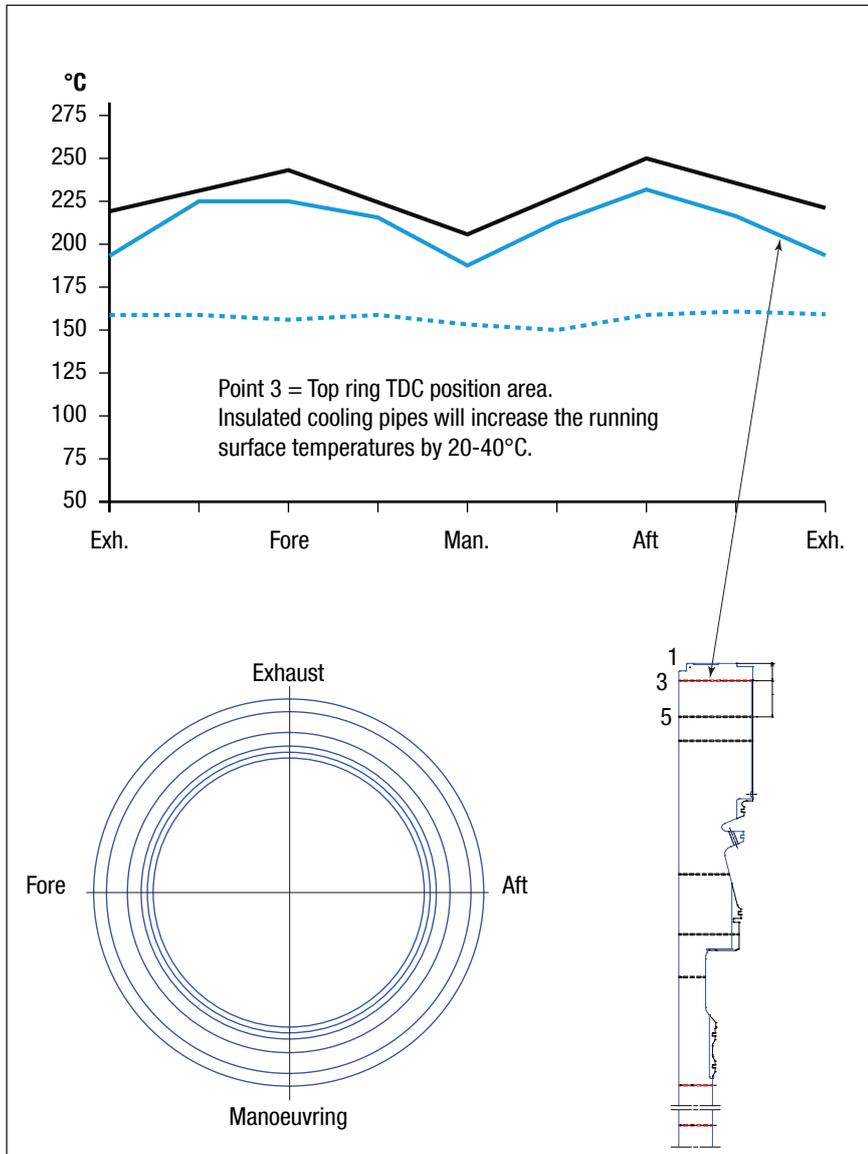
Fig. 26: S70 Semi-high topland (SHTL): circumferential temperature distribution

From the above, it can be seen that cylinder liner wear is normal in one direction (forward-aftward) and excessive in the other direction (exhaust-manoeuvring). The oval wear leads to too early wear-out of the cylinder liner and it also shortens the time between piston overhauls due to a high piston ring wear and poor gas-sealing condition.

The reason for the oval wear is found when looking at the circumferential temperature distribution in the top of the cylinder liner measured on the test bed on the prototype engine. Fig. 26 shows what was measured around the circumference of the cylinder liner. In forward and aftward direction, 225°C was measured, whereas in exhaust and manoeuvring direction only 190°C was recorded. This gives sufficient protec-

tion against cold corrosion in one direction, but not in the other direction.

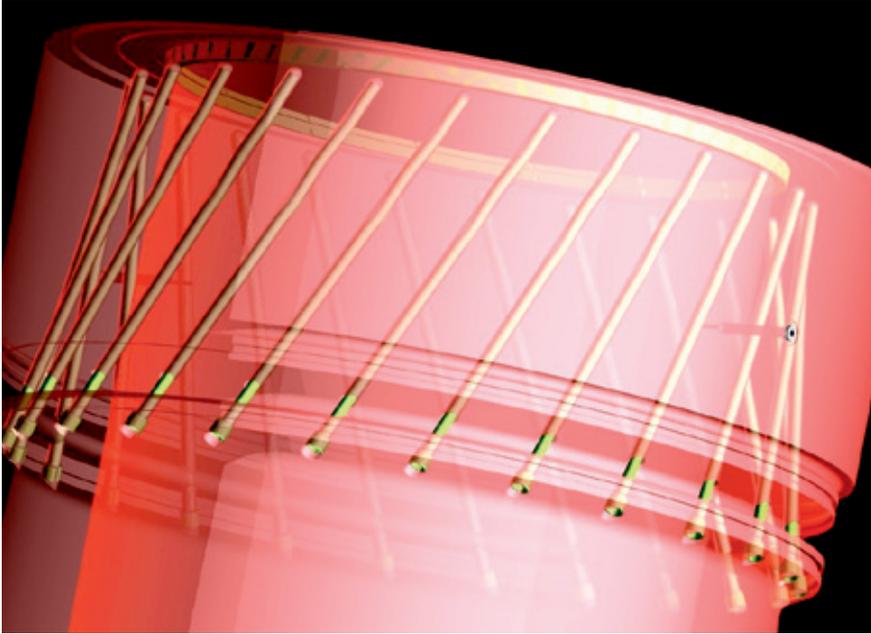
Fig. 27: S70 semi-high topland (SHTL): cooling bores

The cylinder liner design of the bore-cooled type is illustrated in Fig. 25. Cooling bores in the top of the liner are evenly distributed around the circumference. Pipes are inserted in the cooling bores in order to distribute water to the very top of the cooling bores. A version of these pipes is insulated towards the

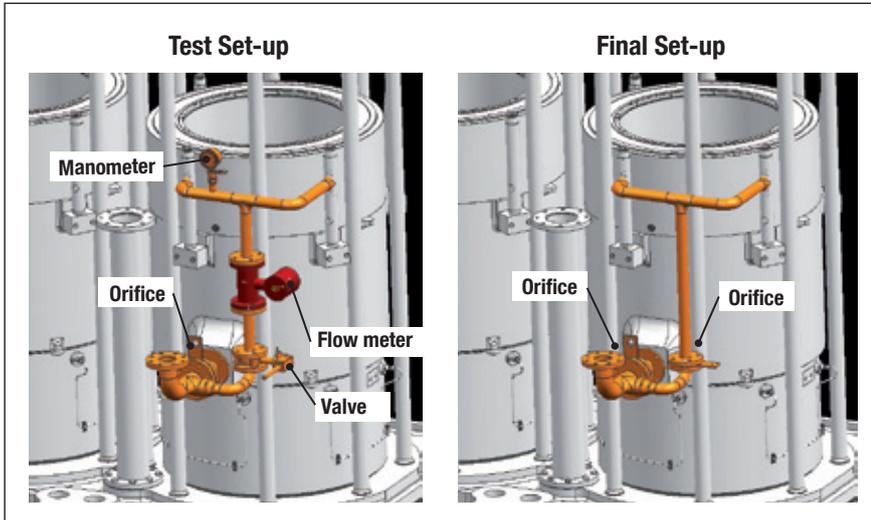
Fig. 30: S70M7/8 jacket cooling water bypass

On a series of 6S70MC-C7 engines, cylinder liners with 30 cooling bores were supplied instead of, as specified, cylinder liners with 24 cooling bores. This led to excessive cylinder liner wear caused by cold corrosion attacks in the upper part of the cylinder liners.

Fig. 30 shows a jacket cooling water bypass that has been shop tested to determine the correct amount of cooling water to be bypassed. The test setup is shown on the left-hand side of Fig. 30. The final setup for service is shown on right-hand side of Fig. 30. The amount of bypassed water is determined by an orifice.

Bypassing 75% of the jacket cooling water will increase the liner wall temperature by 12°C. In addition, the jacket cooling water outlet temperature is increased to 90°C. All together, a 16°C increase of the liner wall temperature is achieved, and the first indications from online drain oil analyses show that the cold corrosion issue has been solved.

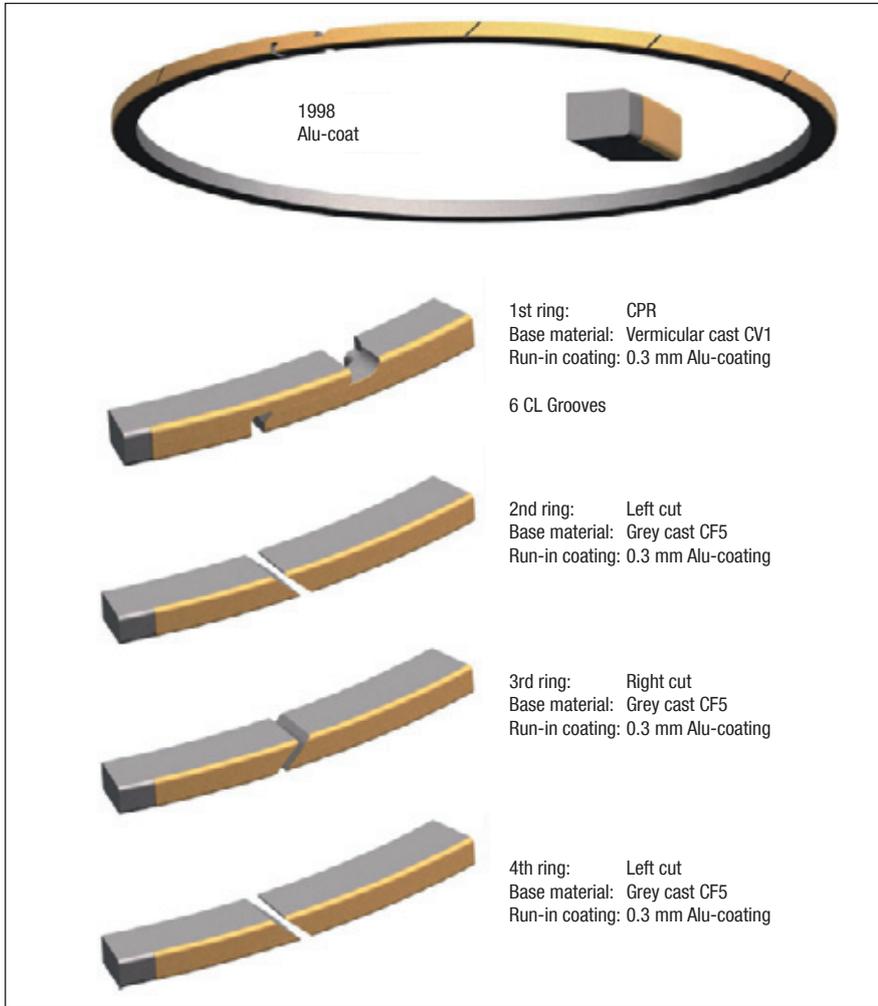
Fig. 35: CPR piston rings on small bore engines

For some years, small bore engines have been specified with our well-proven alu-coated CPR piston ring pack, see Fig. 35. However, in some cases, on small bore engines, this has resulted in shorter overhaul intervals because of wearing out the CL-grooves of the top piston ring.

If complete wear out of CL-grooves on the top piston ring occurs, the pressure drop will often be so large that adhesive wear between liner and ring may be the result and, eventually, leading to damage on the liner surface.

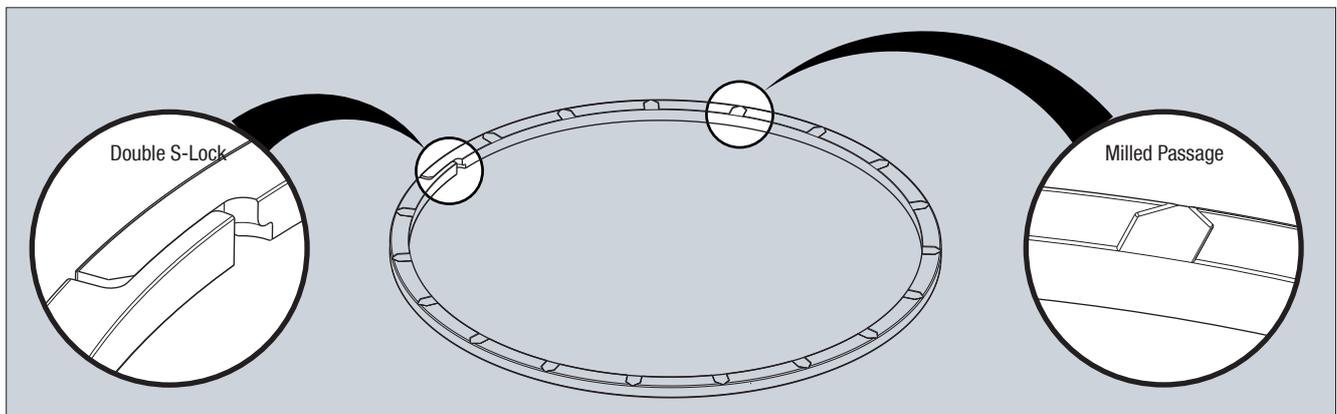
Fig. 36: Port-on-plane (POP) top piston ring design

The port-on-plane (POP) top piston ring, see Fig. 36, will have the opposite characteristic. When the top ring wears, the relief ports will increase the leakage area and, thereby, the pressure drop across the top ring will decrease. This will reduce the contact pressure be-

tween the top piston ring and cylinder liner and reduce the piston ring wear. The POP top piston ring has a stabilising influence on piston ring wear. This is opposite to the conventional CPR ring. For small bore engines this is an important difference that gives the piston ring pack a longer lifetime.

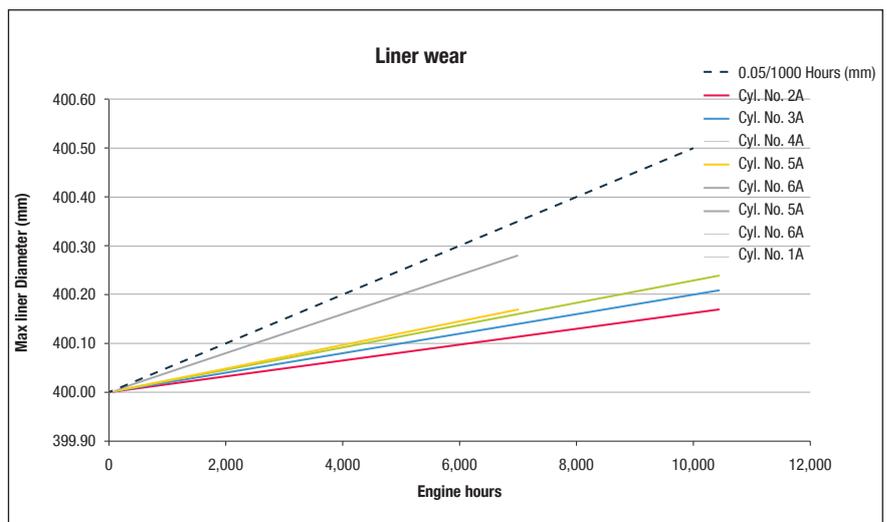
Fig. 38: Cylinder liner wear: 6S40ME-B at 10,000 hours

The background for introducing the POP ring pack can be seen, e.g., on the 6S40ME-B prototype engine. At first glance, the cylinder condition looks very satisfactory after nearly 10,000 hours of operation, see Fig. 37. Also the cylinder liner wear is very satisfactory, see Fig. 38. All liners inspected have wear rates below 0.1 mm per 1,000 hours.

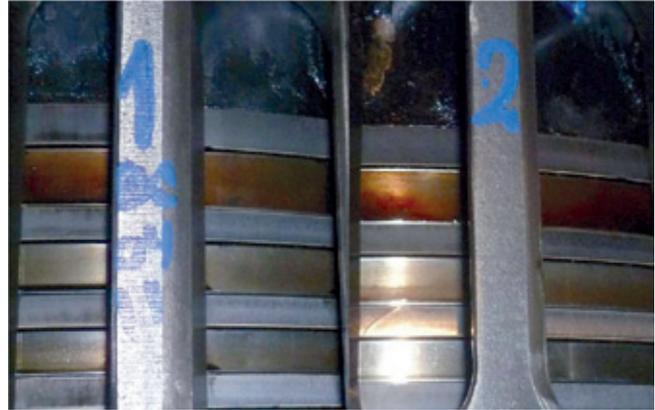
Fig. 40: 6S46MC-C unit with POP ring pack

We now specify POP ring packs for this kind of engine. We have accumulated more than 230,000 service hours on various engine types with the POP rings. One of the service tests has been carried out on all cylinders on a 6S46MC-C engine. After 6,735 hours, the width of the „port-gap” has increased by 1.1 mm, corresponding to a top piston ring wear of 0.55 mm, see Fig. 40. With a wear potential of 2.7 mm, wear-out is estimated to happen after approx. 33,000 hours. Due to the self-stabilising nature of the POP ring, as described above, the estimated lifetime of 33,000 hours is conservative. We can expect even more running hours before wear-out.

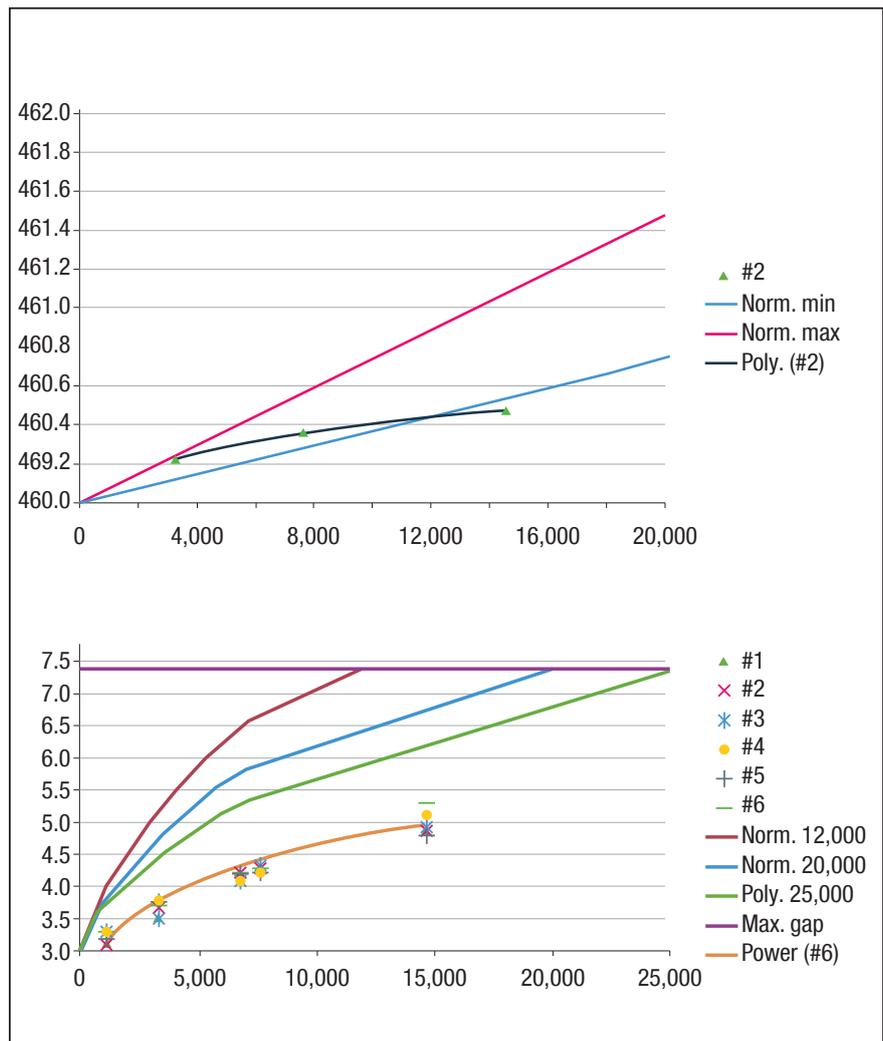
Fig. 41: Cylinder liner wear (upper) and POP piston ring wear (lower) after 14,554 h on 6S46MC-C

Fig. 41 confirms the self-stabilising nature of the POP piston ring pack both on cylinder liner wear and on piston ring wear based on measurements on an S46MC-C engine after approx. 15,000 hours.

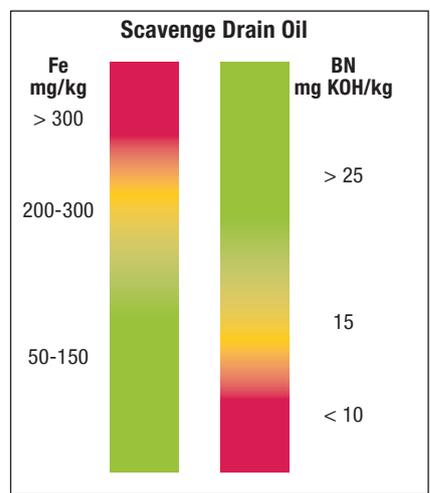
Fig. 43: Scavenge drain oil result

Drain oil analysis is also a strong tool for judging the engine wear condition. Drain oil samples taken in active ACC operation will show if the oil feed rate can be optimised while keeping the BN between 10-25 mgKOH/kg and the iron (Fe) content below 200-300 mg/kg in the drain oil, see Fig. 43.

Used oil taken from the engine through the scavenge bottom drain can be used for cylinder condition evaluation.

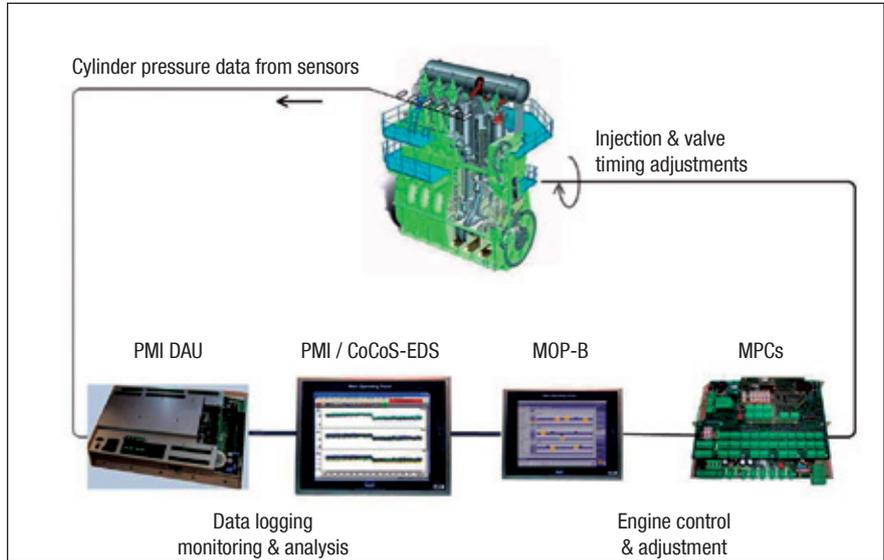
Fig. 45: PMI autotuning

As shown in Fig. 45, the present PMI autotuning system consists of pressure sensors in each cylinder cover. The signals from the sensors are transmitted to the data acquisition unit (DAU), which is a dedicated computer for signal recording and conditioning. Data are shown on the CoCos-EDS PC, and proposals for adjustments are presented on the main operating panel B (MOP-B). Changes to combustion parameters are then introduced via the MPCs on the control of the individual cylinders.

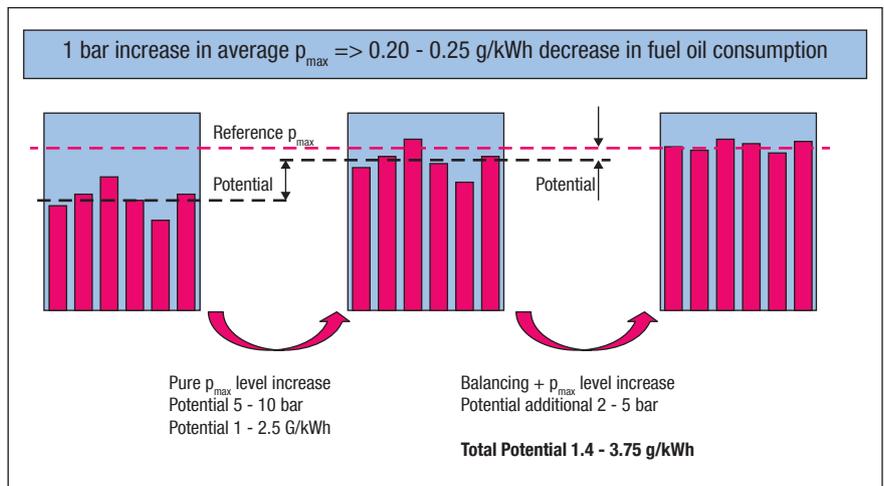
Fig. 46: PMI autotuning: potential fuel reduction

The benefit of applying PMI autotuning is illustrated in Fig. 46. An average increase of the max. pressure of 1 bar will result in a saving in the specific fuel

oil consumption (SFOC) of 0.20-0.25 g/kWh. Furthermore, balancing of the compression pressures and the mean pressure will be beneficial to both fuel oil consumption and overhaul intervals for various components.

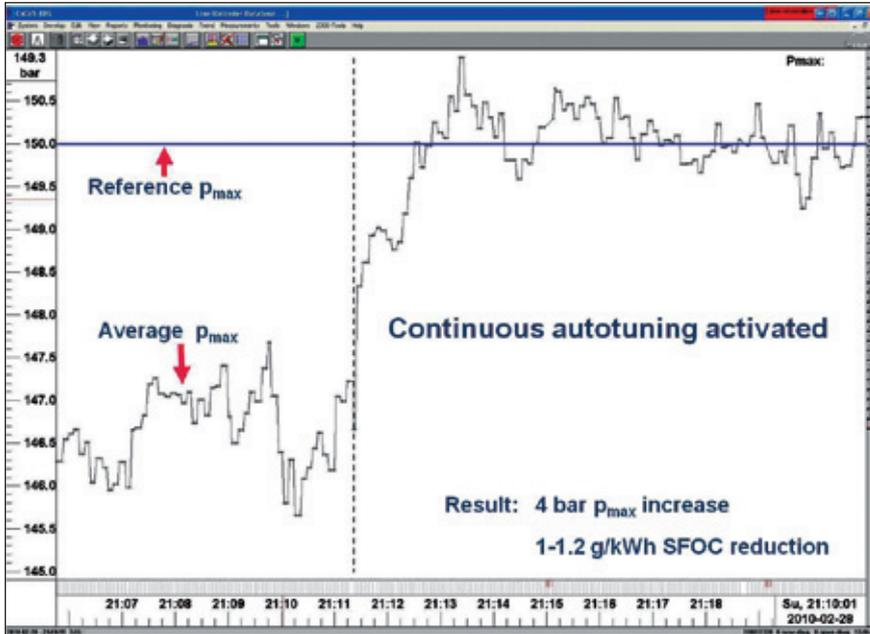
Fig. 47: PMI autotuning: 10K98ME-C

Fig. 47 shows an example of a PMI autotuning application on a 10K98ME-C

engine. Before applying continuous autotuning, the average maximum pressure is approx. 4 bar below the reference value. This is changed by applying the autotuning, and within 1 to 1.5 minute, the average maximum pressure is increased by approx. 4 bar, thereby reducing SFOC by approx. 1 g/kWh.
