Service Experience MAN B&W Two-stroke Engines

MAN B&W Two-Stroke Engines

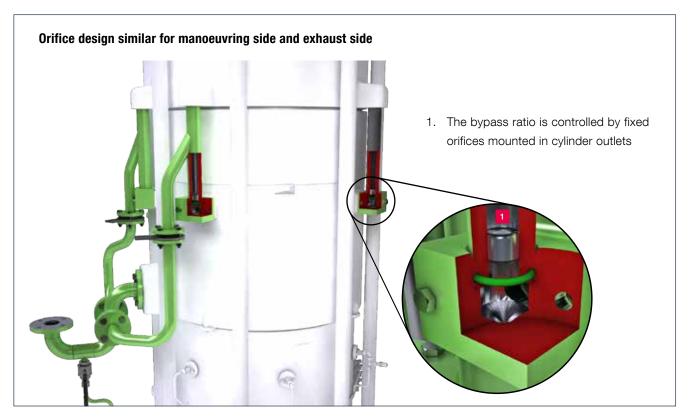
Fig. 6: Jacket cooling water Bypass Basic (JBB) system

Fig. 6 shows a jacket cooling water bypass that has been shop tested to determine the correct amount of cooling water to be bypassed. For the final setup for service, the amount of bypassed water is determined by orifices in the cylinder outlet pipes.

Bypassing 85% of the jacket cooling water will increase the liner wall temperature by approximately 15°C. In addition, the jacket cooling water outlet temperature is increased to 90°C. All together, an approximately 20°C increase of the liner wall temperature is achieved. Tests have revealed that bypassing an even larger amount is possible.

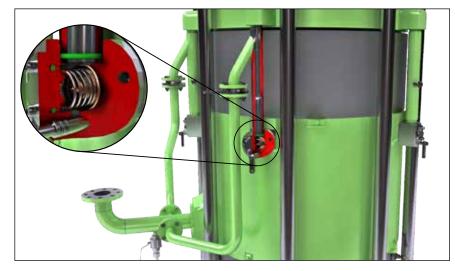
Fig. 7: Controlling corrosive wear by internal Jacket cooling water Bypass Controlled (JBC) system

Furthermore, a controlled version of the JBB system, called JBC, see Fig. 7, is being developed. In this system, a thermostatic valve controls the amount of bypass in such a way that a large amount of water is bypassed at low load and less is bypassed at higher loads.

The JBB and JBC systems can both be easily fitted on engines already in service.

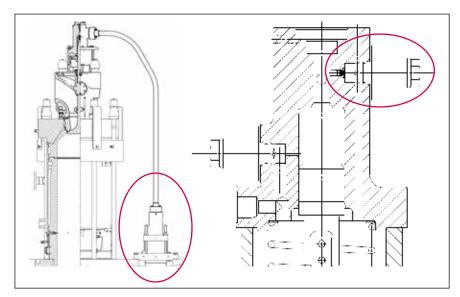
Fig. 18: ME-B/ME-C engine acceleration problems

The root cause has been identified to be a low excess air ratio (air for combustion) at low load and heavy running especially during the acceleration phase. This is due to the application of two-stroke Miller timing with late closing of the exhaust valve.

The countermeasure introduced by MDT has been the installation of a controllable orifice in the exhaust valve oil push rod, see Fig. 18, to facilitate earlier closing of the exhaust valve during low engine speed running. This solution will increase the air excess ratio in the cylinder.

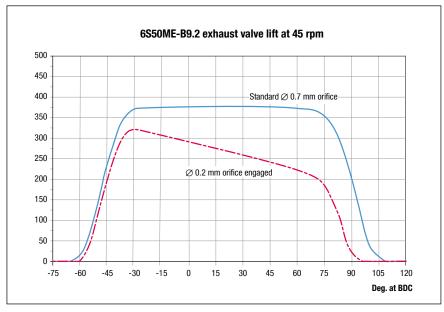
Fig. 19: ME-B9.2 engine acceleration problems

Fig. 19 shows the influence of the controllable orifice on the opening/closing timing of the exhaust valve.

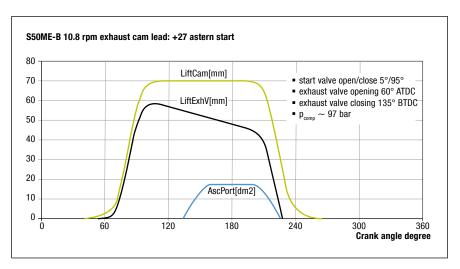
Fig. 21: ME-B9.2 astern start problems

As a result, at astern start, the exhaust valve opens already at 60 deg ahead of TDC, which leads to loss of starting air when applying the standard starting air timing (5-95 deg). Furthermore, the exhaust valve closes at 135 deg before TDC resulting in a compression pressure of approximately 95 bar. Fig. 21 illustrates the timing during astern start. The power of the "air engine" is decreased and the work needed has increased.

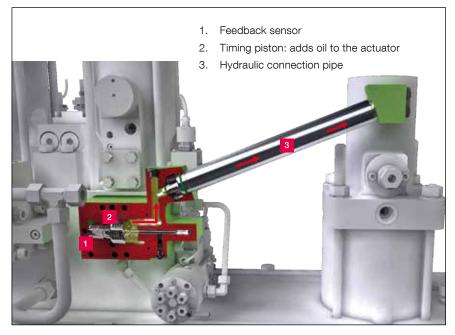
Fig. 23: Variable exhaust valve timing for ME-B

When the dot 3 technology was introduced, we experienced some difficulties with the timing unit system on a number of engines running on test bed, see Fig. 23. High-pressure peaks occurred in the timing unit and in the oil cylinder of the exhaust valve actuator. The high pressure resulted in a number of incidents with broken bolts on the puncture valve and a few cases of broken bolts on the timing unit end cover, see Fig. 24.

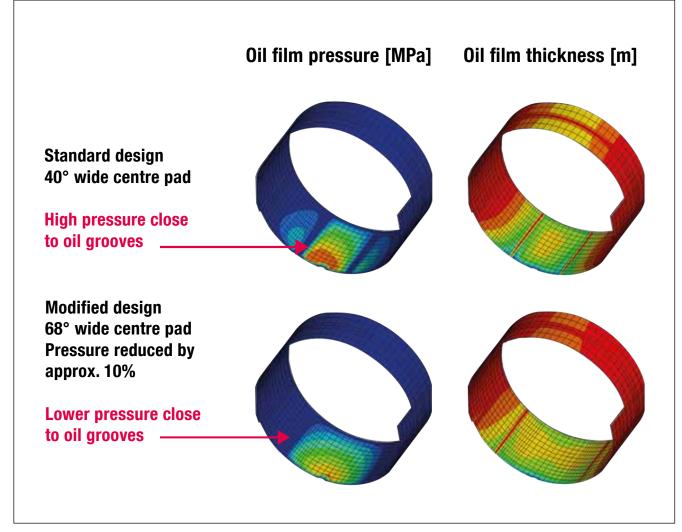
Fig. 30: K98 crosshead bearings and T/C cut-out: modified bearing shell design

Modified designs of crosshead bearing shells are currently being tested in service. However, these will not be concluded quickly as the development of fatigue damage typically takes two years. Fig. 30 shows elasto-hydro dynamic (EHD) bearing calculations of one of the

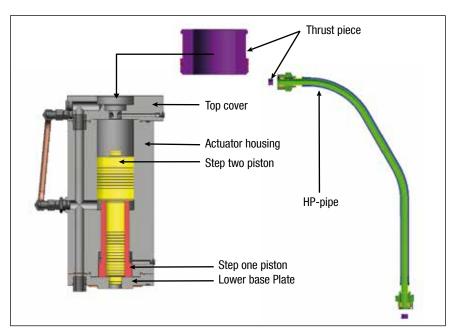
Fig. 51: Points of interest on exhaust actuator - low-force 300-bar

We have received reports of cavitation damage found in various areas in the standard 300-bar low force exhaust valve actuation system. At the time of writing, we are conducting tests to find a solution to this issue. Fig. 51 indicates the areas where cavitation has been found. The extent of cavitation on the thrust piece can be significantly reduced by using a new material. Cavitation has also been found around inlet holes, cooling bores and relief grooves in the actuator top cover, see Fig. 52. We are currently testing some modified actuator top covers, and Fig. 53 shows two alternative test executions where the inlet holes have been redesigned.

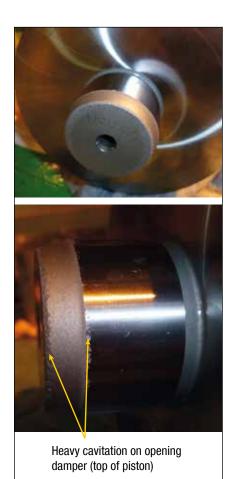
Fig. 54: Exhaust actuator – low-force step-two piston

The actuator housing is in perfect running condition, and only minor cavitation has been found on the step-one piston landing surface at the lower base. On the other hand, on the steptwo piston we have found rather heavy cavitation damage on the opening damper at the top of the piston, see Fig. 54. We have tested a piston with a bolted-on "damper-nose" consisting of a harder alternative damper material (S85W6Mo). As can be seen in Fig. 55, this solution has eliminated the cavitation on the damper. Both actuator pistons show excellent condition on the running surface. Fig. 56 shows a typical
