Service experience

MAN Energy Solutions

Two-stroke technologies

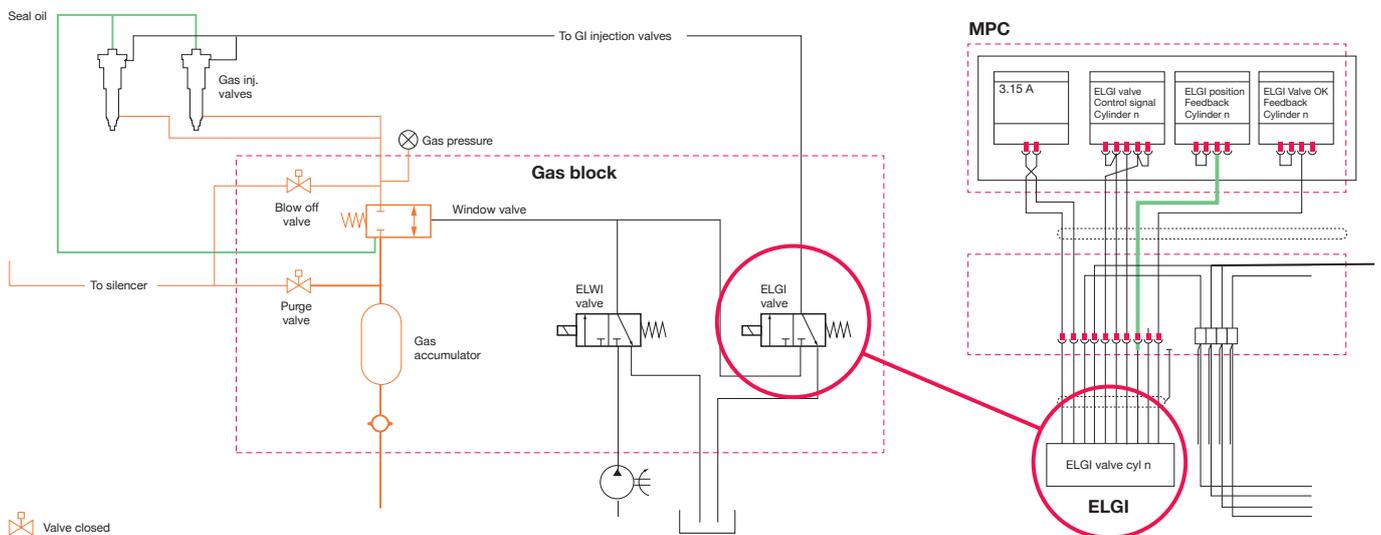
In 2017, we experienced a few cases of overheating of the gas-block on the ME-GI engines after gas purging. On one of the vessels, engine operation continued on liquid fuel while the crew tried to restart gas operation without trouble shooting. An electronic gas injection (ELGI) valve stuck in open position resulted in overheating of the gas-block and damage to various seals. In order to avoid this, we introduced the new engine control system (ECS) software with supervision of the ELGI position feedback. This made it impossible to restart gas operation before the ELGI valve was exchanged or rectified, see Fig. 1. Since this modification was introduced (at the time of writing it is one and a half year ago) no further incidents have occurred.

Fig. 1: Position feedback supervision of the ELGI valve

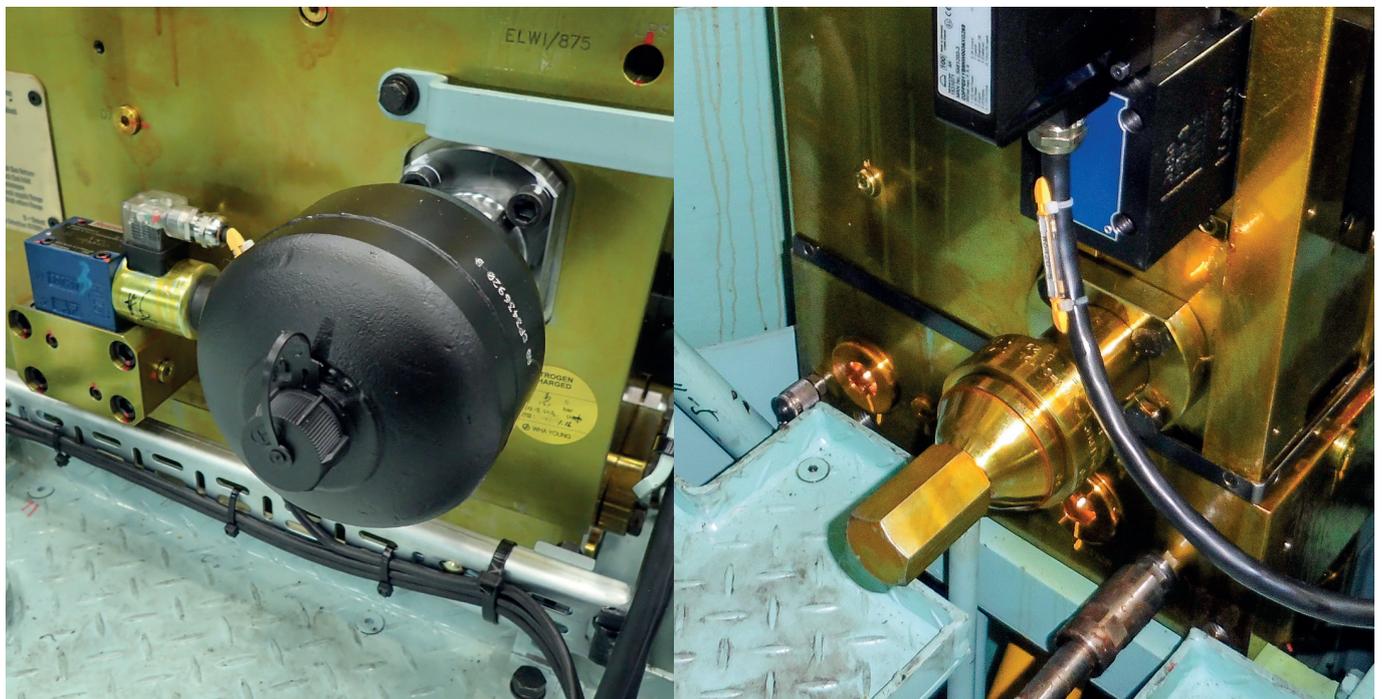
has solved issues with damage to the accumulator diaphragms. Furthermore, the time between nitrogen re-charges has been increased to an acceptable level.

Fig. 3: Left: New 0.7 L accumulator, right: Old 0.2 L accumulator

On the hydraulic side, the use of an enlarged gas-block accumulator (Fig. 3)

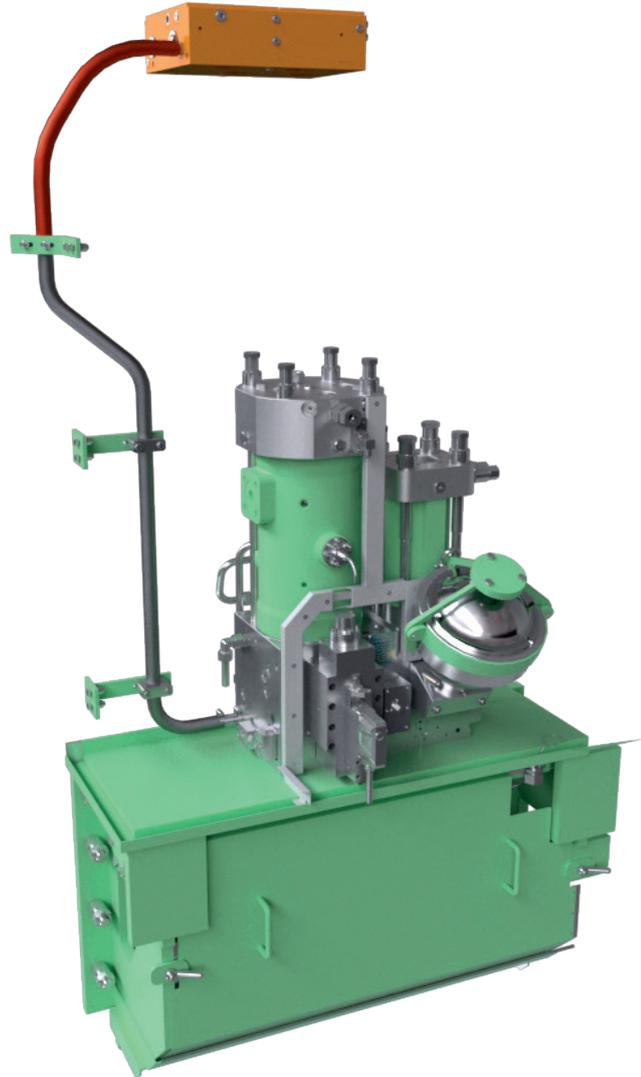
Fig. 4: Control oil pipe design with a combination of hose and pipe

A redesign of the control oil pipe from the HCU to the gas-block, by using a combination of hydraulic hose and pipe, has solved issues with broken control oil pipes, see Fig. 4.

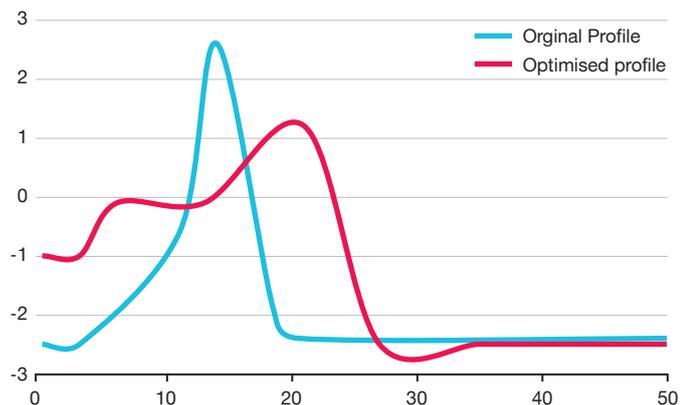
The new pilot oil profile shown in Fig. 5 has lowered the hydraulic peaks in the HCU block. After this change the solenoid valves for the cylinder oil lubricators stopped failing. Furthermore, the new profiles have improved air venting of the cylinder prior to injection. It is also possible to lower the SPOC further with the new profiles. Initial results show an improved condition of the fuel injection valves (FIVs), however, more operating hours are needed to confirm this.

Fig. 5: Modification of the pilot oil profile

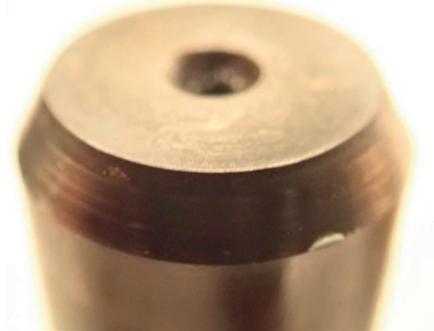
Based on recent inspection of the gas injection valves (GIVs) it has been concluded that the service lifetime of these can be increased. Extremely low wear of the spindle seat was confirmed after approx. 8,000 operating hours and the lapping marks were still visible on the seat (see Fig. 6). We believe that an increase from 16,000 hours to 32,000 hours is possible, and a further increase in lifetime may be possible.

Fig. 6: Spindle tip with lapping marks still visible after 8,000 operating hours

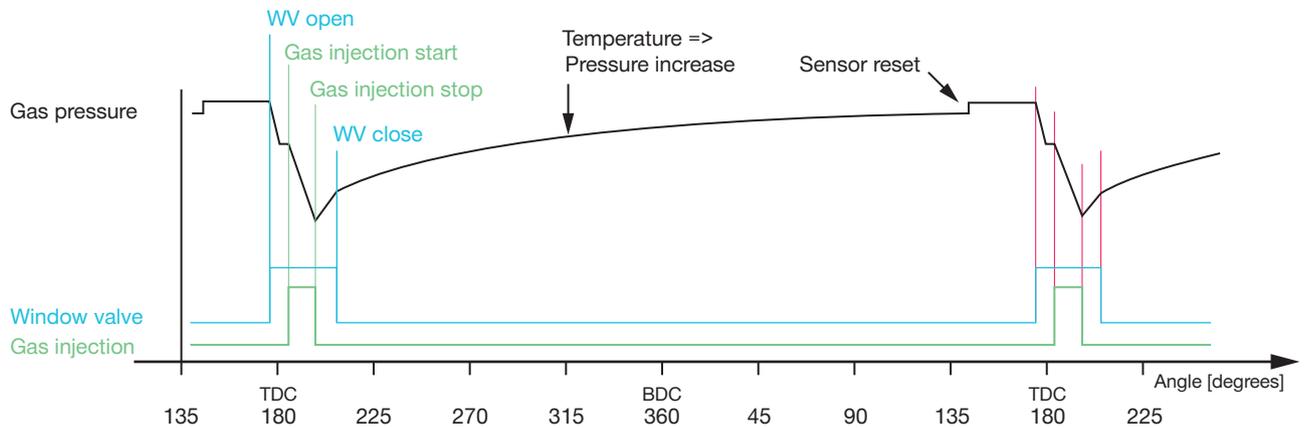
Fig. 9: Gas pressure curve analysis

A manual for systematic analysis of gas trips, i.e. gas alarms and shutdowns, has been made available to the crew on board the ME-GI driven vessels. This manual contains an analysis of the gas pressure curve (Fig. 9) and it provides a description of various deviations from the normal curve caused by known failures. The manual enables the crew to perform more qualified troubleshooting on board to rectify issues on a unit quickly in case of a gas trip.

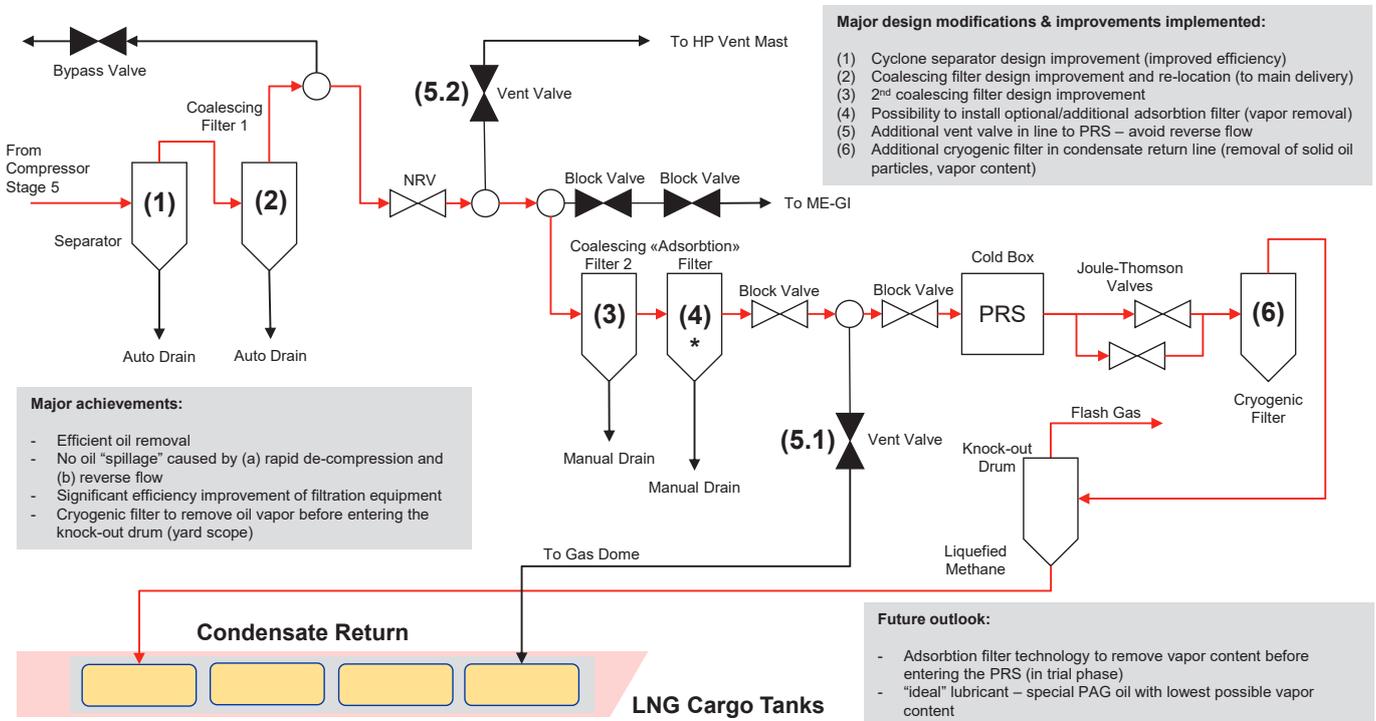
Furthermore, oil transfer from the compressor to the LNG tanks has been seen. The solution is installation of an oil trap system before the BOG returns to the LNG tanks, see Fig. 16.

Fig. 16: Oil trap system before the LNG tanks

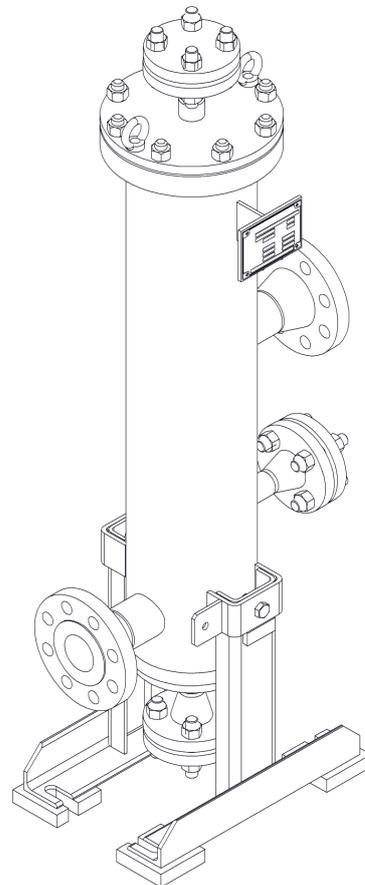
In some cases the LNG high-pressure (HP) pumps have had a limited service time because the cold end of the pumps has been worn. The wear has been caused by contamination of gas and piping and the solution is an installation of a cryogenic 10 micron filter in front of the HP pumps, see Fig. 21.

Fig. 21: The cryogenic 10 micron filter should be installed before the HP pumps

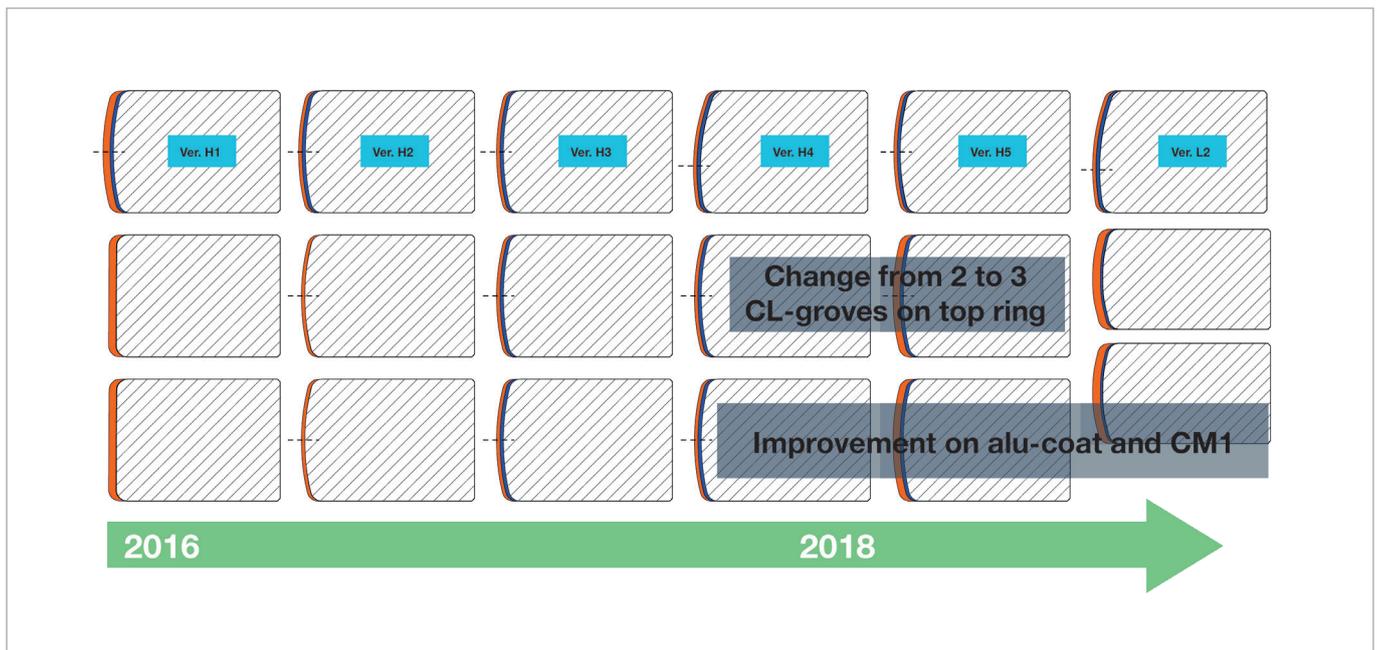
The first focus was the piston ring design, and this led to a number of changes, see Fig. 24.

Fig. 24: Piston ring evolution

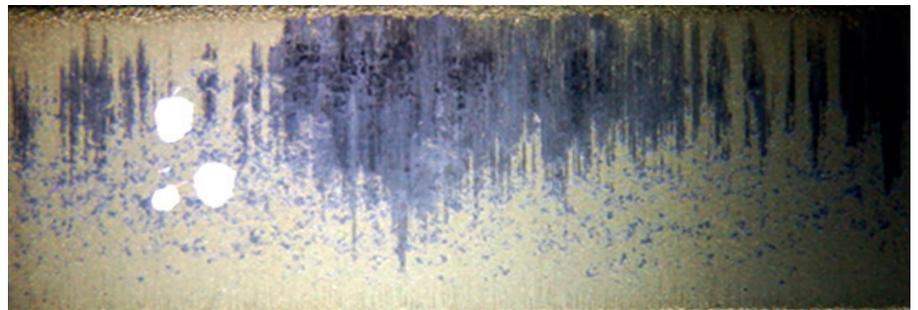
In the early days, the majority of scuffing occurred in the period just after the alucoat had been worn off. This led us to focus on the roughness of the CM1 layer, which is specified as “as-sprayed.” Pictures, where the CM1 layer has penetrated the alucoat, (Fig. 28) showed many small dots indicating a too high surface roughness.

This phenomenon is known to cause scuffing. In addition, some defects were discovered in the coating matrix with un-molten particles, which may potentially weaken the coating matrix.

Fig. 28: Piston ring running surface where the hard coating (CM1) has penetrated the running-in alucoat

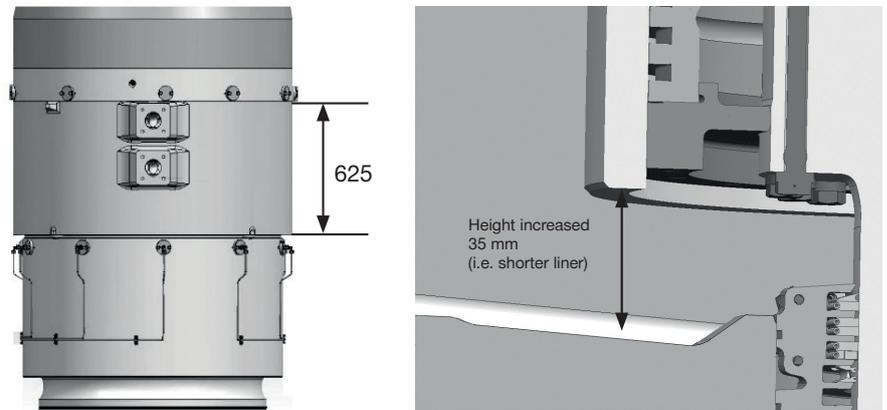
Firstly, reducing the inner diameter of the PC-ring solved the upper contact problem and increased the clearance between the O-ring and the cylinder frame at the lower contact point, which resulted in an increased PC-ring efficiency. Secondly, a longer liner cooling jacket was introduced to improve both the liner deformation and the cooling of the piston rings, see Fig. 30 (left side). As a third countermeasure the airflow path below the liner was

improved to reduce the air speed between the scavenge box bottom and liner as shown in Fig. 30 (right side).

Fig. 30: Left: cylinder liner cooling jacket height; Right: clearance between liner and scavenge bottom

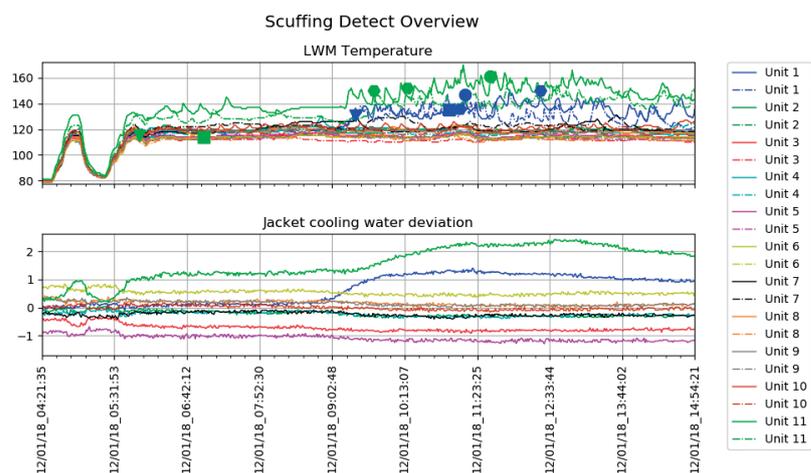
Maybe the most important task prior to any analysis is to locate scuffing in the available data. Best suited for this approach are the liner wall temperatures and liner jacket cooling water temperatures, which show the clearest response to scuffing. A scuffing incident, where two units simultaneously start scuffing, is shown in Fig. 33.

Fig. 33: Liner wall temperature during scuffing

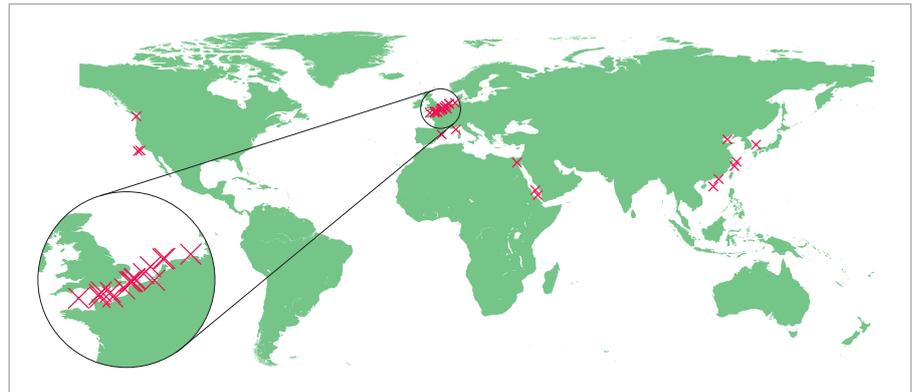
Fig. 35: Location of scuffing incidents in 2018

Fig. 35 displays the locations of all scuffing incidents in 2018 for which the start of the incident could be clearly identified. About 70% of all scuffing incidents happened inside an Emission Controlled Area (ECA). Furthermore, scuffing has not only occurred in the European ECAs, but also in the Asian and American ECAs.

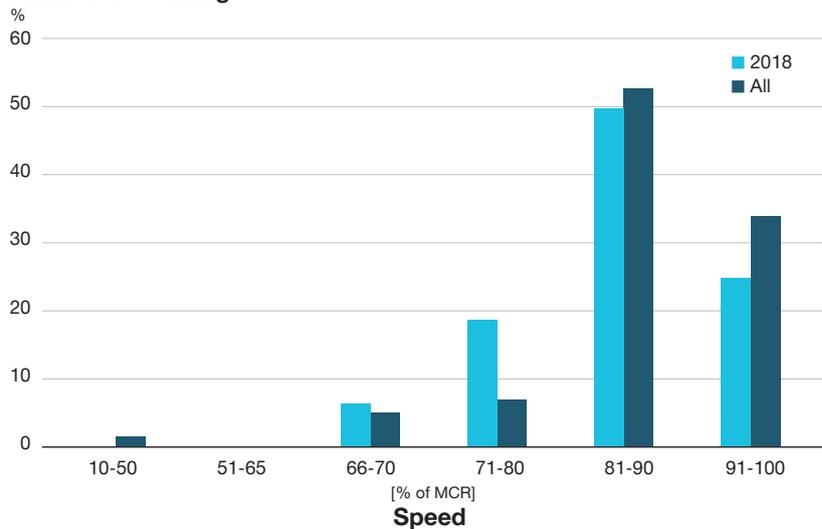
engine speed is above 80% MCR speed, but there is no strong indication that scuffing happens solely at high engine load or speed as shown in Fig. 36.

Fig. 36: Scuffing events 2018, grouped according to engine speed

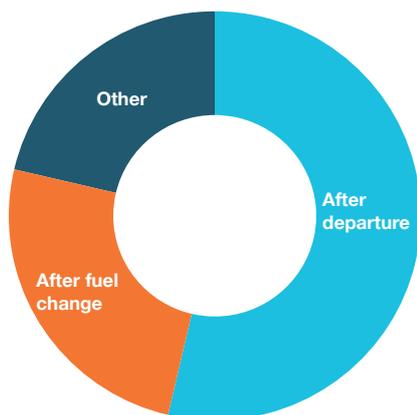
A large fraction of all scuffing cases typically starts shortly after departure from a harbour, where load-up of the main engine takes place. More precisely, 55% of all scuffing cases occurred within the first 12 hours after departure. Besides the scuffing incidents occurring shortly after departure, there is another group of scuffing incidents, which take place after a fuel changeover from high- to low-sulphur fuel. In 2018, 25% of all scuffing cases took place within just 12 hours after such a fuel changeover, as shown in Fig. 37.

Fig. 37: Scuffing incidents in 2018, grouped according to the cause of the incident

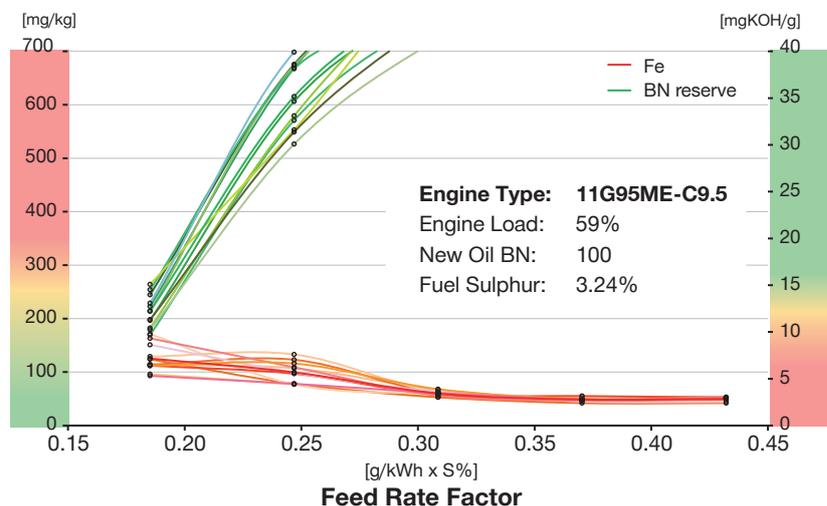
which consists of a stepwise reduction of the cylinder oil feed rate, one step every 24 hours while also taking drain oil samples. Once analysed, a graph can be drawn that shows the correlation between feed rate factor, the iron content and the BN of the drain oil. Fig. 39 shows the sweep test results that when using a BN100 cylinder oil a very low FRF is needed to control the cold corrosion.

Fig. 39: Feed rate sweep test

To optimise the G95ME-C9.5 operation, the operators were recommended to switch to BN70 oil instead of BN100 to ensure that the risk of bore polish was reduced, as many incidents had happened during manoeuvring. A temporary increase of the minimum feed rate from 0.6 to 0.8 g/kWh was also recommended. Once the new LCDv2 features were introduced with the new ECS 1609-6, the guiding minimum was again reduced to the normal 0.6 g/kWh. When using BN70, the FRF often remained low. Cold corrosive wear could only be observed when shutting down the LDCL cooling system and refraining from increasing the part-load temperature. However, liner

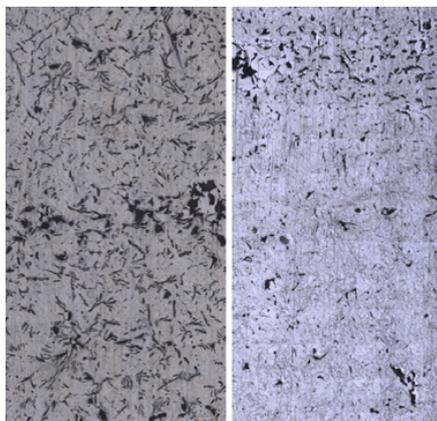
Fig. 40: Enlarged photos of the liner surfaces, the standard liner surface on the right and the laser-hardened on the left

Service experience from operation on both low-sulphur and high-sulphur fuels have shown a very open graphite structure. Test on the G95 engines performed after the initial running-in have shown a clear improvement in the graphite openness when comparing the laser hardened liner with the reference liner, see Fig. 40.

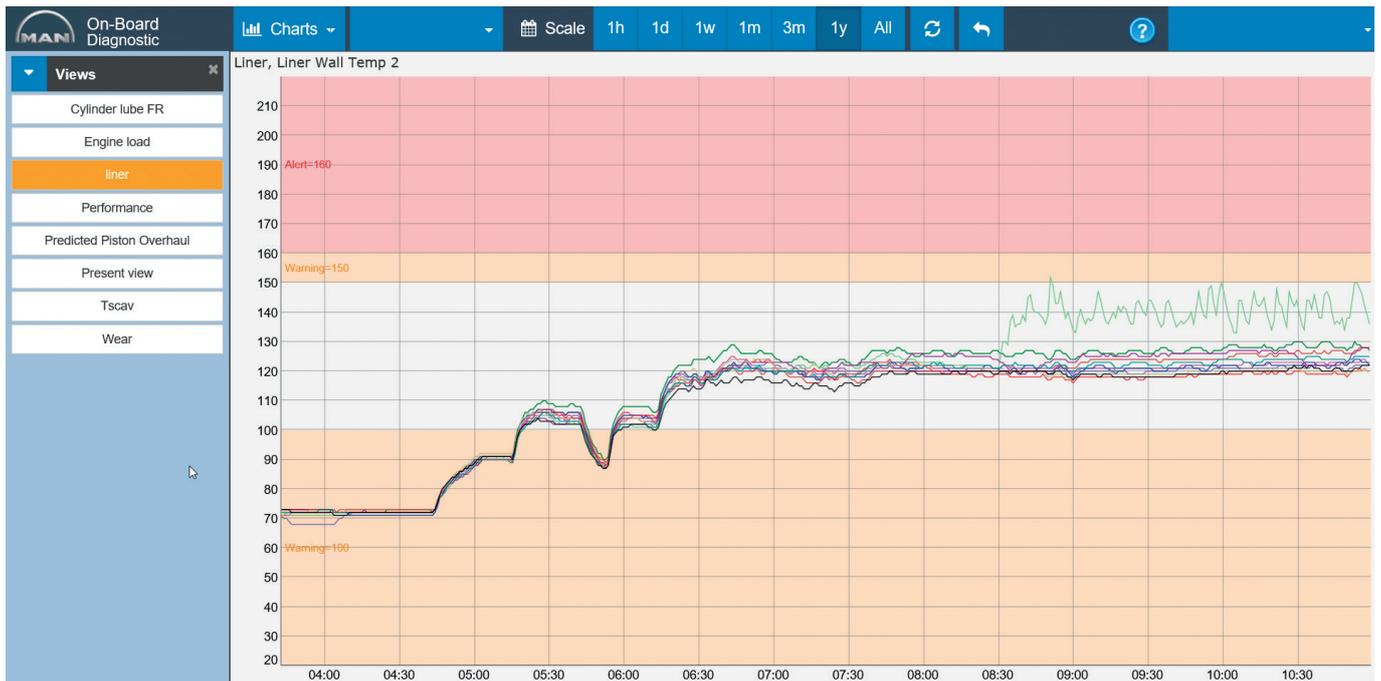
Fig. 47: OBD liner wall graph, during scuffing

occurred 8 October 2018. Once the incident was reported, the liner wall information could be used to confirm the incident (Fig. 47) and engine

conditions, rpm and load, could be recorded for a further analysis of the incident (Fig. 48).

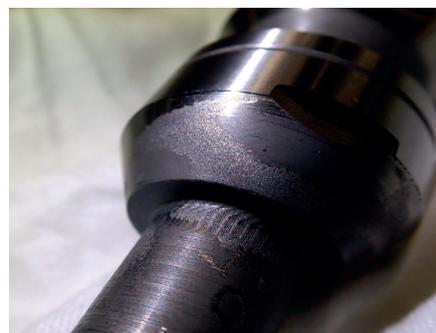
Fig. 58: Cavitation on PEVA slide version I

One of the more long-lasting and repetitive issues is PEVA feedback failure alarms, also referred to in Table 2, third inspection. This issue only pertained during ME manoeuvring, and it was concluded that cavitation and sticking of the PEVA main slide was the cause.

Fig. 58 shows the cavitation damage on the PEVA slide and Fig. 59 shows the damage on corresponding counterpart of the PEVA housing.

As a rapid test, the PEVAs were cleaned and the slide was rotated 180 degrees, thus, the area with cavitation was no longer directly exposed to the flow from the hydraulic pressure port. After assembly, the engine was tested and no alarms have been returned since then. The design was updated immediately because of the findings and the test vessel received a replacement valve with an updated slide, which is now running to accumulate hours. In order to assist with the production of control valve slides, the PEVAs had another slide design than normally for control valves from the beginning.

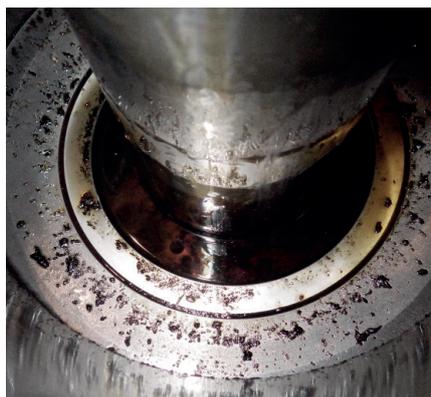
Fig. 62: Air spring chamber

The stem seal was worn down by 23% during the clocked running hours. As a result, the amount of coke deposits inside the spindle guide and air spring chamber were higher than normal. A cause of ring wear can be a too small amount of oil in the controlled oil level (COL) and therefore a lack of preservation of the ring during operation. This may be solved by tuning the safety valve which controls the air

Figs. 62 and 63 display the increased debris in the air spring chamber and the amount of coke deposits in the

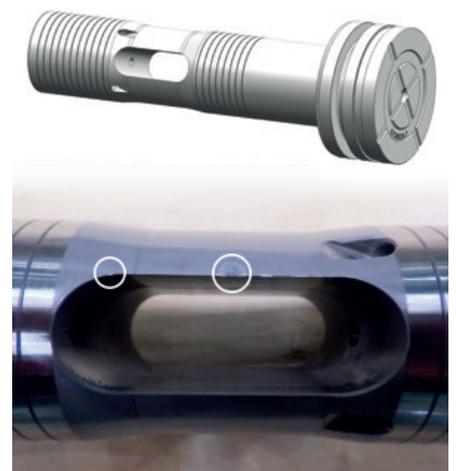
Fig. 67: Inlet hole of suction valve

At an early stage, we saw peel-off of coated material from the inlet hole opening of the suction valve (shown with circles on Fig. 67). The previous design had sharp edges in the oval opening of the suction valve. When the plunger went through a nitrating process, the entire sharp edge around the opening would be fully nitrated and not just surface-coated. This edge would be extremely brittle and not able to withstand the flexing of the plunger

experienced during an injection. The issue has been solved by rounding the edge in the oval opening.

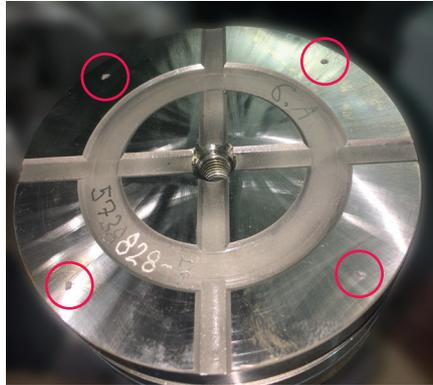
Fig. 68: Cavitation marks on the hydraulic plunger top

Cavitation marks appeared on top of the hydraulic plunger. The marks clearly occurred 90 degrees apart, see Fig. 68. This confirms our suspicion about too few pressure relief grooves on top of the hydraulic plunger.

Design changes have been implemented to solve the issue on future designs. Additional relief grooves have been created, see the illustration in Fig. 69.

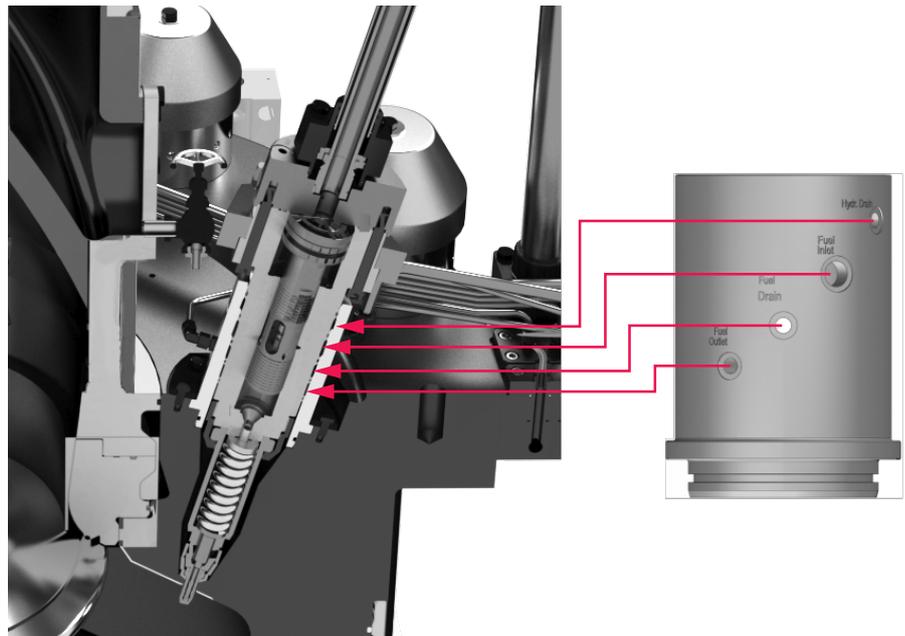
Fig. 70: FBIV design in the cylinder cover

The test vessel where the TCEV/FBIV testing was conducted experienced a breakdown at sea due to a broken O-ring. The failure pointed at additional challenges related to the FBIV design.

The FBIV is mounted in a sleeve, which is protruding from the cylinder cover, see Fig. 70. This sleeve has a relief hole to prevent pressure build-up in case the fuel valve does not seal properly against the seat in the fuel valve pocket.

When the O-ring snapped, the fuel outlet compartment had access to fuel oil return and fuel was spraying up against the exhaust valve housing. Subsequently, the crew attempted to overhaul the FBIV, which resulted in a complete failure of the FBIV due to a

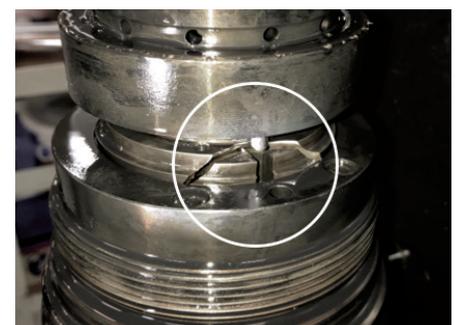
Fig. 71: Wrong assembly of fuel valve part and pump barrel

This incident revealed the vulnerability of the design related to assembly of the fuel valve part and the pump barrel. Guide pins, which can be difficult to align, can create an uneven load distribution between thrust piece and barrel. In this case the mentioned components were crushed, see Fig. 71.

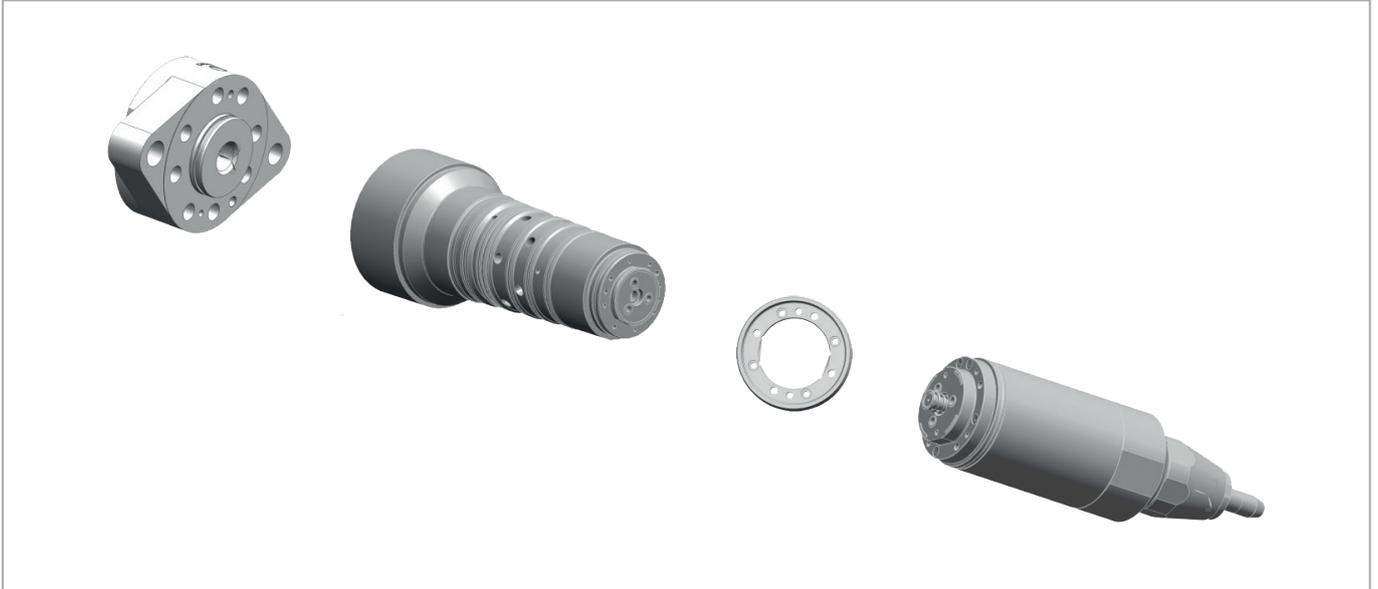
Fig. 72: Updated design of FBIV assembly

Furthermore, the mounting bracket was twisted out of alignment with the pin, when it was mounted in the cylinder cover. The design can cause the mounting bracket to be twisted out of alignment and create a potential risk of an incorrect injection angle into the combustion chamber.

Fig. 72 shows top cover, barrel, guide bushing and the fuel valve part. From the left, the top cover is mounted on the barrel with a heavy-duty guide pin, which leaves only one mounting solution. The bushing is mounted on the barrel and acts as a guide for the fuel valve. All three parts have an asymmetric mating part for easy assembly.

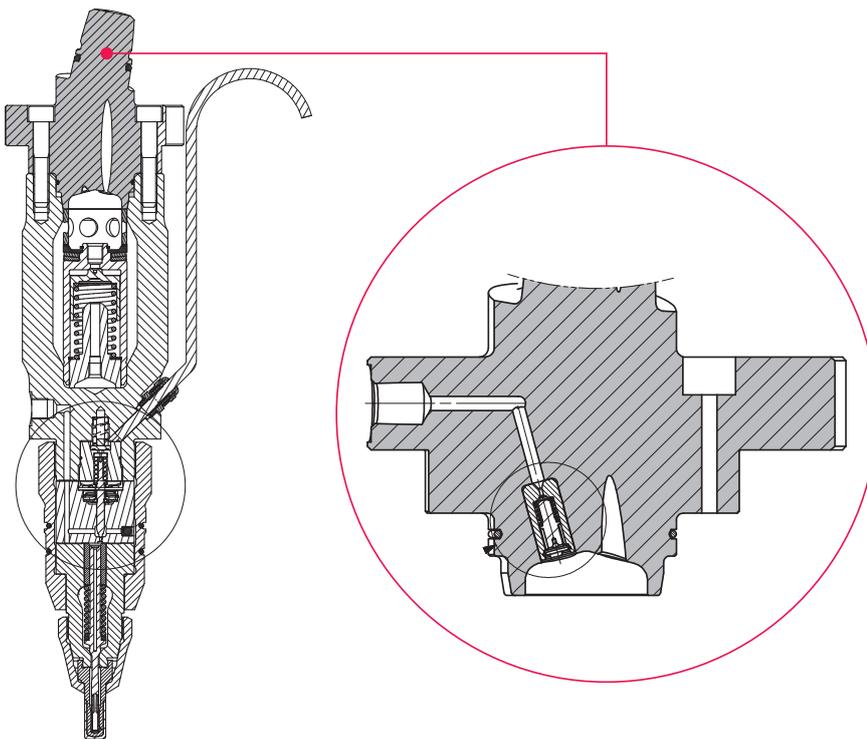
Fig. 76: Redesigned recirculation valve

shop test that only one pump in operation is not sufficient to build-up the rail pressure to the start level specified by the ECS. The reason was that the common flow through the circulation valves of the CR valves, Fig. 76, was larger than the nominal delivery supply of one CR pump. The manufacturer of CR injection valves was asked to redesign the recirculation to reduce the flow. This modification was made during the prototype shop test at Makita.

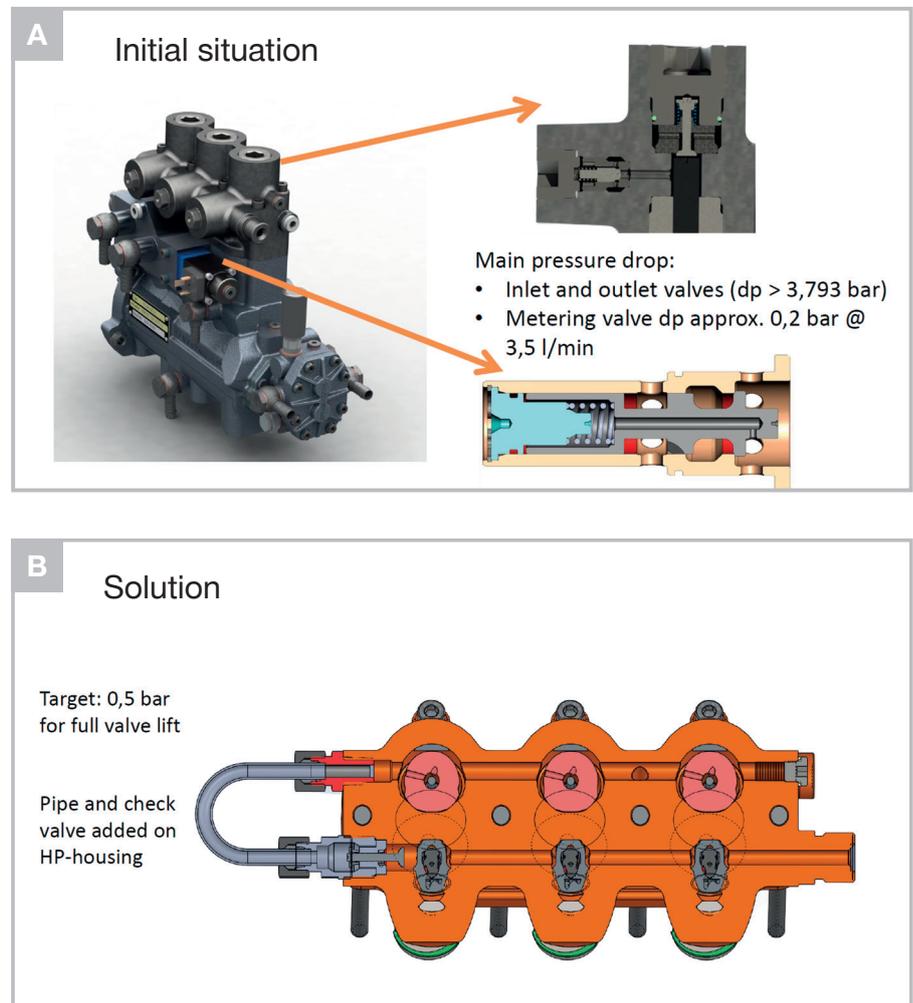
Fig. 77: High-pressure pump redesign

In the process of redesigning the recirculation valve it was discovered that the pressure drop of approximately 4 bar across the stopped HP pump was too large (see Fig. 77A). Consequently, the HP pump manufacturer was asked to reduce the pressure drop across the pump which they solved by inserting an external bypass line in series with a built-in upstream non-return valve (Fig. 77B).

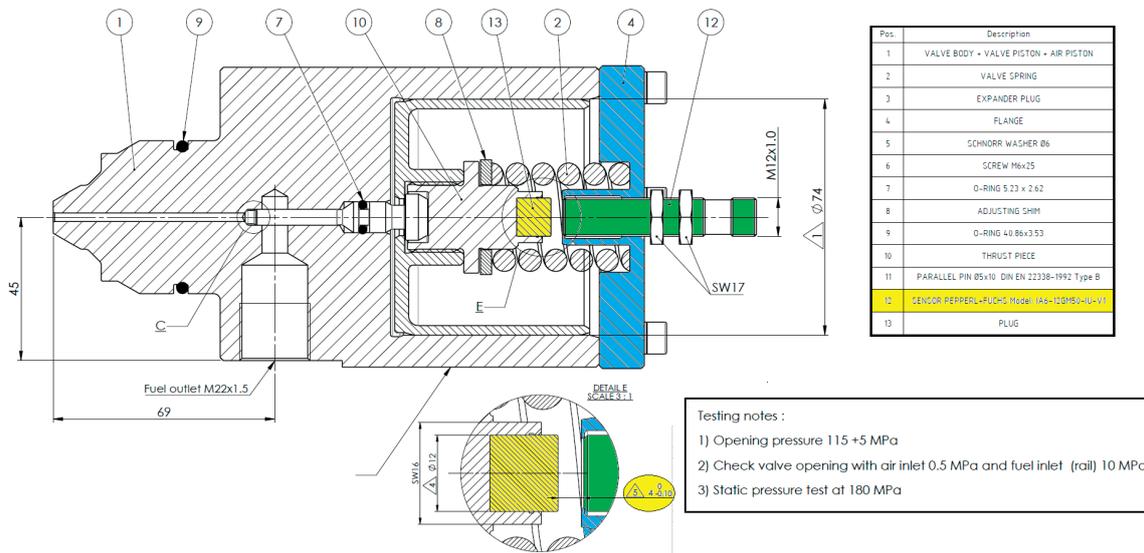
Fig. 79: Combi valve redesign

An issue occurring for an engine running with open COMBI valve was discovered during the preliminary test run. The COMBI valve opened as intended at high rail pressure, but the normal reset function of the COMBI valve did not function correctly. The COMBI valve is reset correctly by stopping the engine and reducing the rail pressure to a level below the COMBI valve reset value (<240 bar). Consequently, it was suggested to include digital position monitoring of

the COMBI valve needle along with the introduction of a position sensor on the COMBI valve top cover. A redesigned top cover was introduced (Figs. 79, pos. 4 and 12). Sensor calibration is performed to achieve a correct position feedback signal to the ECS (ECS SW parameter).

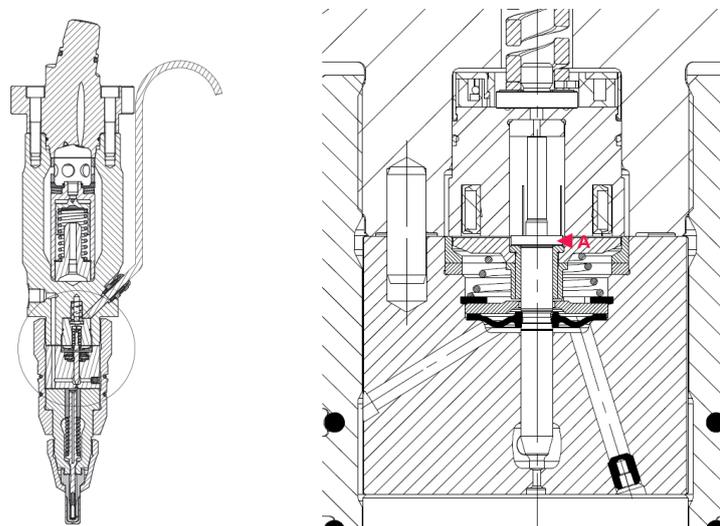
Fig. 80: CR injection valve and control valve

Numerous intermittent driver shutdown alarms occurred during the maiden voyage. The shutdown condition was reset automatically within a few seconds. The extensive troubleshooting finally pointed at a faulty CR injector instead of the driver module, which initially was suspected to be the root cause. At an open-up

inspection, breakage of the control valve piston collar/shoulder (Fig. 80, pos. A) was discovered. As it could be expected, the disturbance in the magnetic flux caused by the collar breakage gave current transient peaks in the driver outlet channel. These current peaks were detected by the driver supervision as a fault condition.

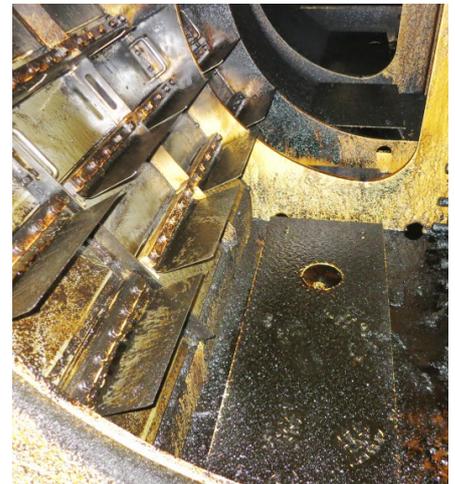
Fig. 84: Sludge and dirt accumulation in the scavenge receiver when operating with EGR

The amount of sludge and dirt accumulated in the scavenge air receiver is increased in EGR operation compared to operation without EGR, Fig. 84. The feedback from owners operating continuously with EGR or EcoEGR is that the cleaning interval has been slightly reduced.
